| BILL NO. | SPONSOR | TITLE | DATE INTRODUCED | DATE REFERRED | CMTE REFERRED | FISCAL NOTES | PUBLIC HEARING DATE | DATE COMMITTEE REPORT FILED | NOTES |
|---|---|---|---|---|---|---|---|---|---|
| 12-38 (COR) | Therese M. Terlaje | AN ACT TO RESERVE LOT NO. 2417-I-R7, THE FORMER DEPARTMENT OF PUBLIC HEALTH AND SOCIAL SERVICES MAIN BUILDING IN MANGILAO, FOR IMMEDIATE USE BY THE DEPARTMENT OF PUBLIC HEALTH AND SOCIAL SERVICES AND TO AUTHORIZE ITS USE FOR THE GUAM COMMUNITY COLLEGE NURSING PROGRAM. | 1/13/25<br>9:18 a.m. | 1/21/25 | Committee on Land, Environment, Housing, Agriculture, Parks, and Infrastructure. | Request: 1/21/25 | 4/1/25<br>9:00 a.m. | 7/11/25<br>As Amended. | Exhibit A |

RE: **Committee Report on Public Hearing** [Bill No. 12-38 \(COR\)](#) – Therese M. Terlaje – AN ACT TO RESERVE LOT NO. 2417-1-R7, THE FORMER DEPARTMENT OF PUBLIC HEALTH AND SOCIAL SERVICES MAIN BUILDING IN MANGILAO, FOR IMMEDIATE USE BY THE DEPARTMENT OF PUBLIC HEALTH AND SOCIAL SERVICES AND TO AUTHORIZE ITS USE FOR THE GUAM COMMUNITY COLLEGE NURSING PROGRAM.

# CONDITIONAL ASSESSMENT OF MANGILAO PUBLIC HEALTH BUILDING

PROJECT NO.: 460-5-1007-F-MAN  
FINAL REPORT  
July 18, 2025

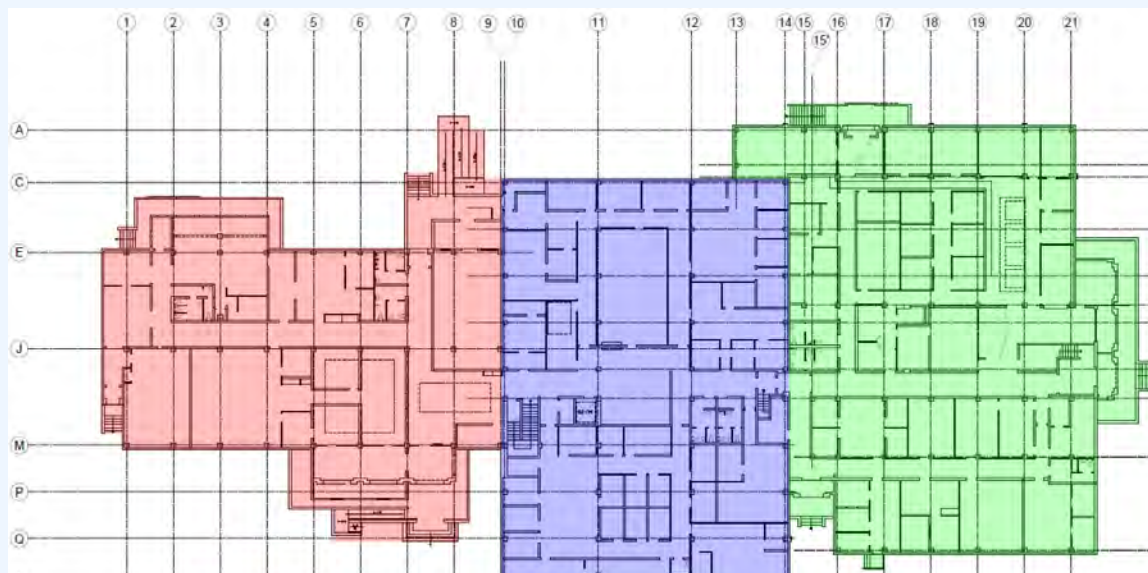
Initial observations show that the facility is divided into three (3) distinct structural segments. The first segment is a one-story structure spanning grid lines 1 through 9. The second segment is a two-story structure between grid lines 10 and 14, while the third is another two-story section extending from grid lines 14 to 21. These segments are separated by visible joints/gaps, which can be observed upon removal of the suspended ceiling tiles at grid lines 10 and 14. An annotated floor plan illustrating the segmented layout of the building is provided below.

Figure 4: Existing facility divided into three (3) segments.

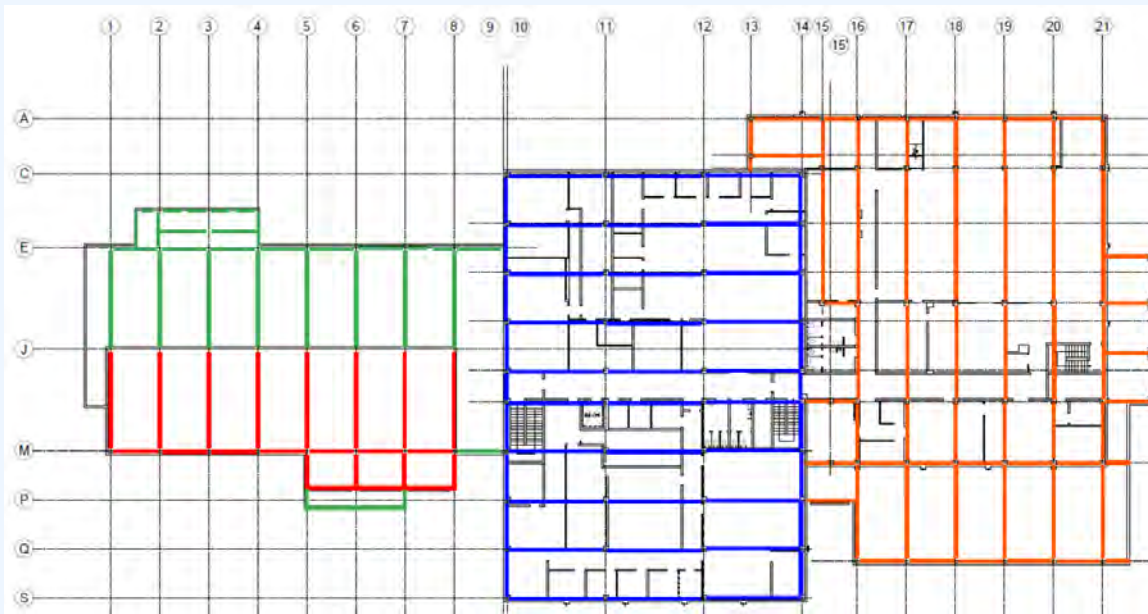
The main LFRS utilized for this facility is moment-resisting frames (MRF), as observed in the presence of rigid connections between beams/girders and columns. However, due to the absence of record drawings, the MRF's degree of ductility was not fully confirmed.

Figure 5: All colored lines shown indicate beams/girders. The green and red lines support segment #1's roof. The blue lines support segment #2's second floor. The orange lines support segment #3's second floor and roof of segment #3's laboratories.

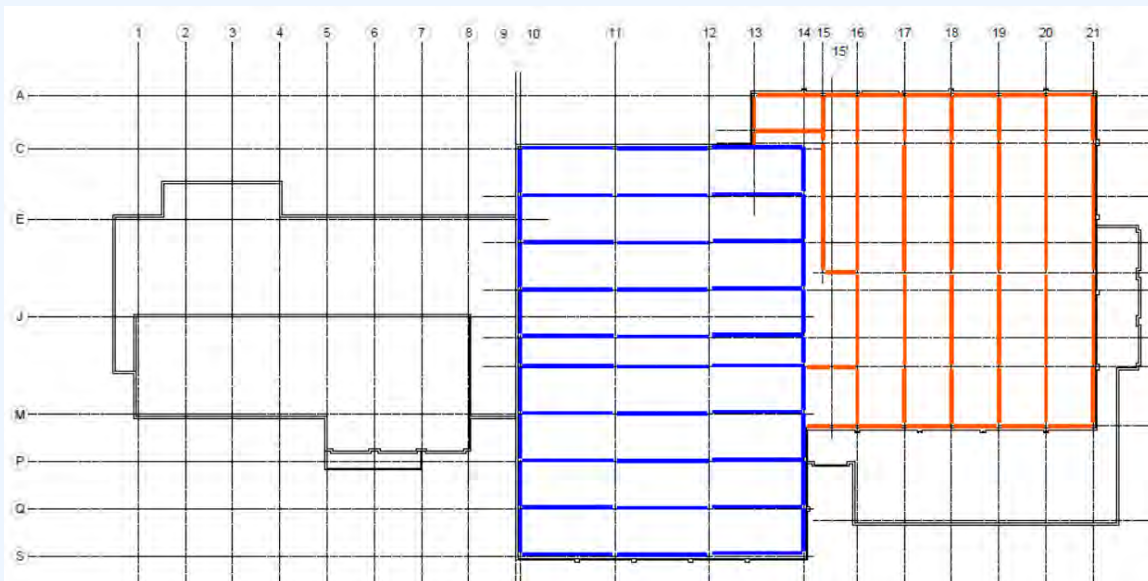
Figure 6: All colored lines shown indicate beams/girders. The blue lines support segment #2's roof. The orange lines support segment #3's roof.

Upon detailed observation, it was noted that the moment-resisting frames (MRFs) in each building segment are oriented differently.

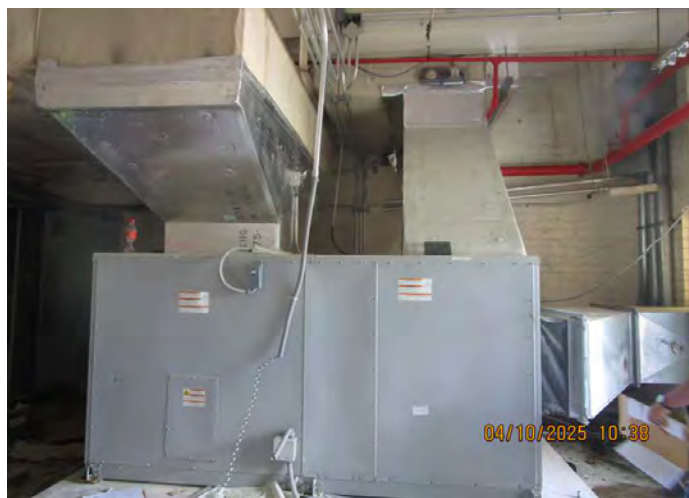
**Photo 7:**

| Remarks: | Damage Air Handling unit (AHU). Cut refrigerant piping. |

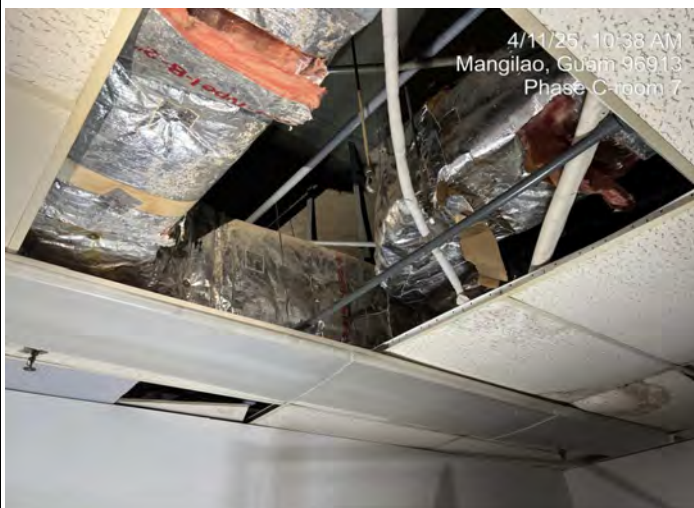
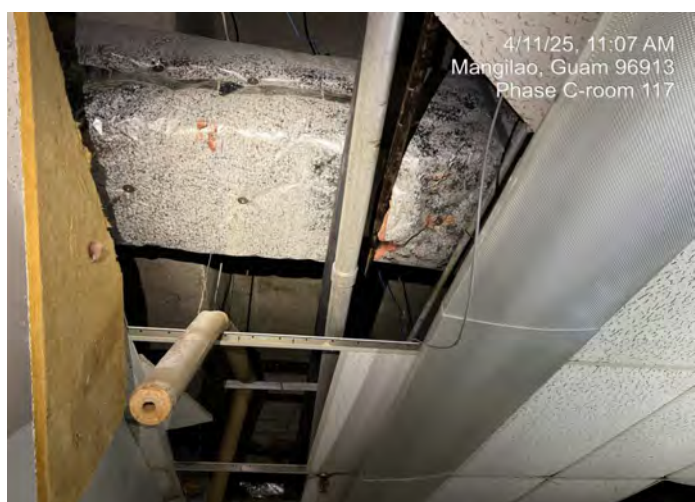
**Photo 15:**

| Remarks: | Damage and abandoned Air-Handling unit. Cut refrigerant piping connections and electrical wirings. |

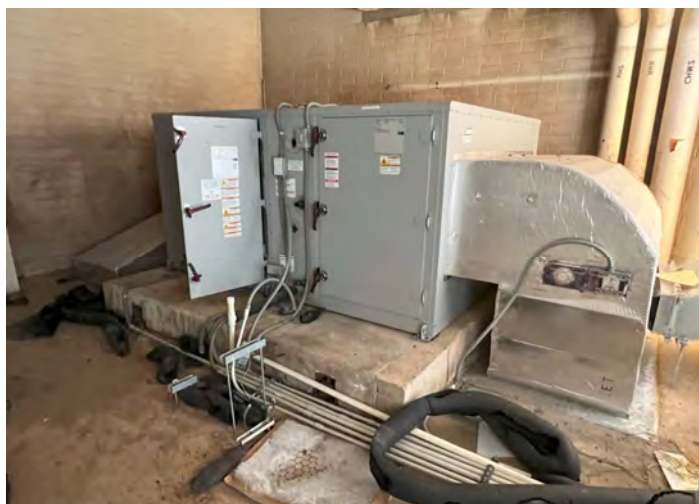
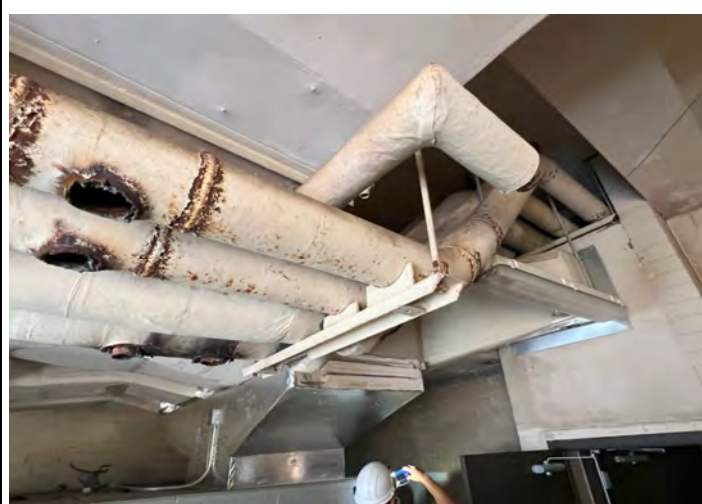
**Photo 35:**

| Remarks: | No insulation of outside air intake ductwork (Not compliance). Corroded duct. |

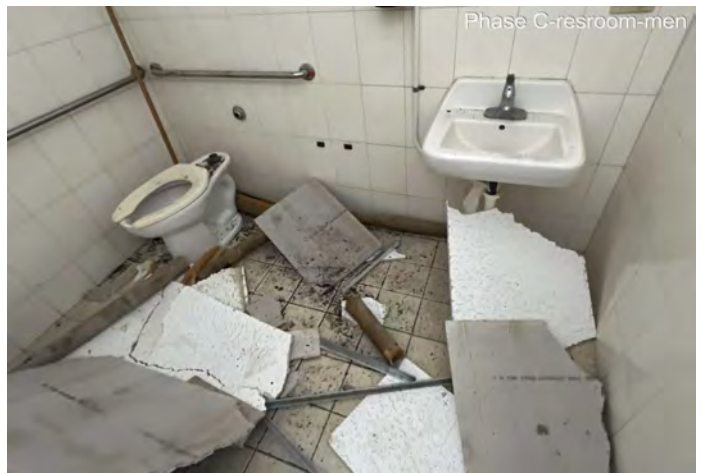
**Photo-16:**

| Remarks: | Typical condition of damage Urinals with cut piping connections and missing flush valves. |

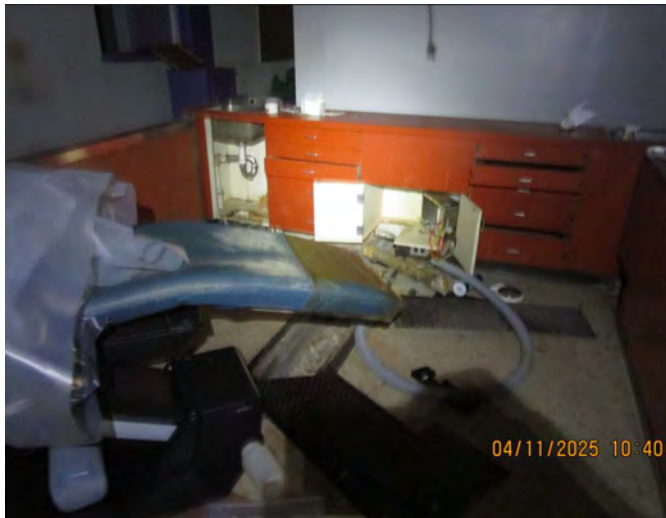
**Photo 19:**

| Remarks: | Cut and damage coldwater piping in trench for dental equipments and sinks cold water supply. Damage sink |

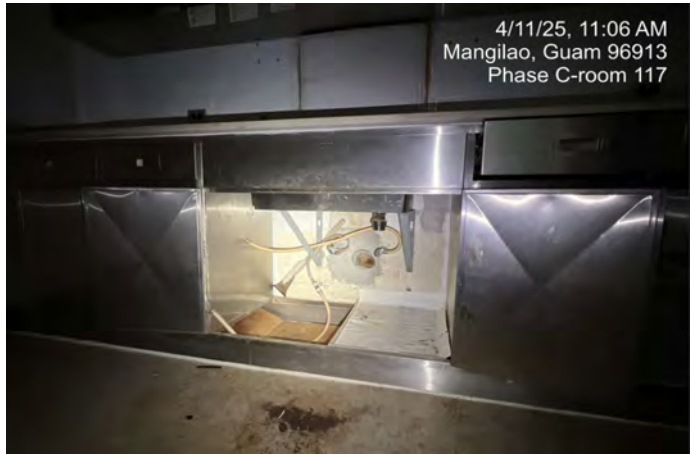
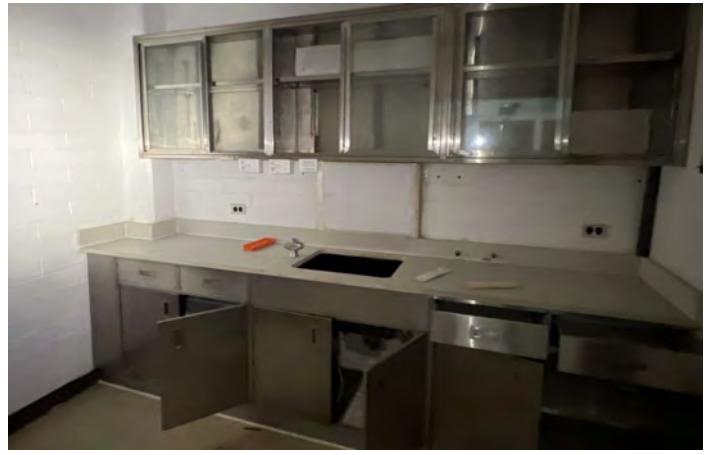
**Photo-21:**

| Remarks: | Cut and damage coldwater piping in trench for dental equipments and sinks cold water supply. Missing faucets in sinks. |

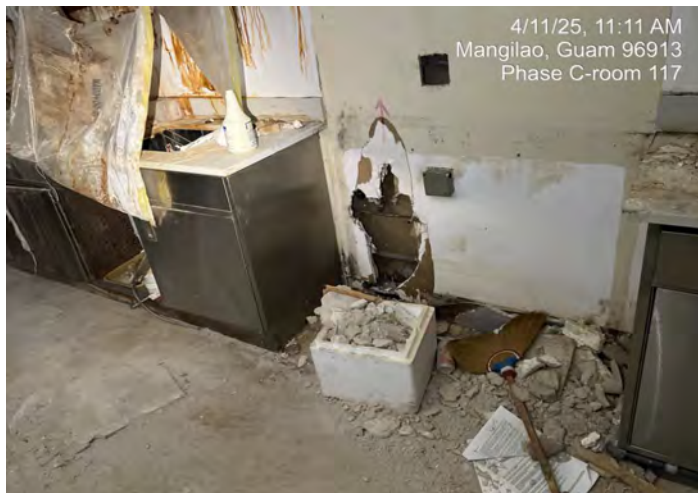
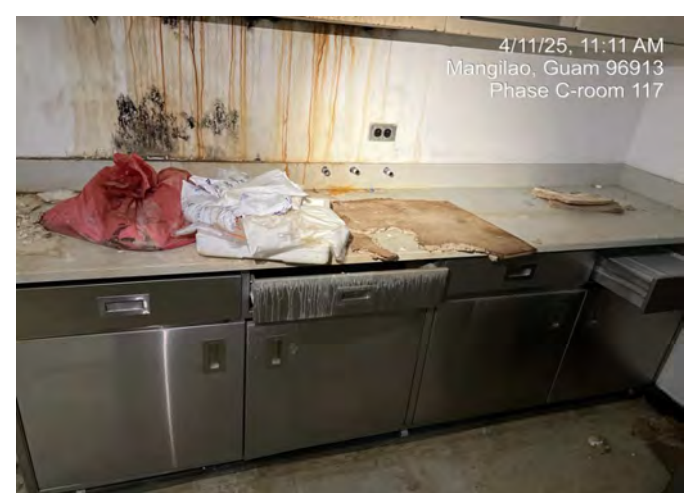
**Photo 23:**

| Remarks: | Cut and damage cold & hot water piping supply and waste piping in sink. Missing faucets. |

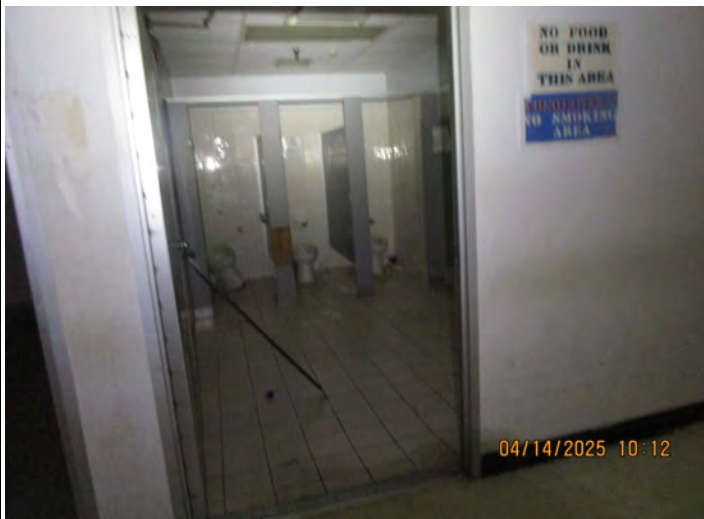
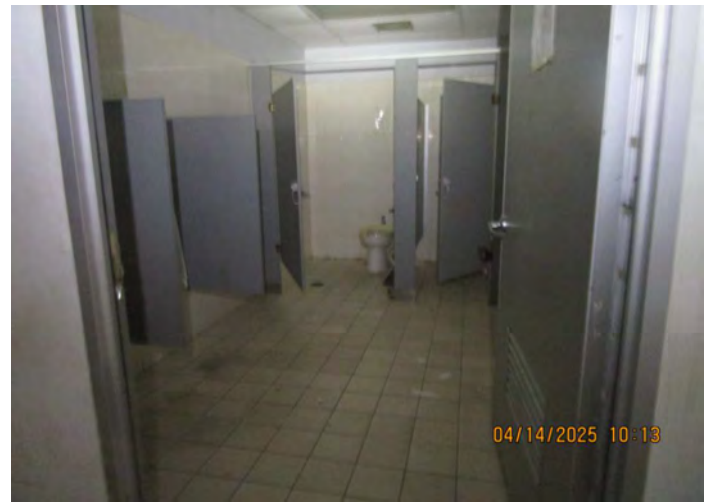
**Photo-29:**

| Remarks: | Typical condition of damage Water Closets with cut piping connections and missing flush Valves and covers. |

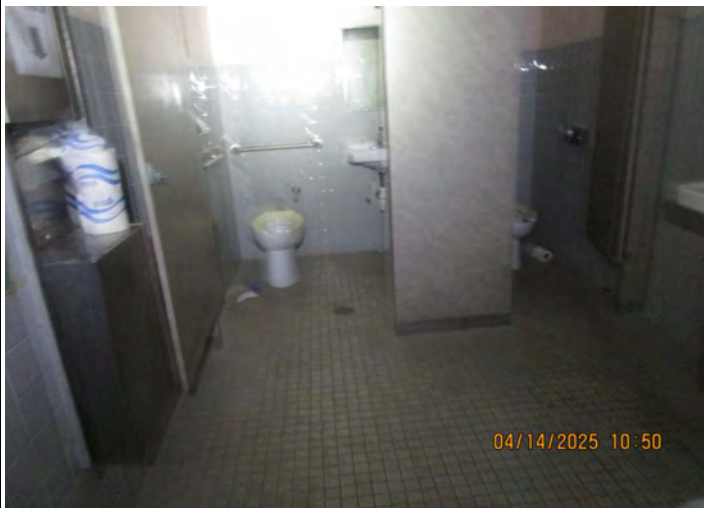
**Photo 31:**

| Remarks: | Typical condition of damage Water Closets with cut piping connections and missing flush Valves and covers. |

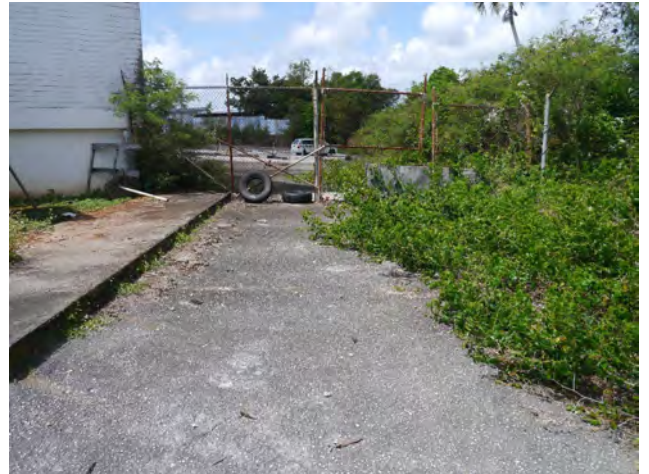
| 3 | Description: | <b>Cyclone fence is barely visible due to overgrown shrubs and bushes – West side</b> |

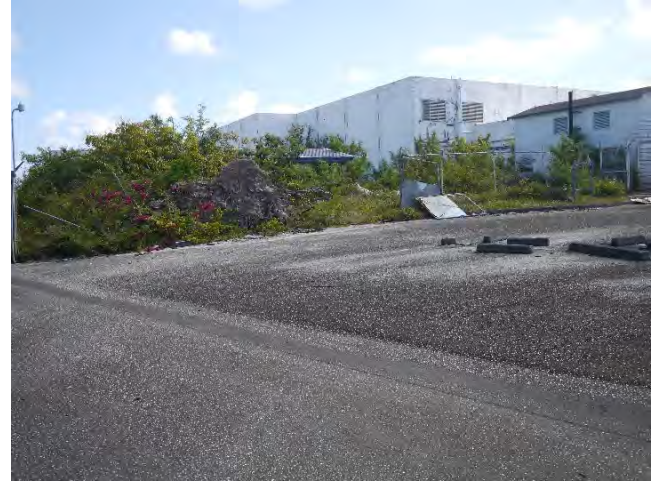
| 4 | Description: | <b>Vehicular access gate and cyclone fence extensively damaged – Northwest side</b> |

| 1 | Description: | <b>Damaged vehicular access gate and cyclone fence from generator building to concrete wall – West Side</b> |

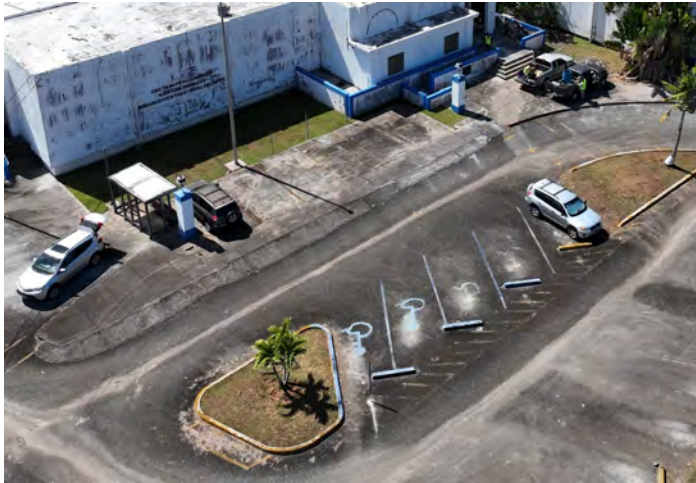
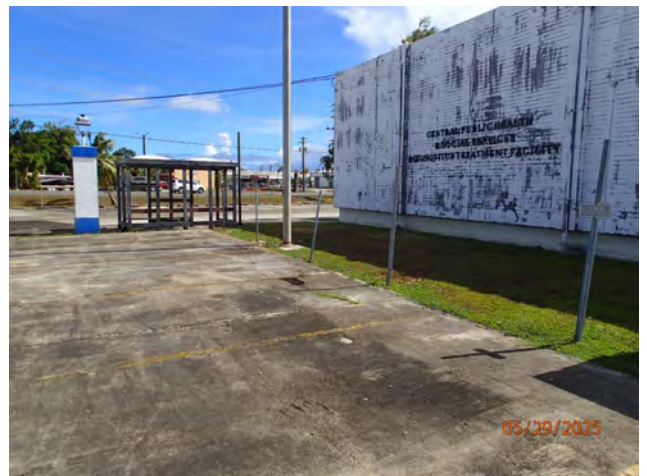
| 3 | Description: | <b>No designated signs and access isle for ADA parking. ADA pavement stripes and marking are faded.</b> |

| 4 | Description: | <b>Designated parking signs are missing..</b> |

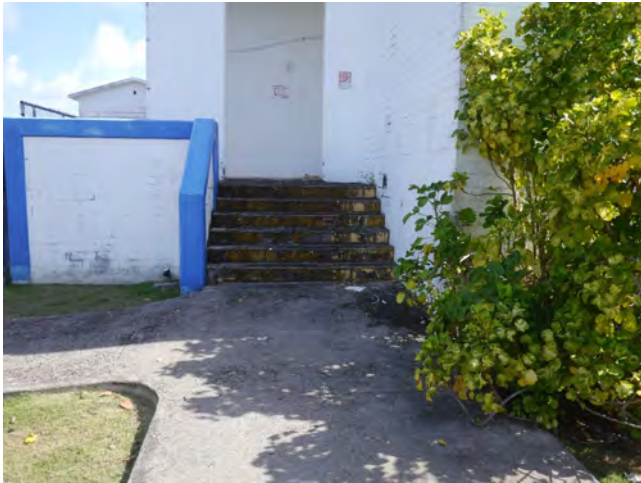
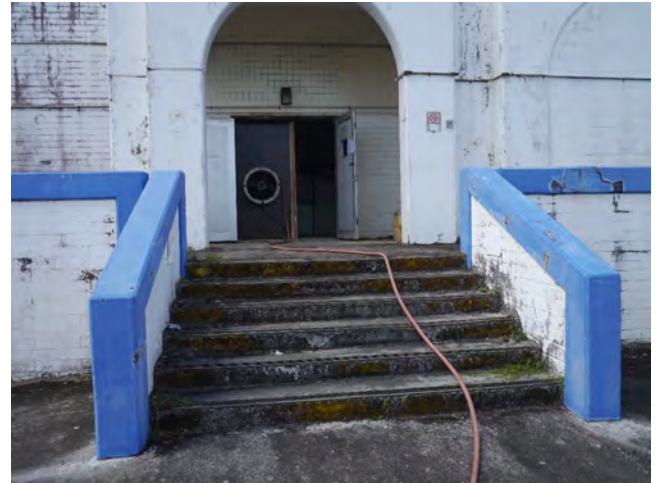
| 3 | Description: | <b>Missing handrails at exterior stairs at southwest side of building 1.</b> |

| 4 | Description: | <b>Missing handrails at exterior stairs at north side of building 3.</b> |
