RE: **Amended Committee Report on Public Hearing [Bill No. 21-38 \(COR\)](#)** – Tina Rose Muna Barnes – AN ACT TO TRANSFER LOT NO. 2417-1-R7, MUNICIPALITY OF MANGILAO FORMERLY KNOWN AS THE DEPARTMENT OF PUBLIC HEALTH AND SOCIAL SERVICES CENTRAL HEADQUARTERS, FROM THE DEPARTMENT OF PUBLIC HEALTH AND SOCIAL SERVICES TO THE GUAM COMMUNITY COLLEGE FOR THE CONSTRUCTION OF A NURSING ANNEX.

# CONDITIONAL ASSESSMENT OF MANGILAO PUBLIC HEALTH BUILDING

PROJECT NO.:460-5-1007-F-MAN  
FINAL REPORT  
July 18, 2025

**PROJECT: Professional Consulting Services for a Conditional Assessment of the Mangilao Public Health Building, Project No. 460-5-1007-F-MAN**

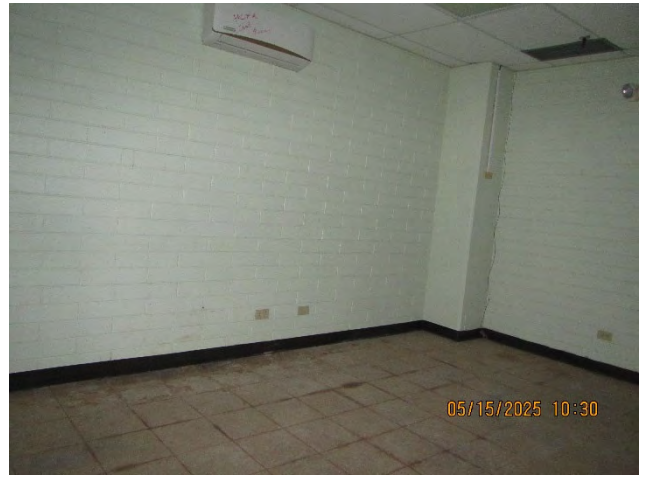
2	Building Component:	<b>1<sup>ST</sup> FLOOR TYPICAL FLOOR CONDITIONS WITH MOLD</b>

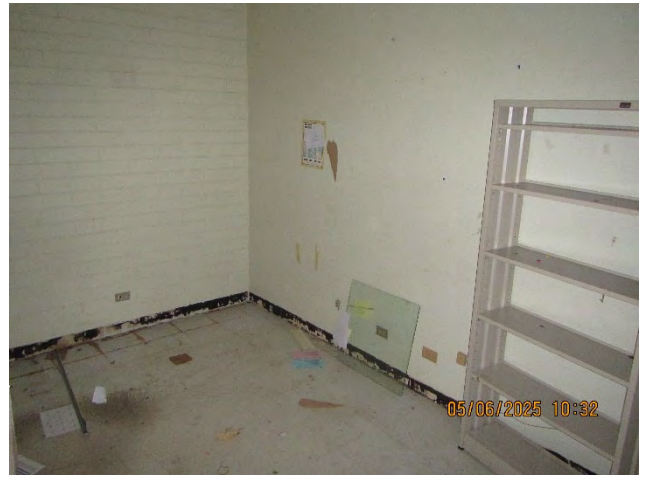
2	<i>Building Component:</i>	<b>2<sup>ND</sup> FLOOR TYPICAL FLOOR CONDITIONS WITH MOLD</b>

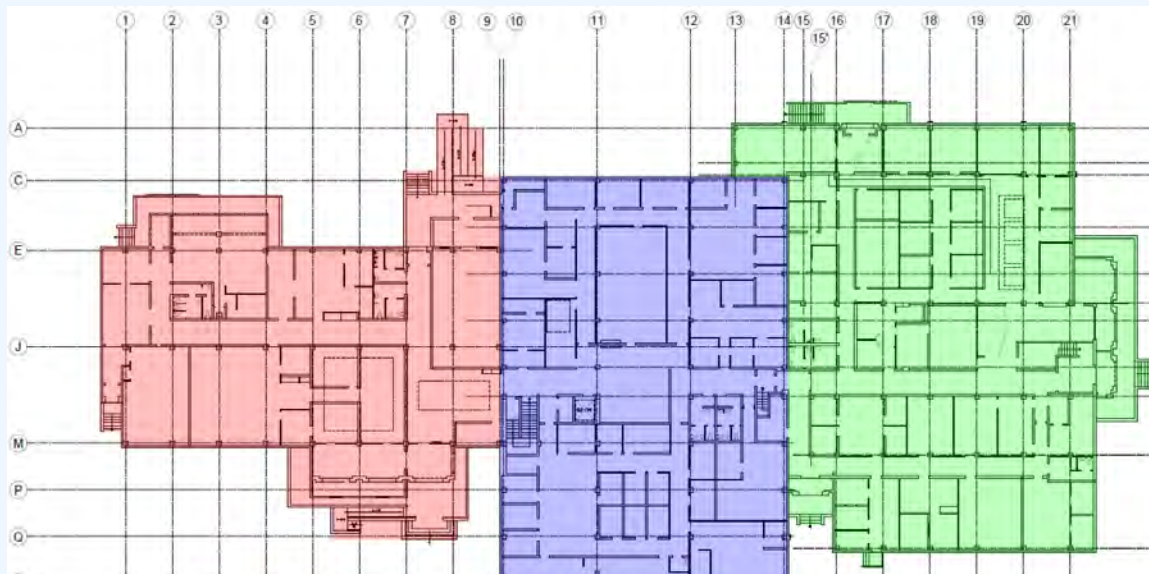
Figure 4: Existing facility divided into three (3) segments.

Initial observations show that the facility is divided into three (3) distinct structural segments. The first segment is a one-story structure spanning grid lines 1 through 9. The second segment is a two-story structure between grid lines 10 and 14, while the third is another two-story section extending from grid lines 14 to 21. These segments are separated by visible joints/gaps, which can be observed upon removal of the suspended ceiling tiles at grid lines 10 and 14. An annotated floor plan illustrating the segmented layout of the building is provided below.

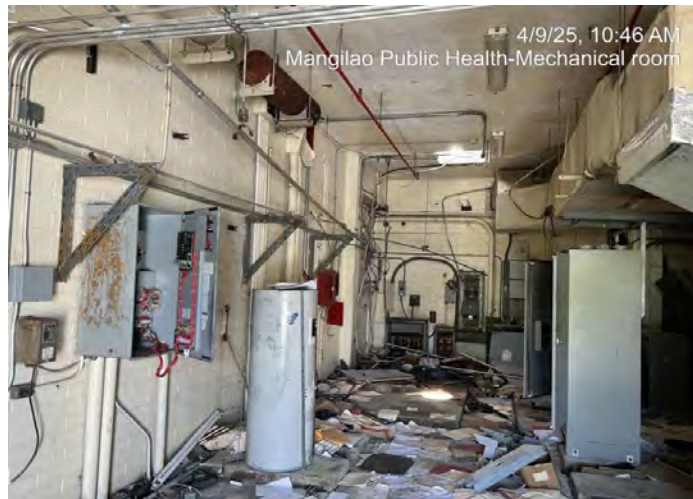
**Photo-5:**

Location:	Ground Floor - Mechanical Room
Remarks:	Damage Mechanical control panels for AHU. Abandoned corroded expansion tanks.

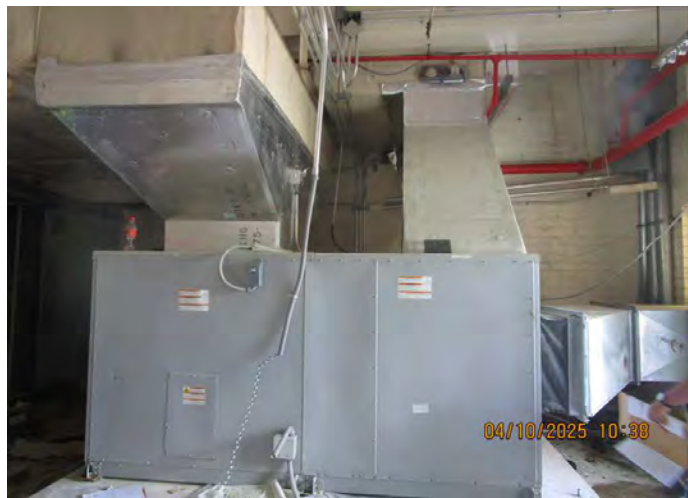
**Photo 7:**

Location:	Ground Floor - Mechanical Room
Remarks:	Not working Air Handling unit (AHU) show cut electrical connections. No insulation of outside air intake ductwork (Not compliance)

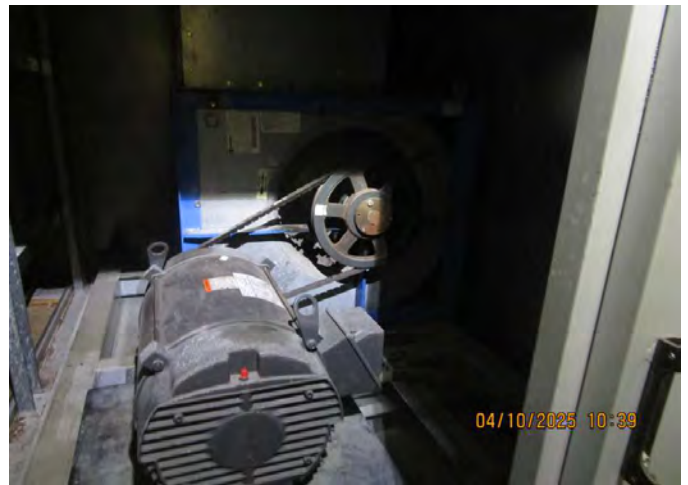
**Photo-8:**

Location:	Ground Floor - Mechanical Room
Remarks:	Inside Air-Handling Unit blower fan and motor with presence of corrosion.

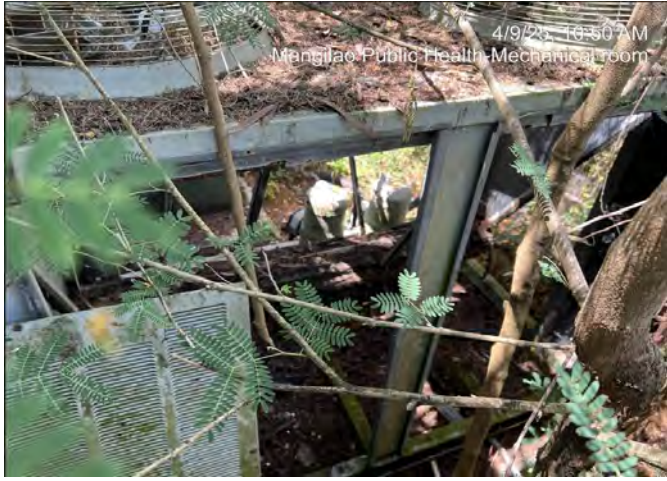
**Photo-9:**

Location:	Ground Floor - Mechanical Room
Remarks:	Damage and abandoned outdoor unit outside mechanical room.

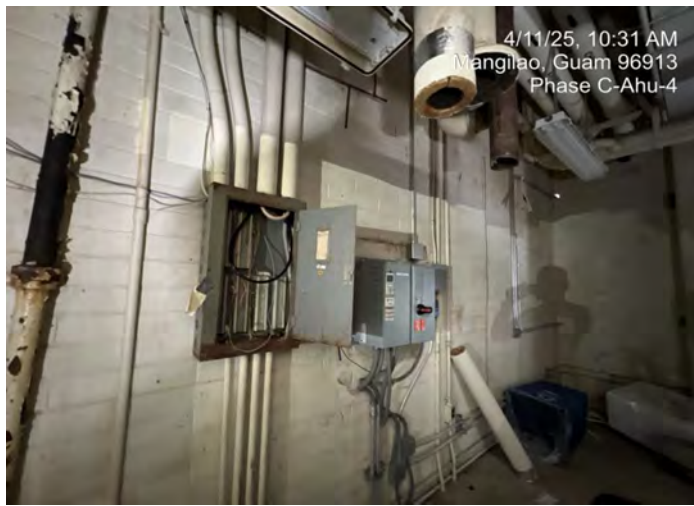
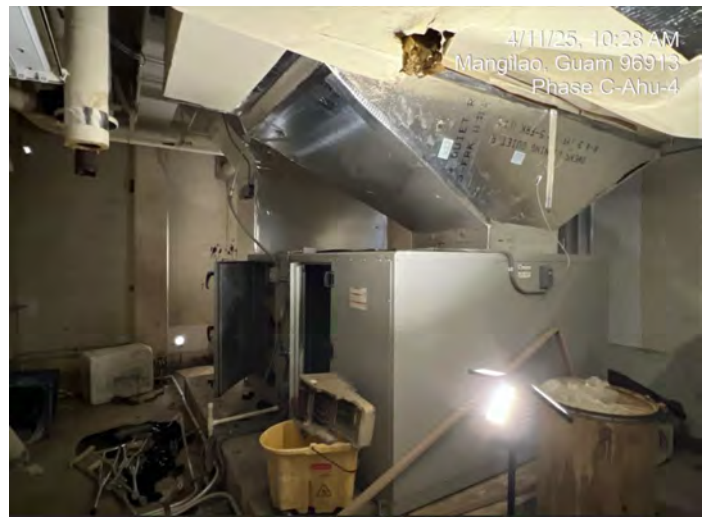
**Photo-13:**

Location:	Ground Floor - Mechanical Room 1C
Remarks:	Damage and abandoned chilled water & refrigerant piping. Cut refrigerant piping for AHU-4. Visible signs of corrosions in piping. Damage control panels.

Location:	Ground Floor - Mechanical Room 1C
Remarks:	Damage and abandoned Air-Handling unit. Cut refrigerant piping connections and electrical wirings.

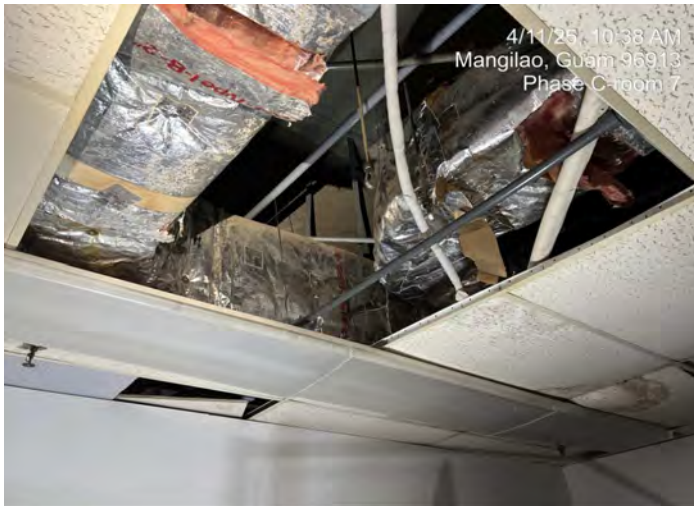
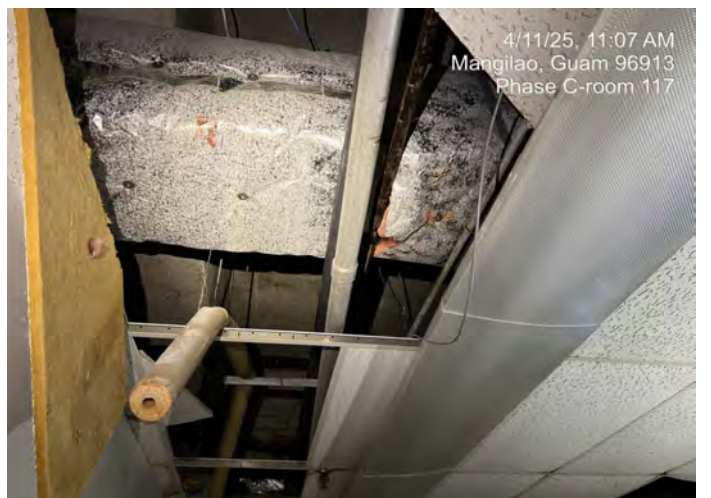
**Photo 15:**

Location:	Ground Floor - Dental Clinic Areas
Remarks:	Typical Supply Air Ductworks with visible sign of molds, damage ductworks and insulation.

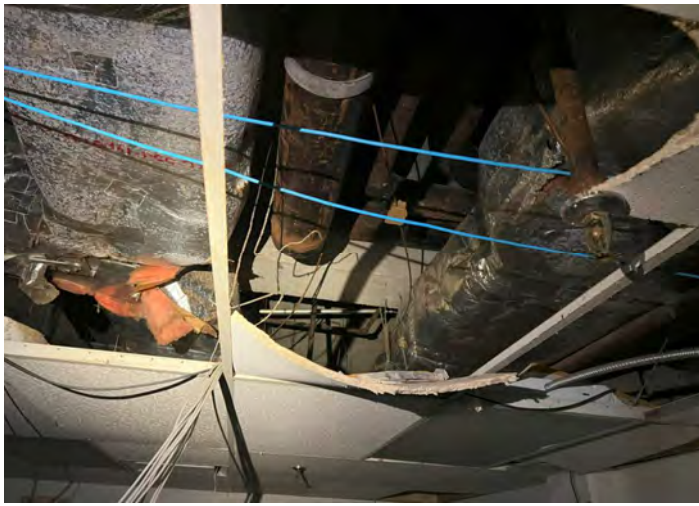
**Photo-17:**

Location:	Ground Floor - Medical Records Area
Remarks:	Typical Supply Air Ductworks with visible sign of molds, damage ductworks and insulation.

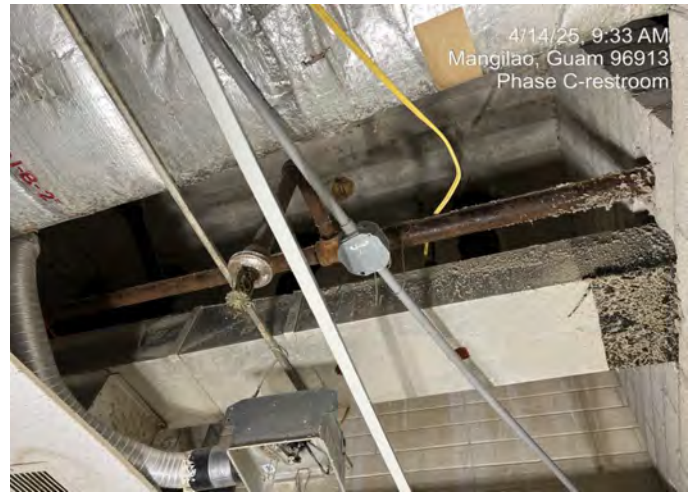
**Photo-21:**

Location:	Ground Floor - Restroom
Remarks:	Typical restroom supply and exhaust air registers condition. Shows visible sign of molds, deterioration & corrosion.

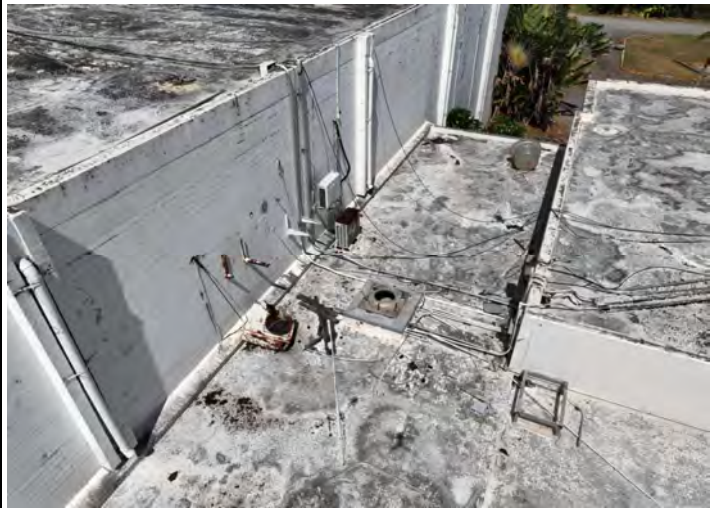
**Photo-32:**

**Location:** Roof Area 1A  
**Remarks:** Damage and blown-out roof mounted and wall mounted ACCU units and Exhaust Ventilation Equipment including refrigerant piping, supports, wirings and accessories.

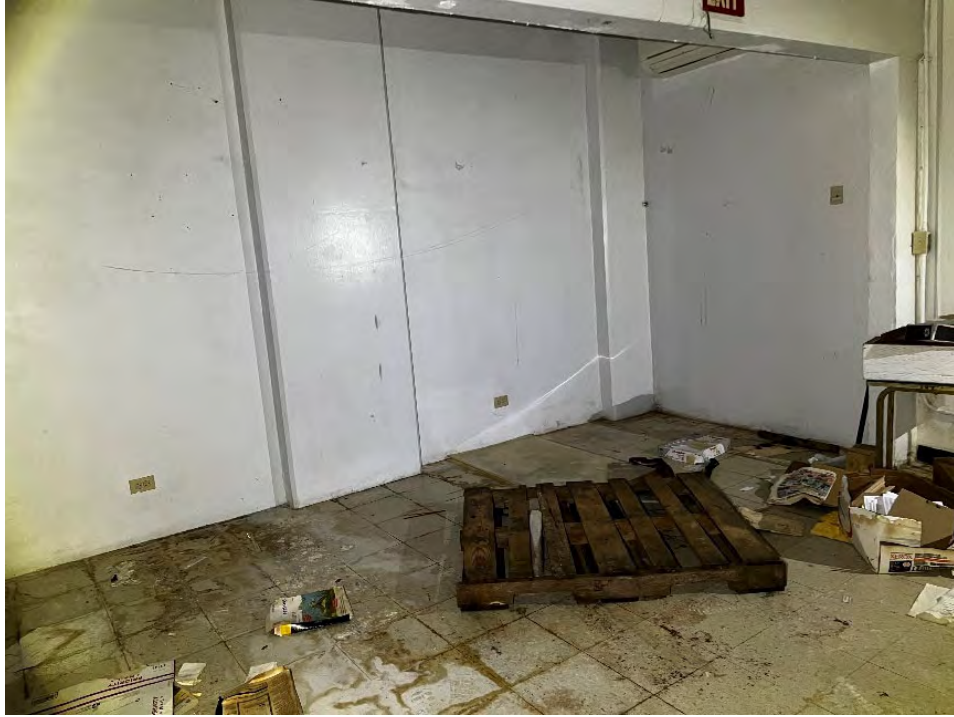
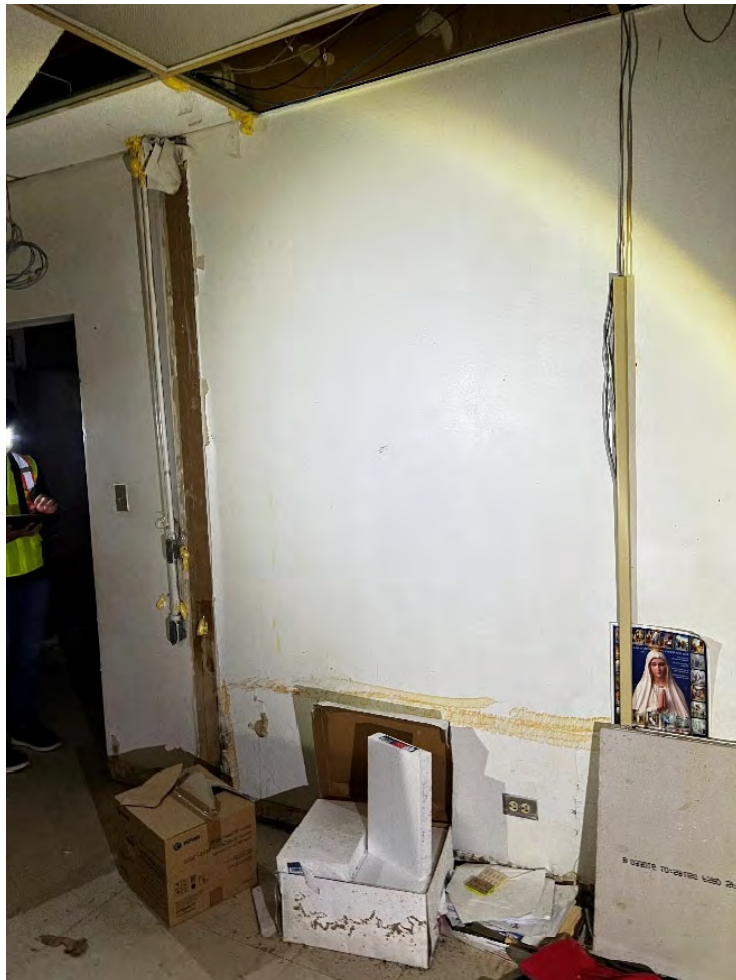
PHOTO #8 – OUTLETS AND SWITCHES, OLD AND CORRODED

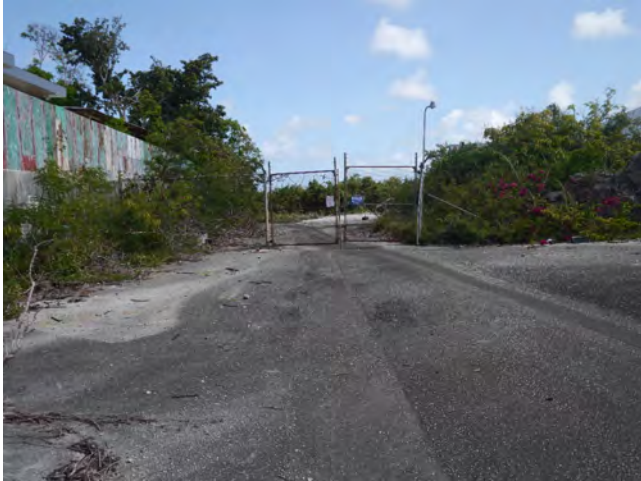
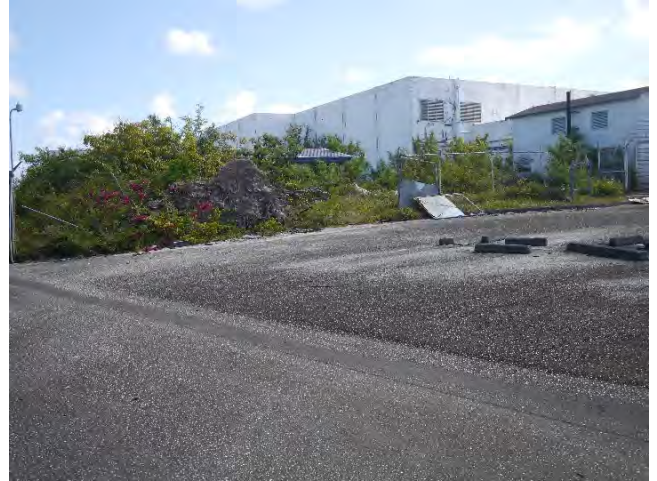
1	<i>Description:</i>	<b>Damaged vehicular access gate and cyclone fence from generator building to concrete wall – West Side</b>

2	<i>Description:</i>	<b>Cyclone fence from generator building to concrete wall – West Side</b>

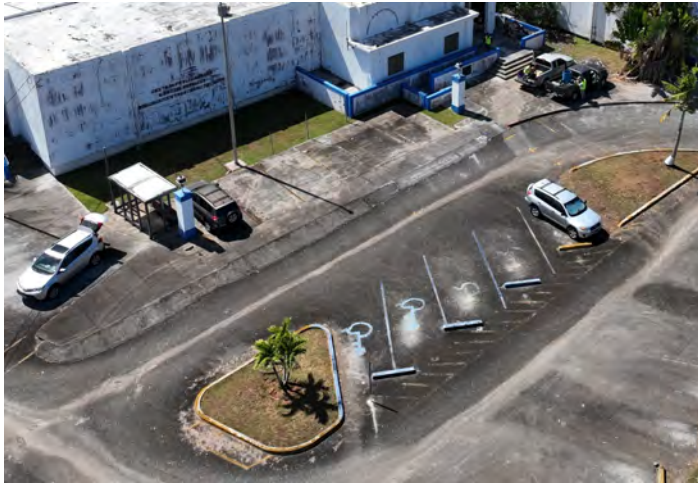
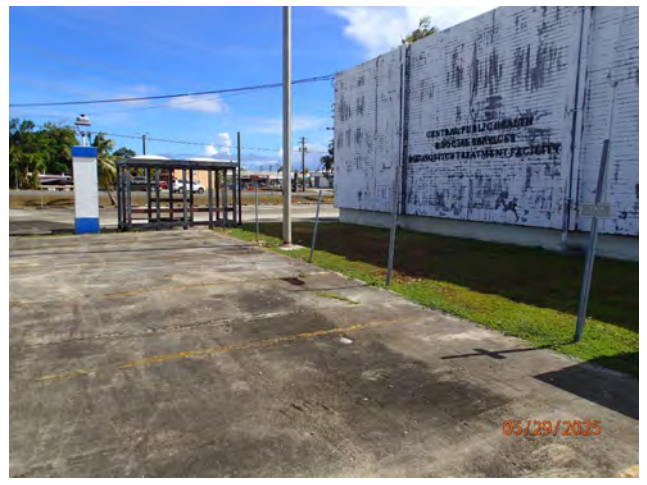
3	<i>Description:</i>	<b>No designated signs and access isle for ADA parking. ADA pavement stripes and marking are faded.</b>

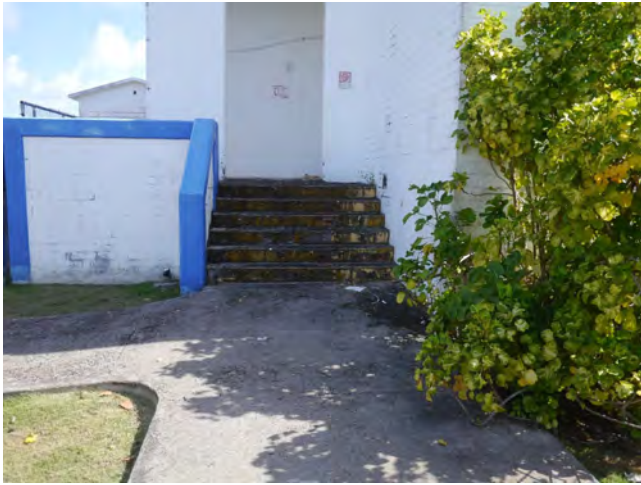
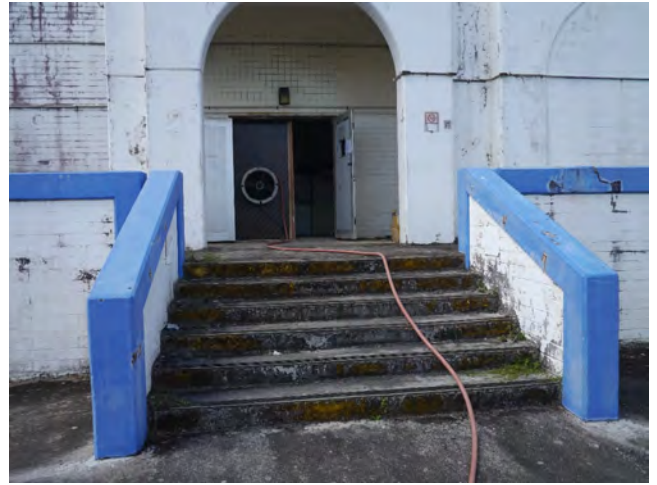
3	<i>Description:</i>	<b>Missing handrails at exterior stairs at southwest side of building 1.</b>

4	<i>Description:</i>	<b>Missing handrails at exterior stairs at north side of building 3.</b>
