| BILL NO. | SPONSOR | TITLE | DATE INTRODUCED | DATE REFERRED | CMTE REFERRED | FISCAL NOTES | PUBLIC HEARING DATE | DATE COMMITTEE REPORT FILED | NOTES |
|---|---|---|---|---|---|---|---|---|---|
| 12-38 (COR) | Therese M. Terlaje | AN ACT TO RESERVE LOT NO. 2417-I-R7, THE FORMER DEPARTMENT OF PUBLIC HEALTH AND SOCIAL SERVICES MAIN BUILDING IN MANGILAO, FOR IMMEDIATE USE BY THE DEPARTMENT OF PUBLIC HEALTH AND SOCIAL SERVICES AND TO AUTHORIZE ITS USE FOR THE GUAM COMMUNITY COLLEGE NURSING PROGRAM. | 1/13/25<br>9:18 a.m. | 1/21/25 | Committee on Land, Environment, Housing, Agriculture, Parks, and Infrastructure. | Request: 1/21/25 | 4/1/25<br>9:00 a.m. | 7/11/25<br>As Amended. | Exhibit A |

RE: **Committee Report on Public Hearing** [Bill No. 12-38 \(COR\)](#) – Therese M. Terlaje – AN ACT TO RESERVE LOT NO. 2417-1-R7, THE FORMER DEPARTMENT OF PUBLIC HEALTH AND SOCIAL SERVICES MAIN BUILDING IN MANGILAO, FOR IMMEDIATE USE BY THE DEPARTMENT OF PUBLIC HEALTH AND SOCIAL SERVICES AND TO AUTHORIZE ITS USE FOR THE GUAM COMMUNITY COLLEGE NURSING PROGRAM.

# CONDITIONAL ASSESSMENT OF MANGILAO PUBLIC HEALTH BUILDING

PROJECT NO.: 460-5-1007-F-MAN  
FINAL REPORT  
July 18, 2025

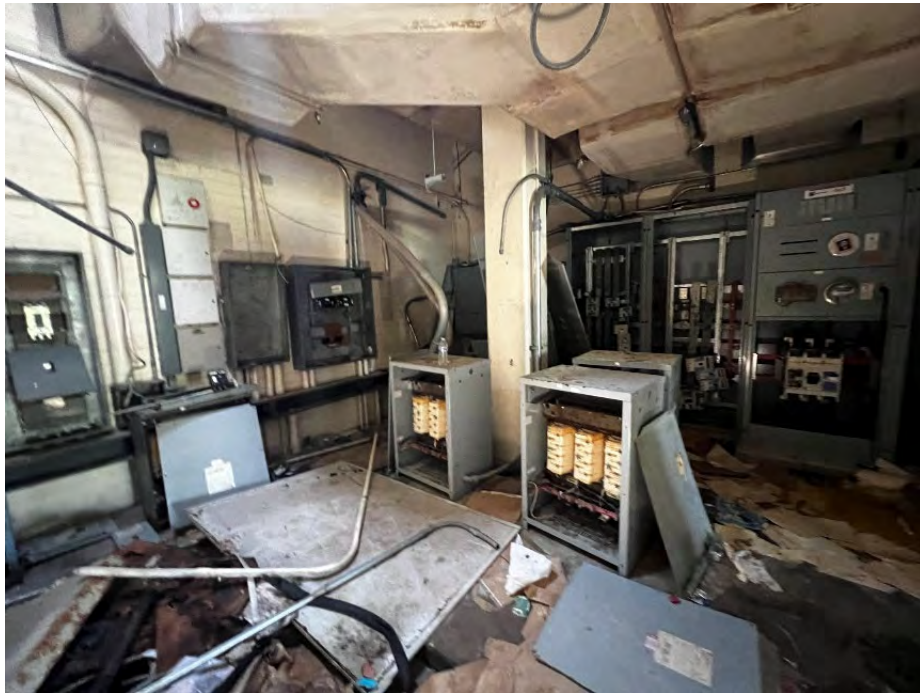
PHOTO #3 – UNUSABLE ELECTRICAL EQUIPMENT, CONDUITS, AND WIRING

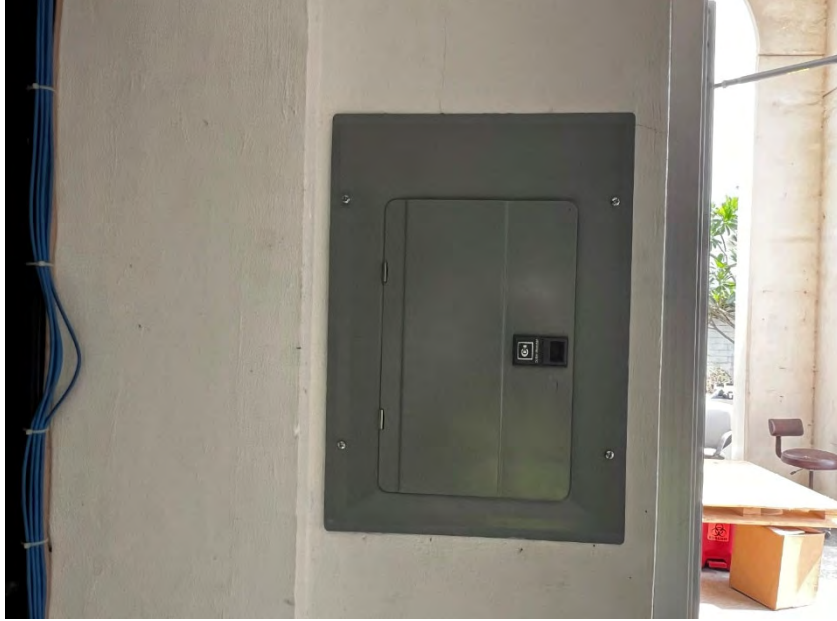
PHOTO #4 – PANELBOARD AT MAIN BUILDING ENTRANCE

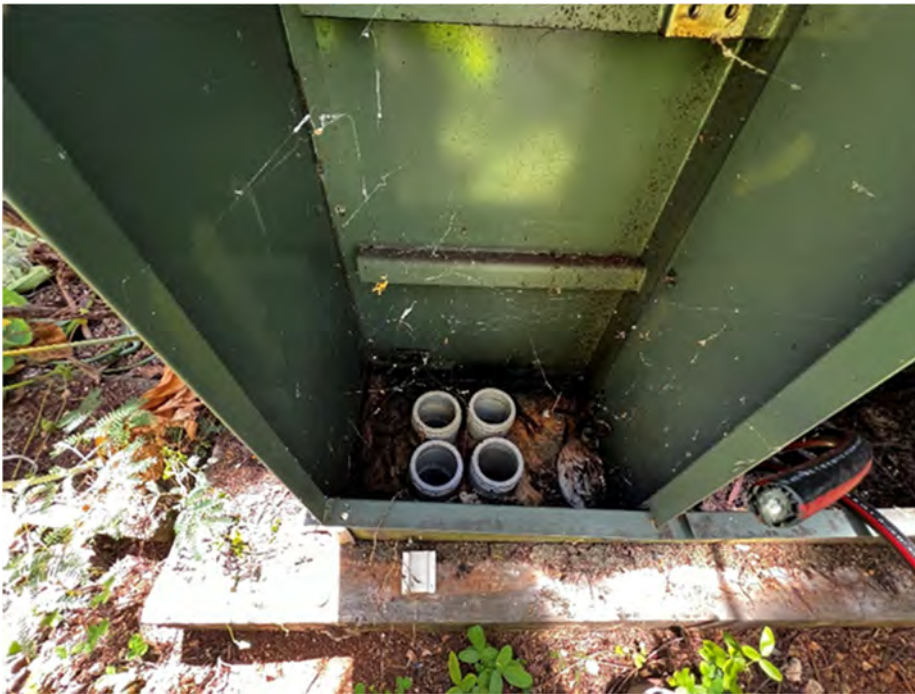
PHOTO #7 – THEFT OF TRANSFORMER PARTS AND WIRING

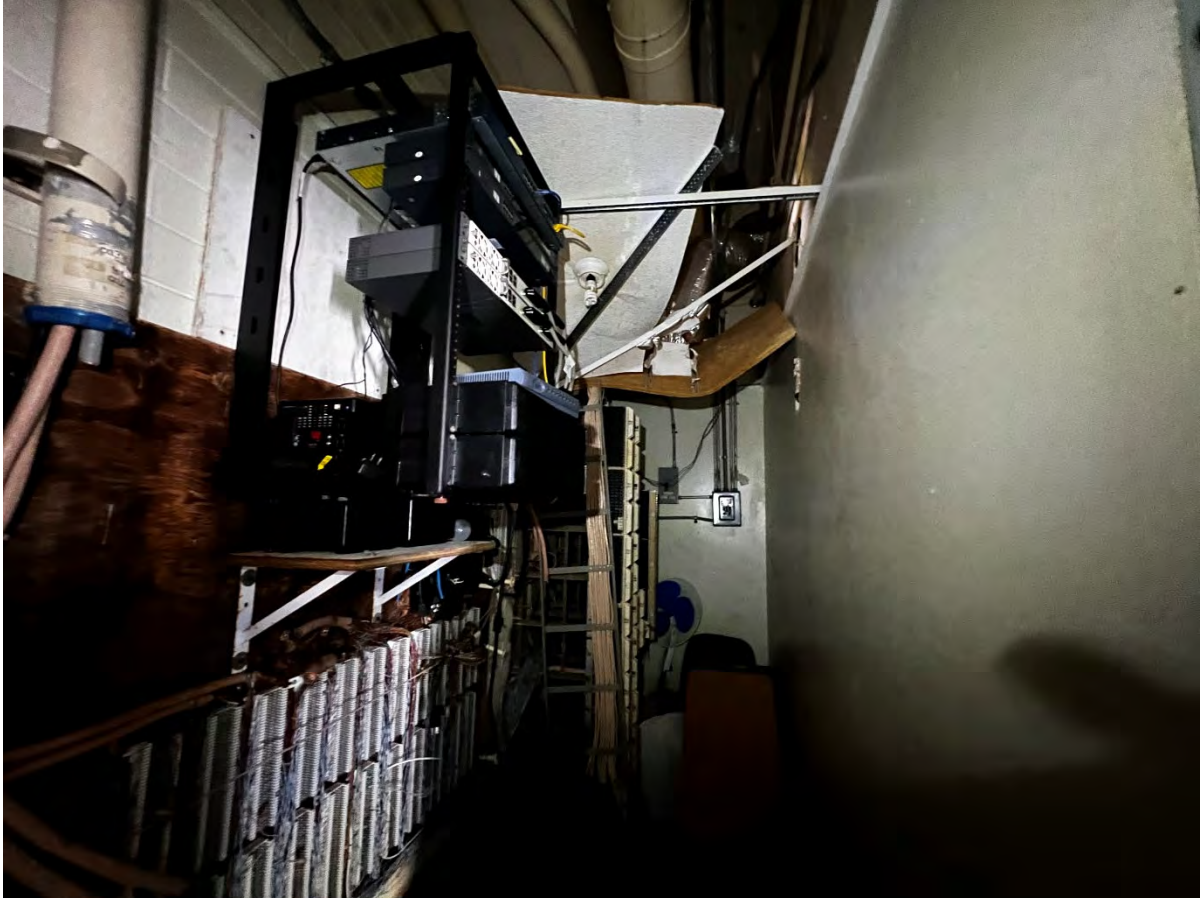
PHOTO #10 - EXISTING TELECOM ROOM

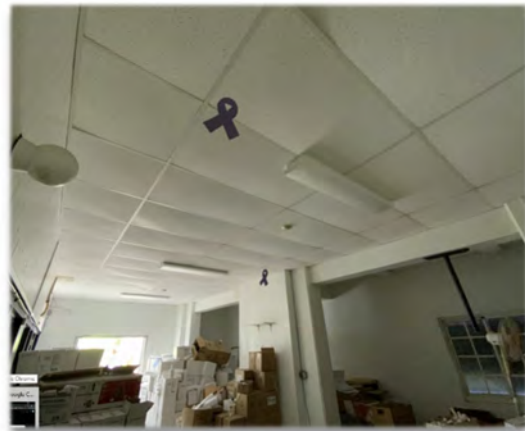
Fig. 2 Room with no sprinkler protection

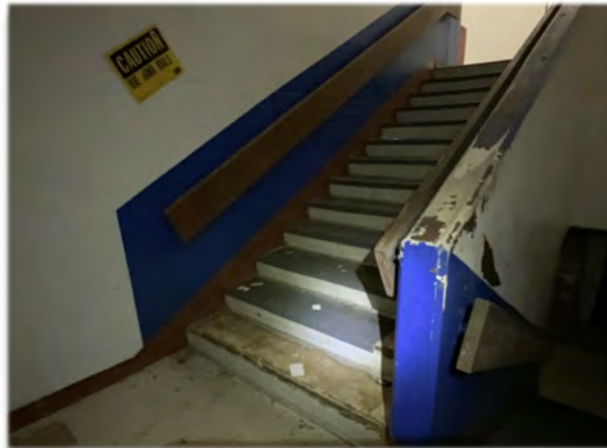
Stairs guardrails and guardrails should be reconfigured to comply with latest applicable code (IBC 2009) if the building will be major renovation.

Fig. 6 Stair handrails, no guard rails.
