RE: **Amended Committee Report on Public Hearing [Bill No. 21-38 \(COR\)](#)** – Tina Rose Muna Barnes – AN ACT TO TRANSFER LOT NO. 2417-1-R7, MUNICIPALITY OF MANGILAO FORMERLY KNOWN AS THE DEPARTMENT OF PUBLIC HEALTH AND SOCIAL SERVICES CENTRAL HEADQUARTERS, FROM THE DEPARTMENT OF PUBLIC HEALTH AND SOCIAL SERVICES TO THE GUAM COMMUNITY COLLEGE FOR THE CONSTRUCTION OF A NURSING ANNEX.

# CONDITIONAL ASSESSMENT OF MANGILAO PUBLIC HEALTH BUILDING

PROJECT NO.:460-5-1007-F-MAN  
FINAL REPORT  
July 18, 2025

**PROJECT: Professional Consulting Services for a Conditional Assessment of the Mangilao Public Health Building, Project No. 460-5-1007-F-MAN**

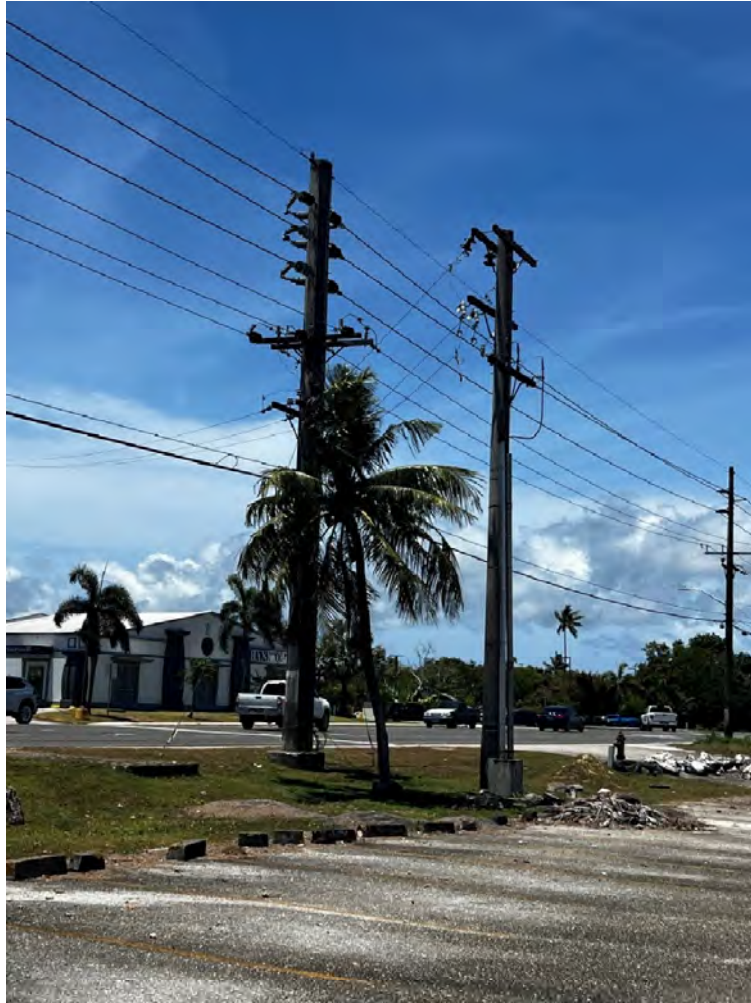
PHOTO #1 - EXISTING CONDUIT RISER ON GPA POLE ALONG ROUTE 10

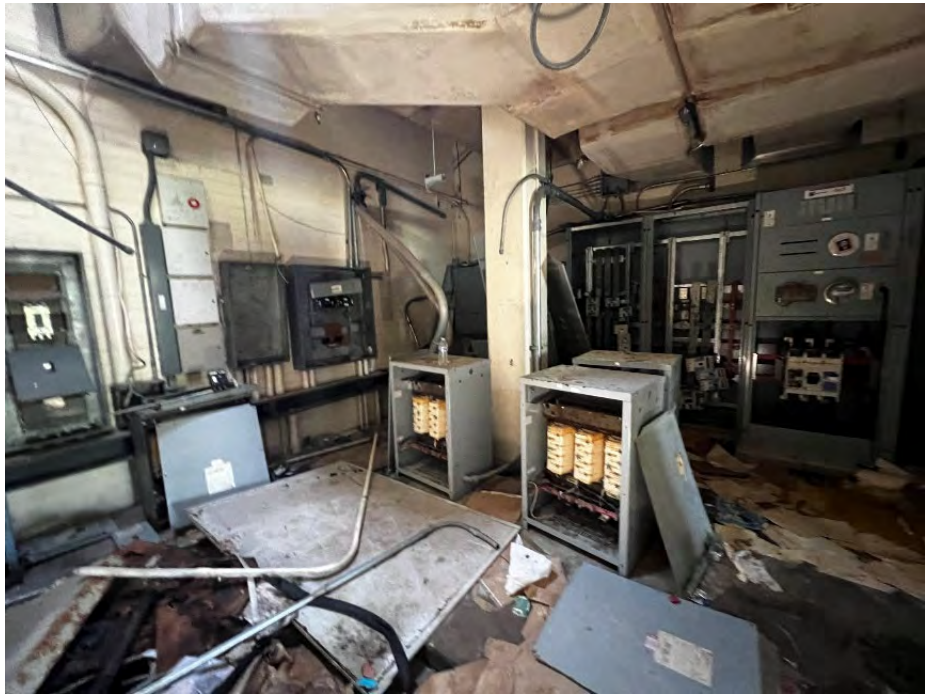
All electrical components in this area, including conduits and wiring, are visibly corroded, outdated, and non-functional. Additionally, the facility's electrical infrastructure includes sub-electrical rooms (one on the 1st floor, two on the 2nd floor), with some panelboards placed in public areas—a clear code and safety concern. The panelboard involved in the 2019 electrical fire incident is located along an office entryway wall.

PHOTO #3 – UNUSABLE ELECTRICAL EQUIPMENT, CONDUITS, AND WIRING

A full and uncompromising replacement of the electrical service and distribution systems is imperative. The existing infrastructure presents serious life safety hazards, is in violation of multiple NEC requirements, and cannot be trusted to support operations—particularly in a facility that delivers essential public health services.

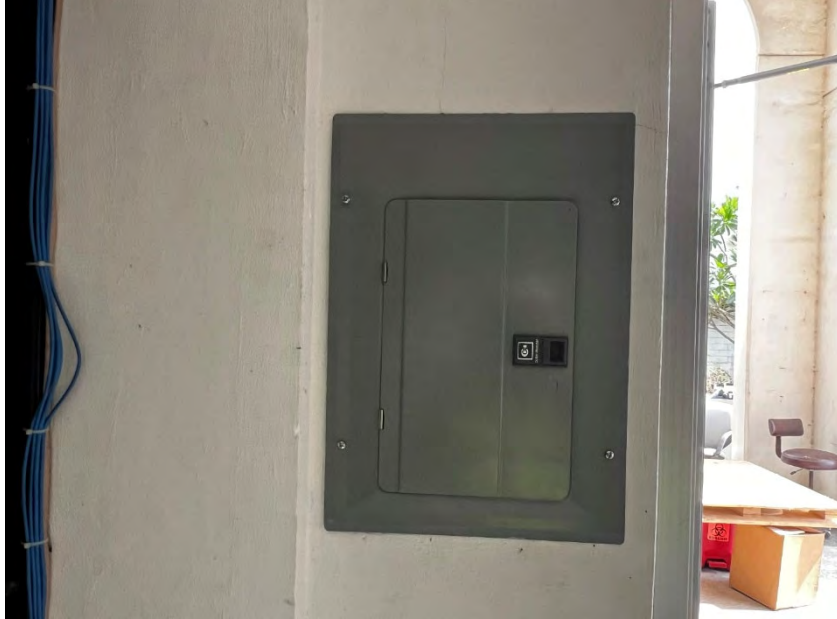
PHOTO #4 – PANELBOARD AT MAIN BUILDING ENTRANCE

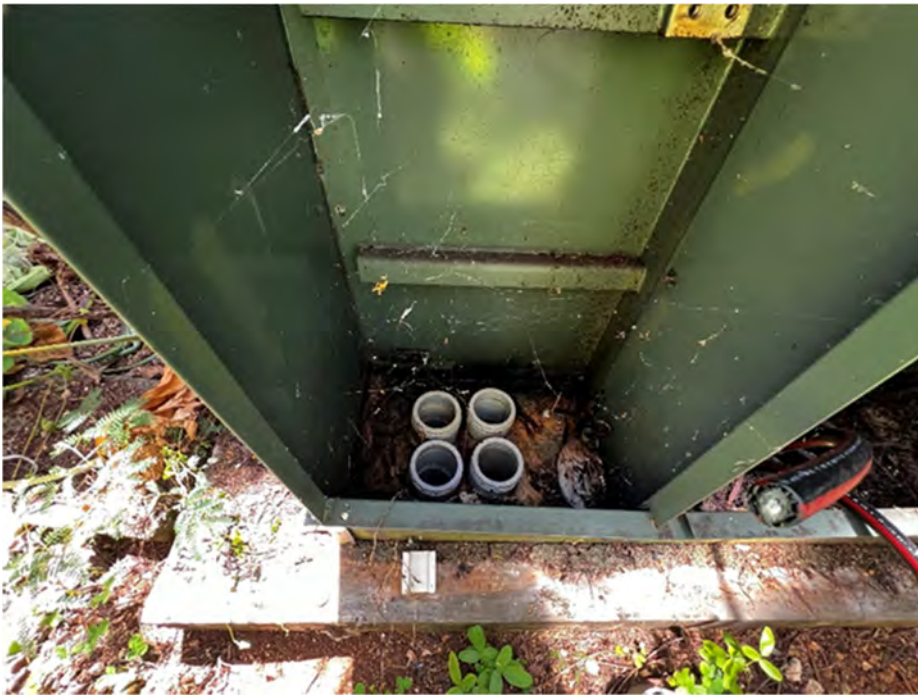
PHOTO #6 – THEFT OF GENERATOR FEEDER WIRING

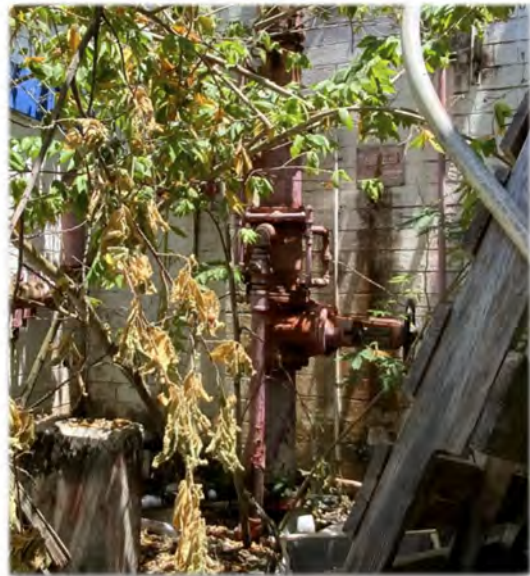
The sprinkler system riser valve was found in the closed position, indicating a dry system condition and suggesting potential leakage. The exposed main sprinkler riser show some corrosion. The sprinkler piping seems to be in good condition. However, the interior condition of the piping should be inspected for microbiologically influenced corrosion (MIC), as the presence of air pockets and the absence of water within the system can accelerate the onset and progression of MIC.

Further, the Fire Department Connection (FDC) is not easily accessible, which could impede emergency response operations. The main system riser also exhibits visible signs of corrosion, raising concerns about long-term system integrity.

Fig. 1 Closed Fire Sprinkler Riser

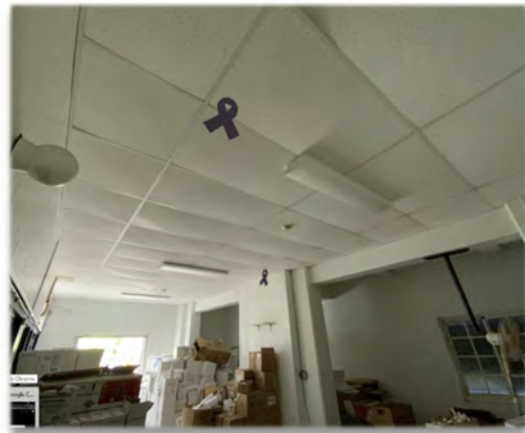
The building does not have complete sprinkler coverage—several areas, particularly those that have undergone modifications or reconfigurations, were observed to lack sprinkler protection.

Fig. 2 Room with no sprinkler protection

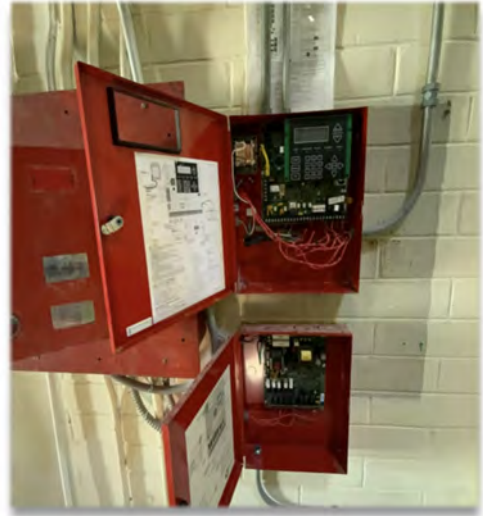
The main fire alarm control panel, located in the mechanical room, has been stripped of its components, with backup batteries and portions of system wiring missing. Power was unavailable in the building at the time of assessment, preventing verification of the system's operational status. However, based on physical observations, the existing fire alarm system does not comply with notification and accessibility requirements as mandated by NFPA 72 and ADA.

Fig. 3 Silent Knight Fire Alarm Control

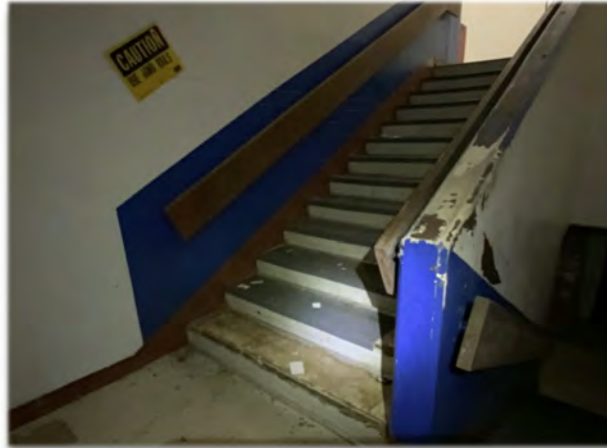
Fig. 6 Stair handrails, no guard rails.

Stairs guardrails and guardrails should be reconfigured to comply with latest applicable code (IBC 2009) if the building will be major renovation.
