| BILL NO. | SPONSOR | TITLE | DATE INTRODUCED | DATE REFERRED | CMTE REFERRED | FISCAL NOTES | PUBLIC HEARING DATE | DATE COMMITTEE REPORT FILED | NOTES |
|---|---|---|---|---|---|---|---|---|---|
| 12-38 (COR) | Therese M. Terlaje | AN ACT TO RESERVE LOT NO. 2417-I-R7, THE FORMER DEPARTMENT OF PUBLIC HEALTH AND SOCIAL SERVICES MAIN BUILDING IN MANGILAO, FOR IMMEDIATE USE BY THE DEPARTMENT OF PUBLIC HEALTH AND SOCIAL SERVICES AND TO AUTHORIZE ITS USE FOR THE GUAM COMMUNITY COLLEGE NURSING PROGRAM. | 1/13/25<br>9:18 a.m. | 1/21/25 | Committee on Land, Environment, Housing, Agriculture, Parks, and Infrastructure. | Request: 1/21/25 | 4/1/25<br>9:00 a.m. | 7/11/25<br>As Amended. | Exhibit A |

RE: **Committee Report on Public Hearing** [Bill No. 12-38 \(COR\)](#) – Therese M. Terlaje – AN ACT TO RESERVE LOT NO. 2417-1-R7, THE FORMER DEPARTMENT OF PUBLIC HEALTH AND SOCIAL SERVICES MAIN BUILDING IN MANGILAO, FOR IMMEDIATE USE BY THE DEPARTMENT OF PUBLIC HEALTH AND SOCIAL SERVICES AND TO AUTHORIZE ITS USE FOR THE GUAM COMMUNITY COLLEGE NURSING PROGRAM.

# CONDITIONAL ASSESSMENT OF MANGILAO PUBLIC HEALTH BUILDING

PROJECT NO.: 460-5-1007-F-MAN  
FINAL REPORT  
July 18, 2025

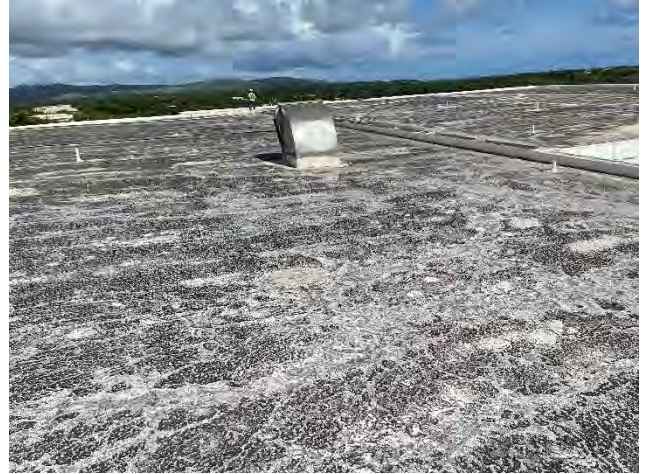
| 2 | Building Component: | <b>TYPICAL ROOF CONDITION</b> |

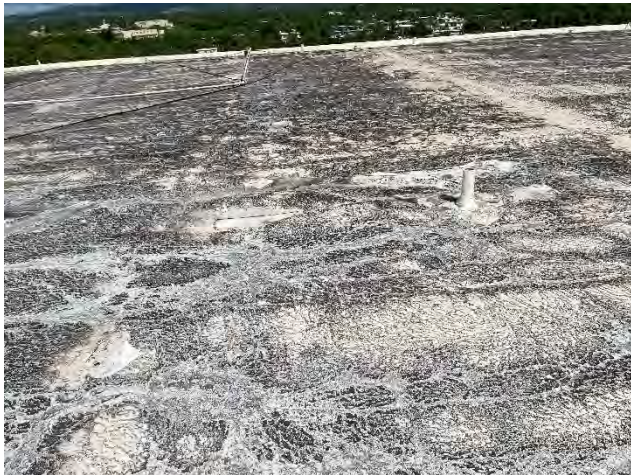
| 3 | Building Component: | <b>TYPICAL ROOF CONDITION</b> |

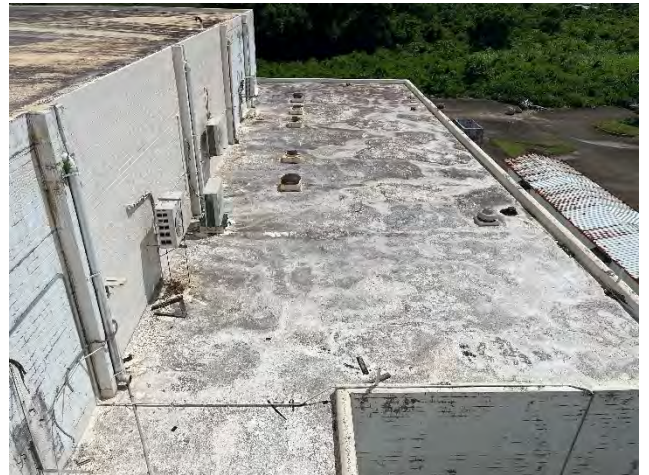
| 4 | Building Component: | <b>TYPICAL ROOF CONDITION</b> |

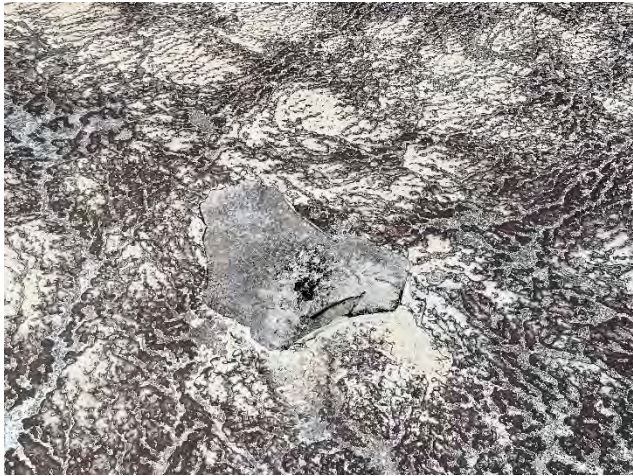
| 1 | Building Component: | TYPICAL ROOF CONDITION |

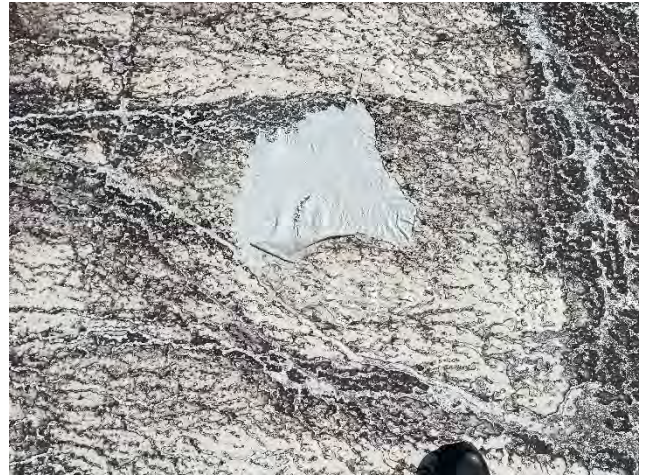
| 2 | Building Component: | TYPICAL ROOF CONDITION |

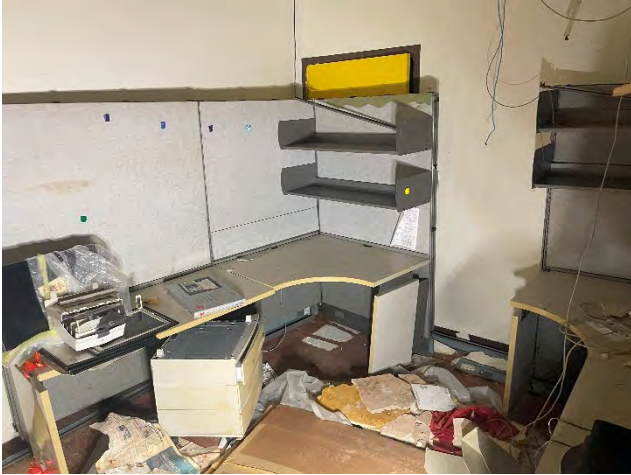
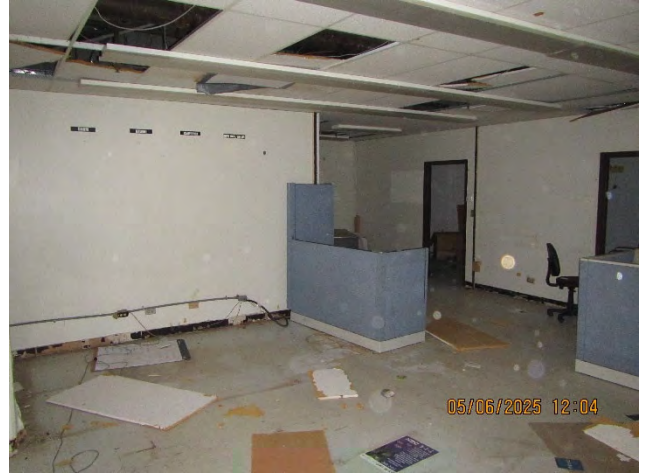
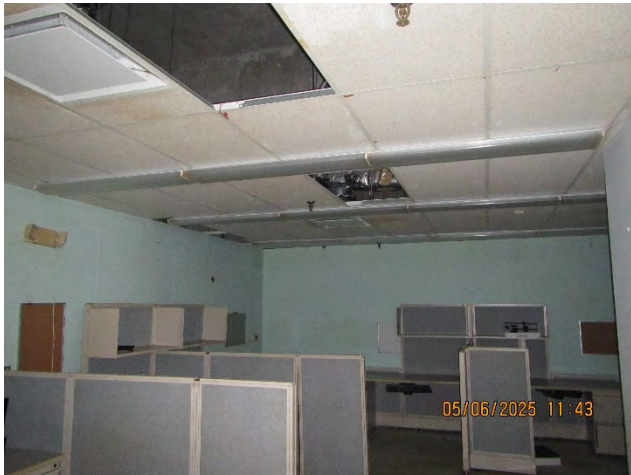
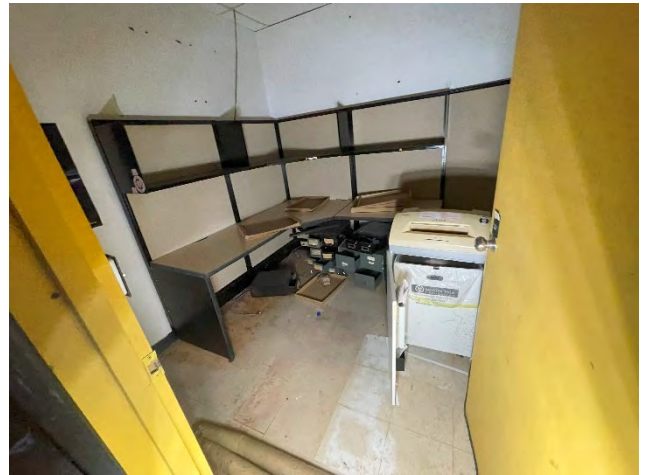
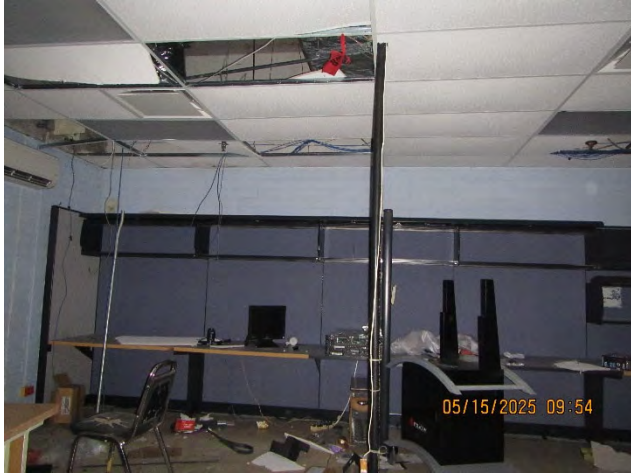
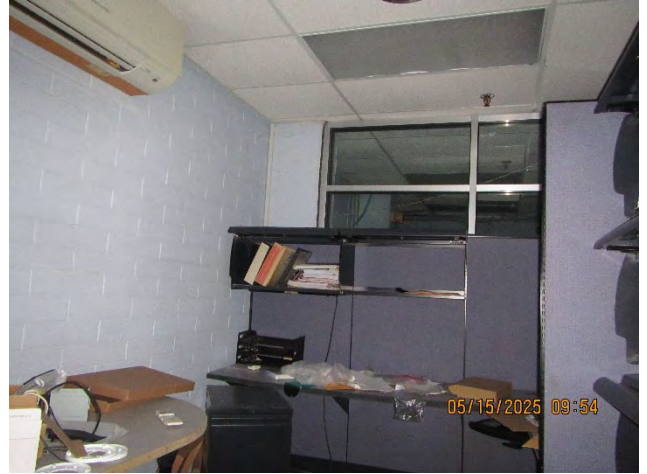
Several office spaces are observed have loose furniture and equipment. The condition of these furnishings varies from satisfactory, fair to damaged. As observed, there are remaining pieces of furniture that are observed in good condition and may be still useable.

| 3 | Building Component: | 1 <sup>ST</sup> FLOOR TYPICAL OFFICE ROOMS |

Recommend that an inventory of stored FFE (fixture, furnishings and equipment) be made by DPHSS prior to beginning any renovation work.

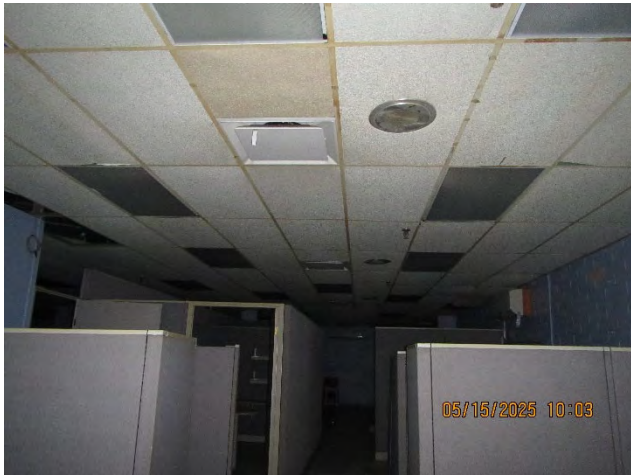
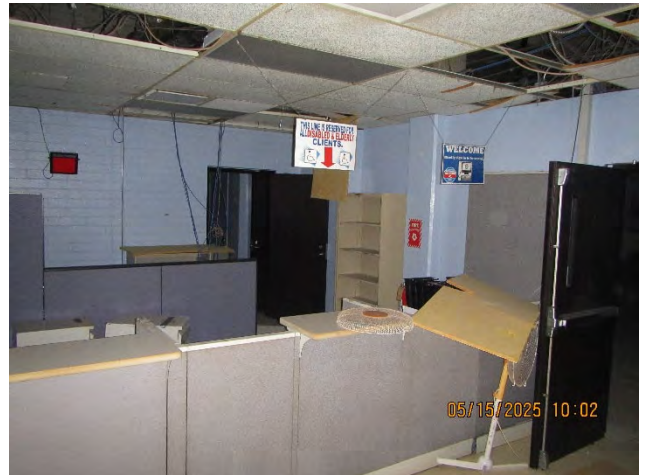
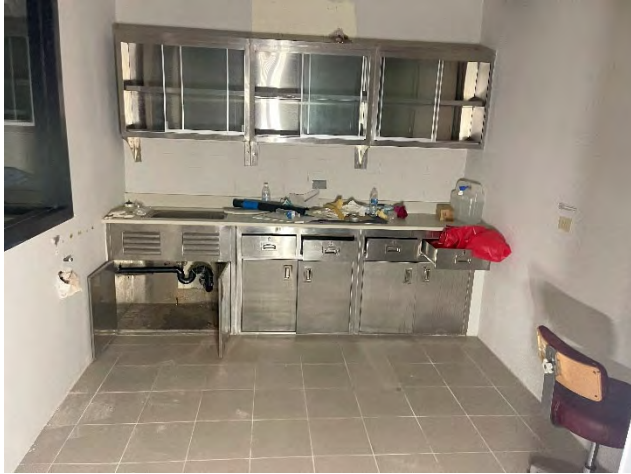
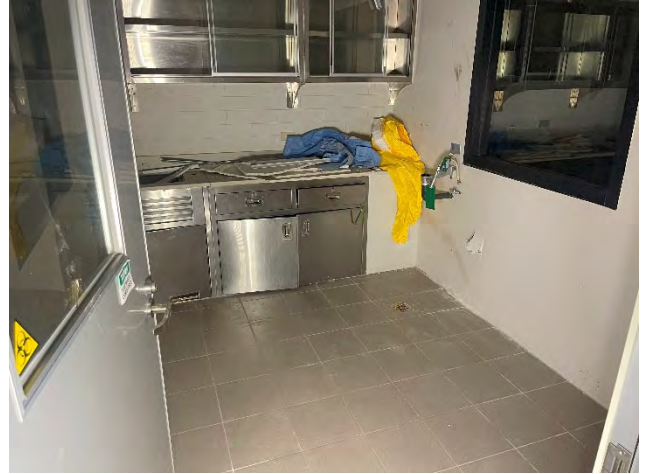
| 1 | Building Component: | 2 <sup>ND</sup> FLOOR TYPICAL OFFICE ROOMS |

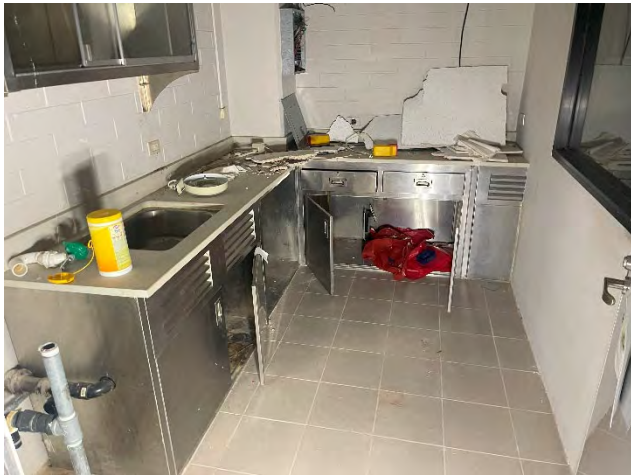
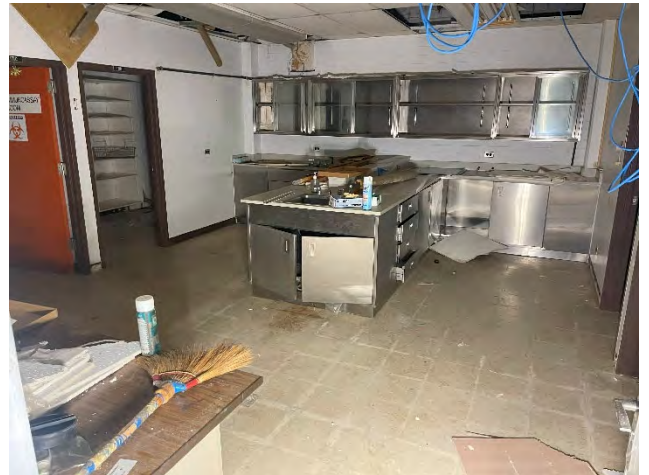
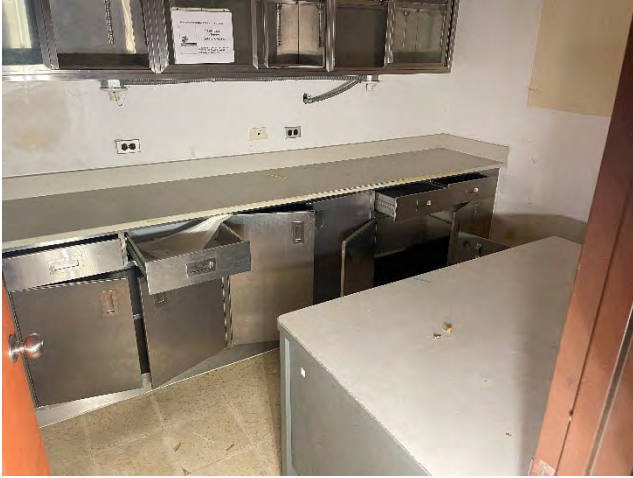
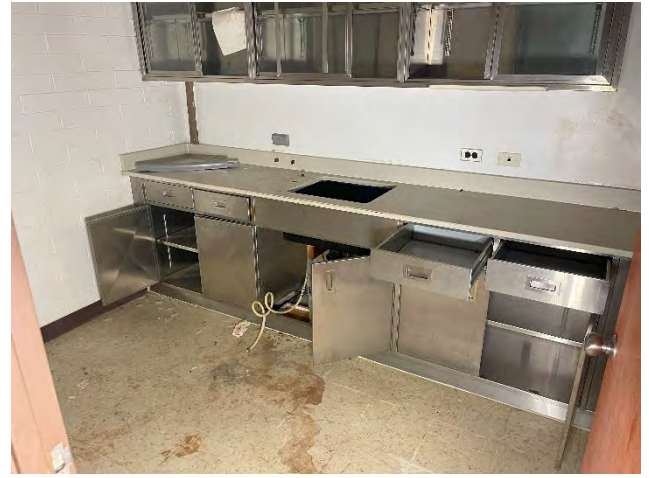
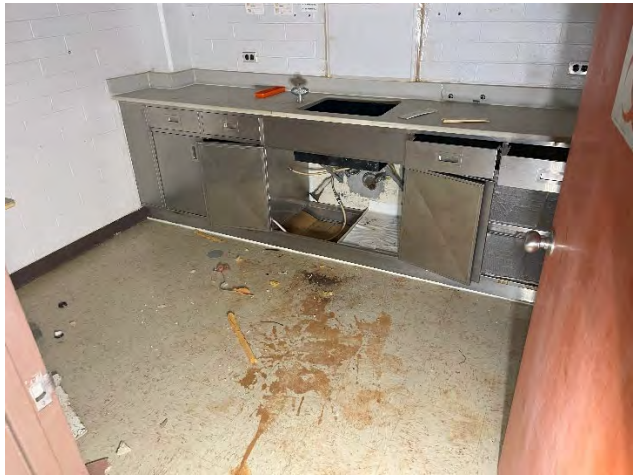
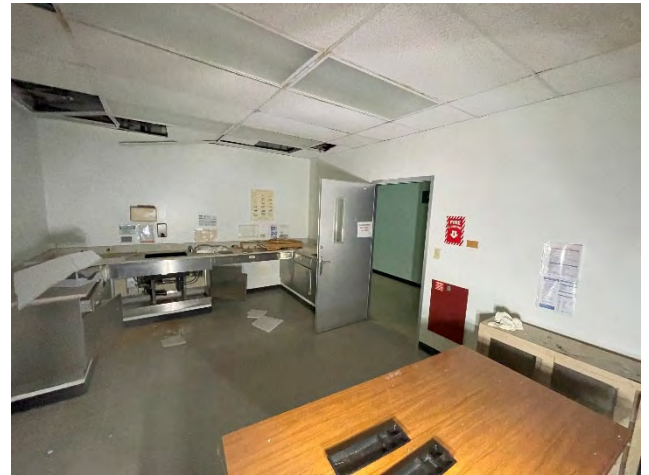
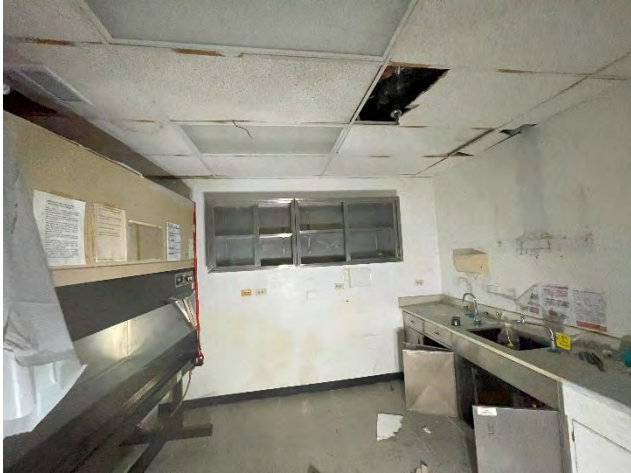
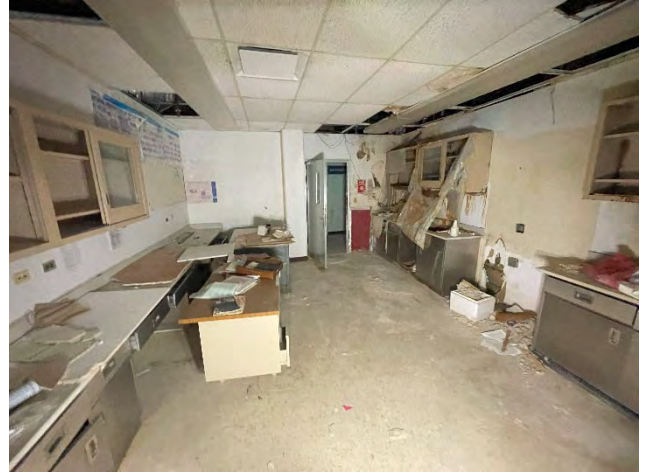
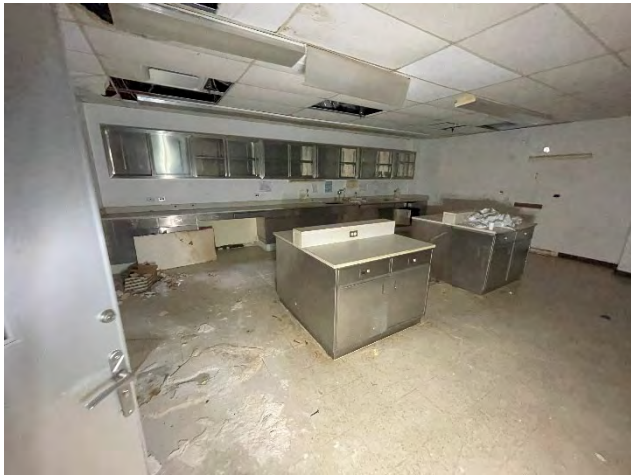
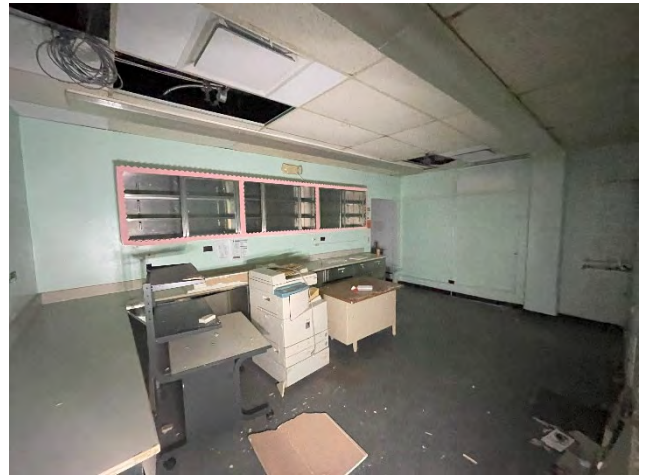
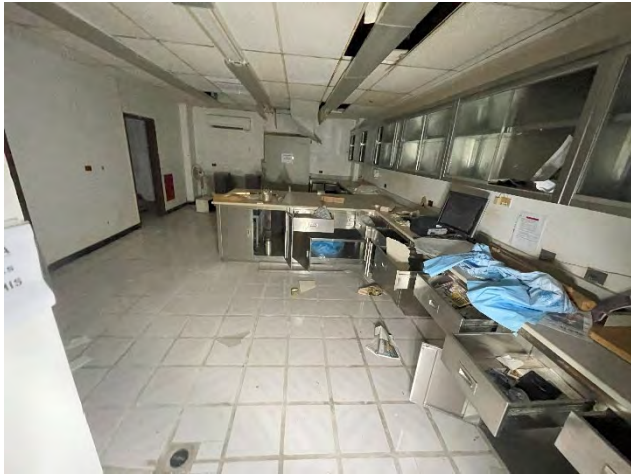
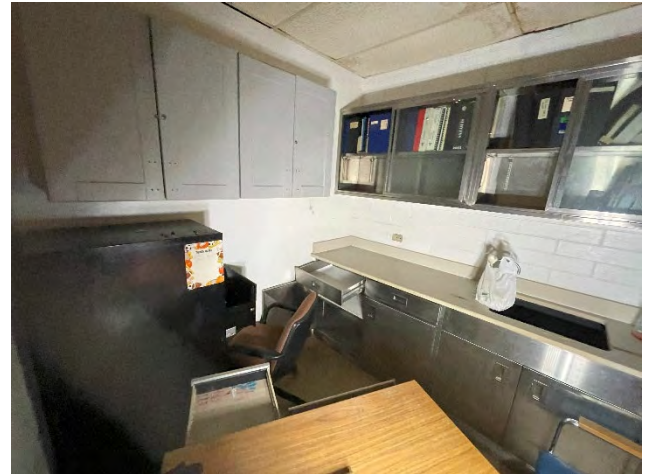
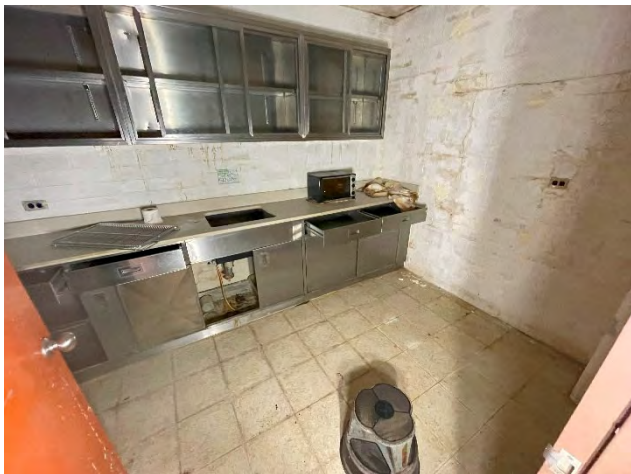
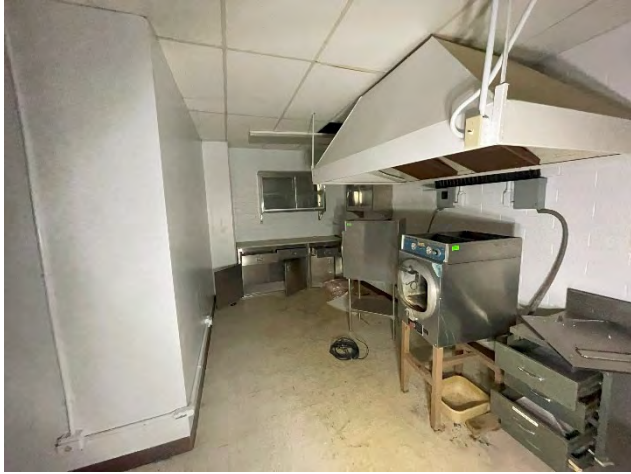
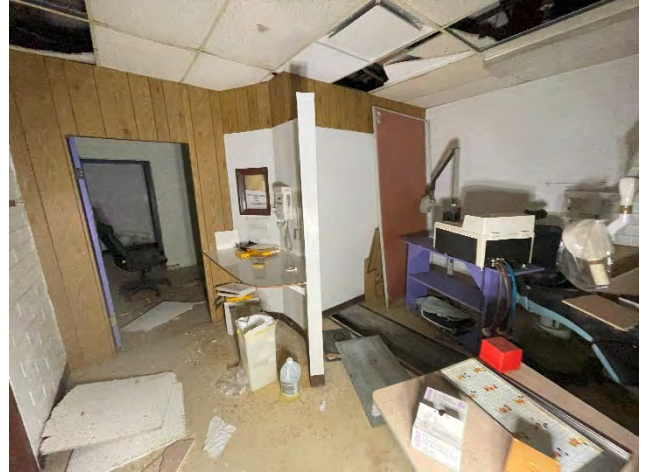
| 1 | Building Component: | 1 <sup>ST</sup> FLOOR – STAINLESS STEEL CABINETS |

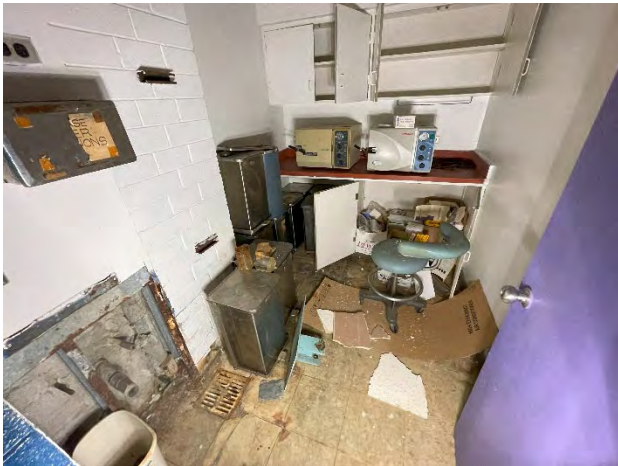
| 1 | Building Component: | 1 <sup>ST</sup> FLOOR – LAB EQUIPMENT |

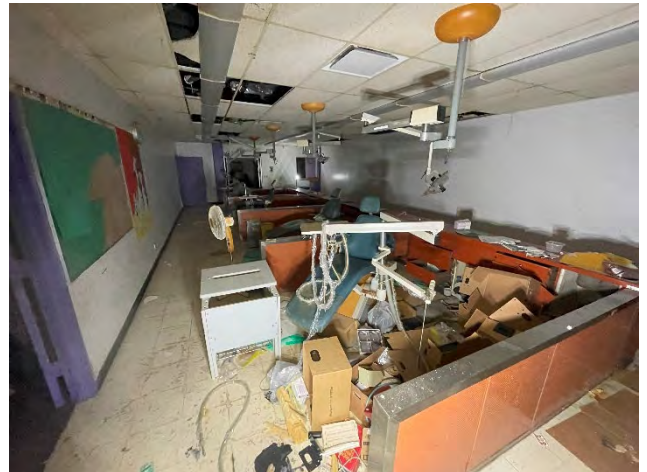
| 2 | Building Component: | 1 <sup>ST</sup> FLOOR – DENTAL EQUIPMENT |

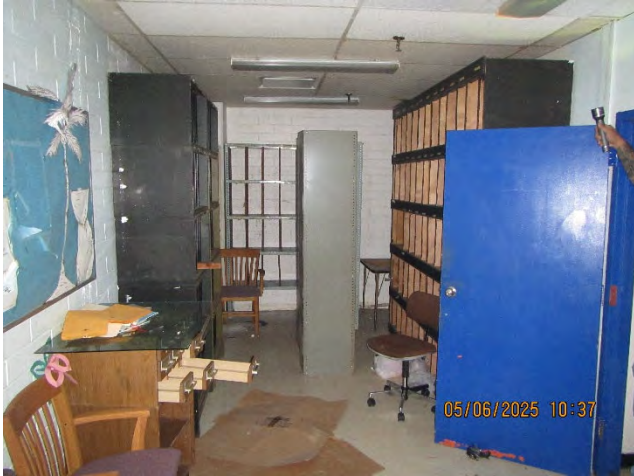
| 3 | Building Component: | 1 <sup>ST</sup> FLOOR – DENTAL EQUIPMENT |

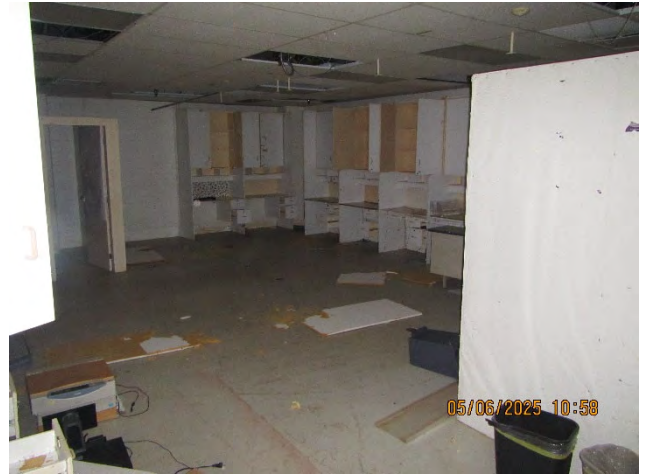
| 4 | Building Component: | 1 <sup>ST</sup> FLOOR – DENTAL EQUIPMENT |

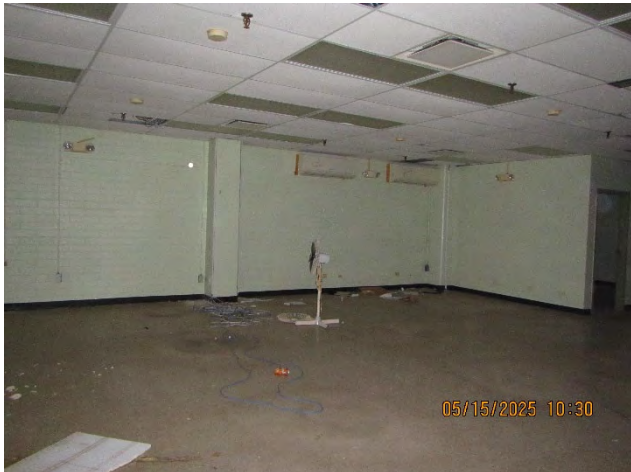
| 1 | Building Component: | 1 <sup>ST</sup> FLOOR TYPICAL FLOOR CONDITIONS |

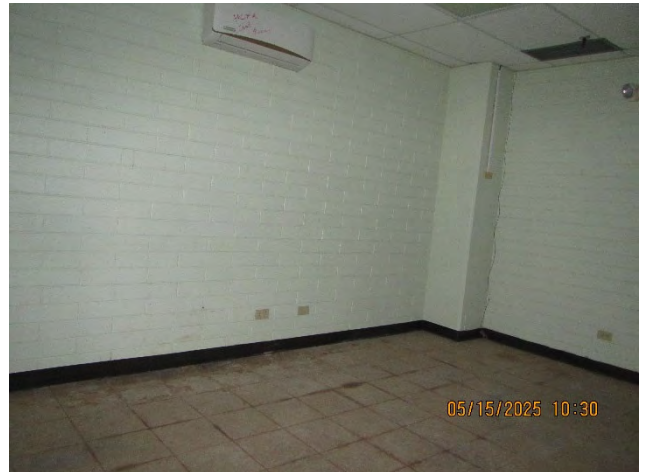
| 2 | Building Component: | 1 <sup>ST</sup> FLOOR TYPICAL FLOOR CONDITIONS WITH MOLD |

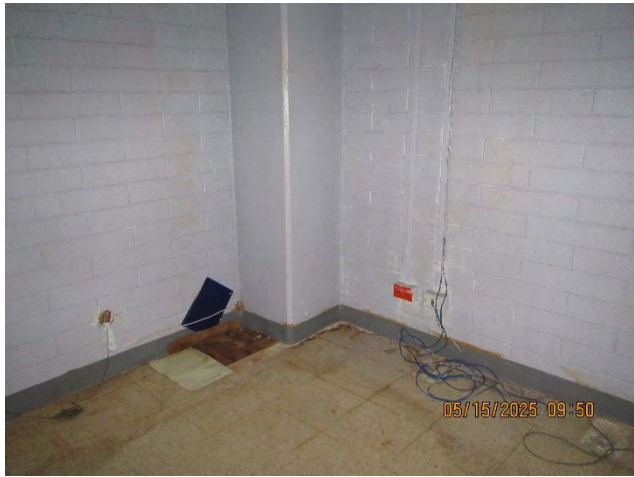
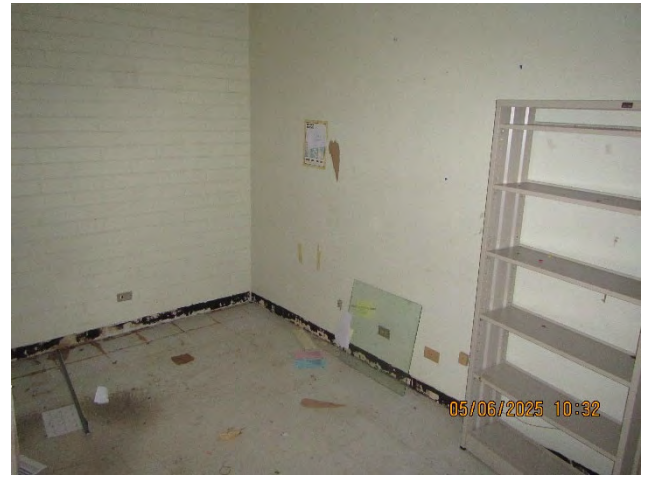
| 1 | Building Component: | 2 <sup>ND</sup> FLOOR TYPICAL FLOOR CONDITIONS | 2 | Building Component: | 2 <sup>ND</sup> FLOOR TYPICAL FLOOR CONDITIONS WITH MOLD |

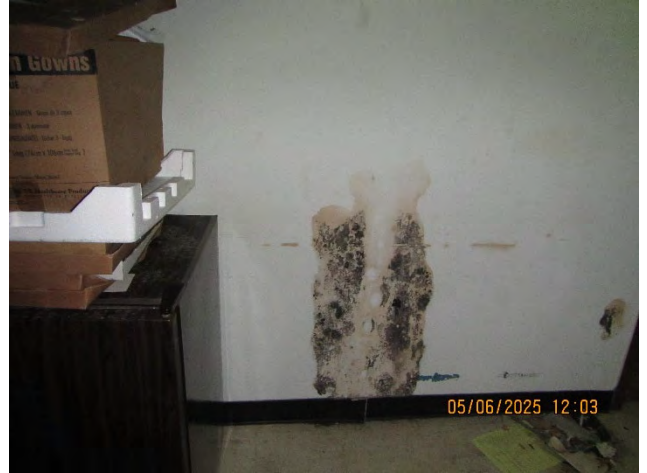
| 3 | Building Component: | 2 <sup>ND</sup> FLOOR TYPICAL FLOOR CONDITIONS | 4 | Building Component: | 1 <sup>ST</sup> FLOOR TYPICAL WALL CONDITION |

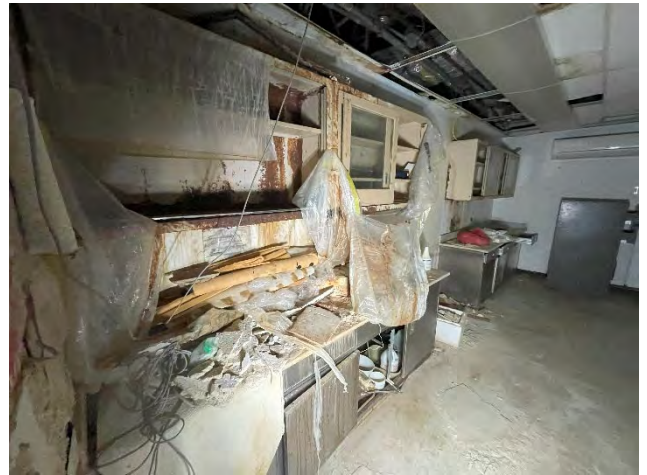
| 2 | Building Component: | 1 <sup>ST</sup> FLOOR TYPICAL WALL CONDITION WITH MOLD |

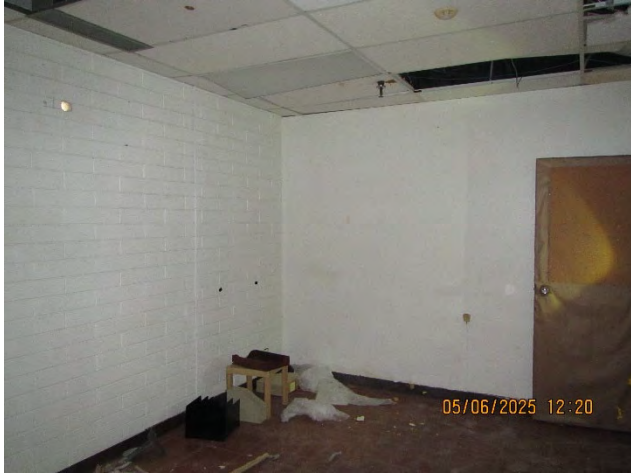
| 3 | Building Component: | 1 <sup>ST</sup> FLOOR TYPICAL WALL CONDITION WITH MOLD |

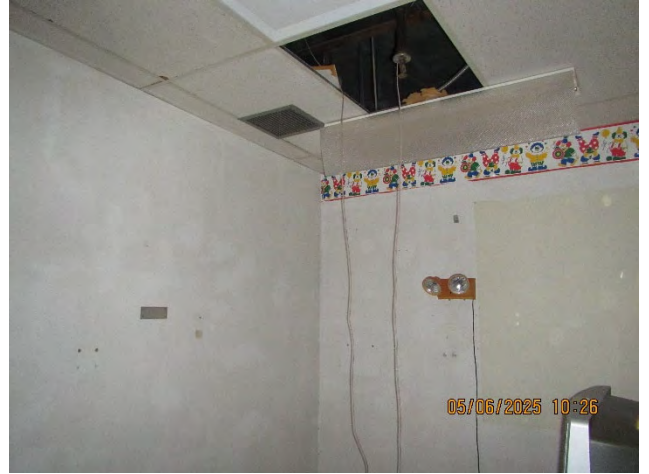
| 4 | Building Component: | 1 <sup>ST</sup> FLOOR TYPICAL WALL CONDITION WITH MOLD |

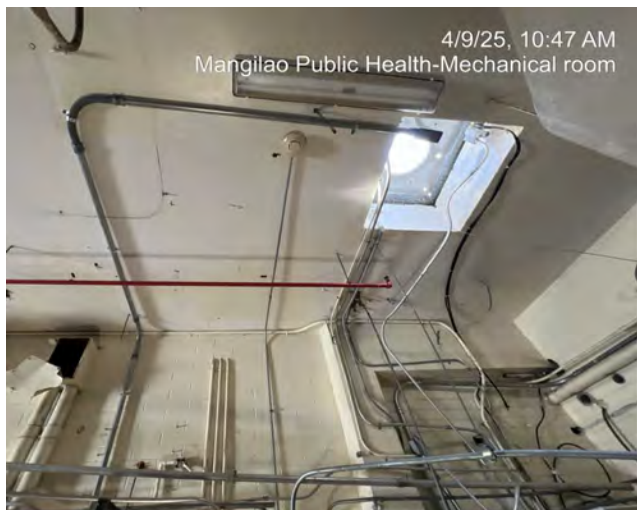
**Photo-1:**

| Location: | Ground Floor - Mechanical Room |
| Remarks: | Blown-out Exhaust Ventilator |

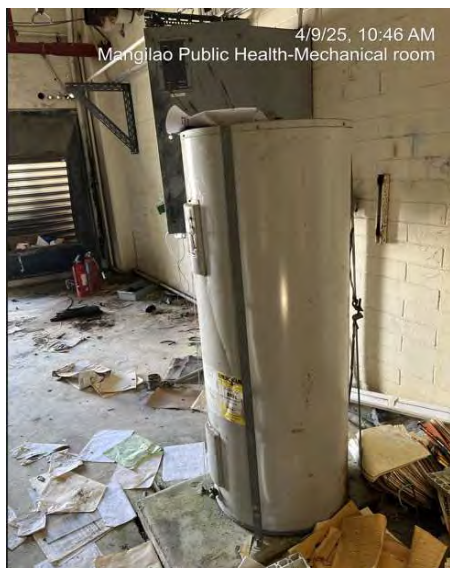
**Photo 3:**

| Location: | Ground Floor - Mechanical Room |
| Remarks: | Abandoned Electric water heater. No piping |

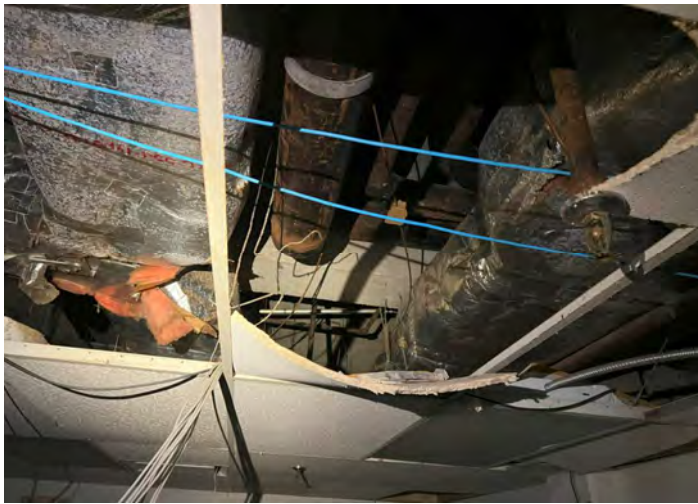
**Photo-17:**

| Location: | Ground Floor - Medical Records Area |
| Remarks: | Typical Supply Air Ductworks with visible sign of molds, damage ductworks and insulation. |

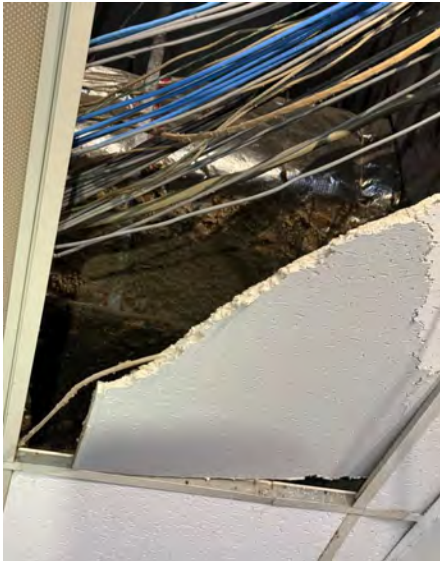
**Photo 19:**

| Location: | Ground Floor - Dental Clinic Areas |
| Remarks: | Typical Supply Air Ductworks with visible sign of mold build-up. |

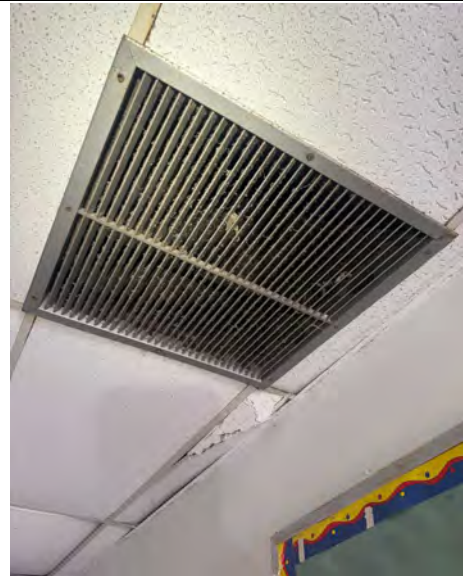
**Photo-20:**

| Location: | Ground Floor - Dental Clinic Areas |
| Remarks: | Typical condition of return air registers with visible mold build-ups. |

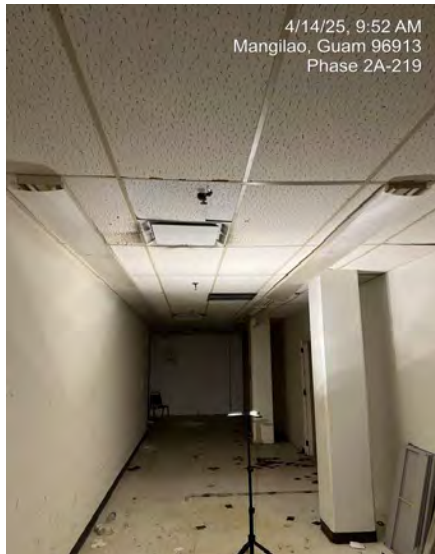
**Photo 23:**

| Location: | Second Floor - Typical Office Area |
| Remarks: | Typical supply registers with visible molds. |

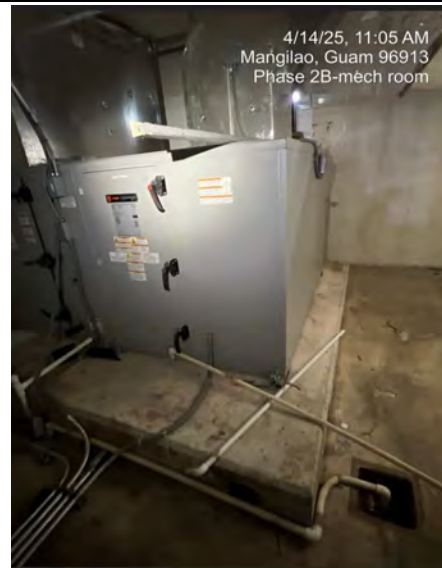
**Photo-26:**

| Location: | Second Floor - Mechanical Room |
| Remarks: | Damage and abandoned Air-Handling unit. Cut refrigerant piping connections and electrical wirings |

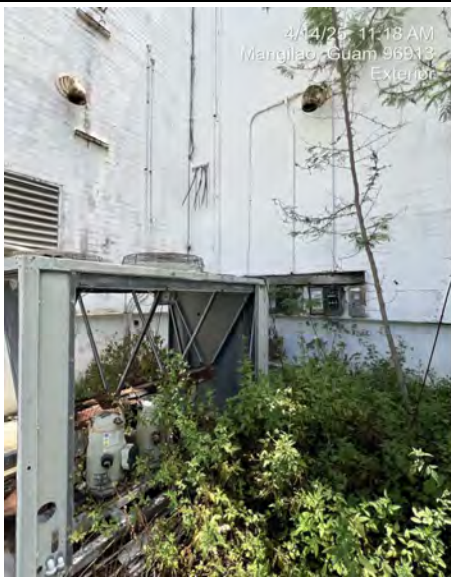
**Photo-29:**

**Location:** Outdoor - Air cooled condensing unit (ACCU)

**Remarks:** Damage, corroded and blown-away casing of condensing unit of the split Air Conditioning system serving the facility. Damage control wirings and disconnect switch of ACCU units.

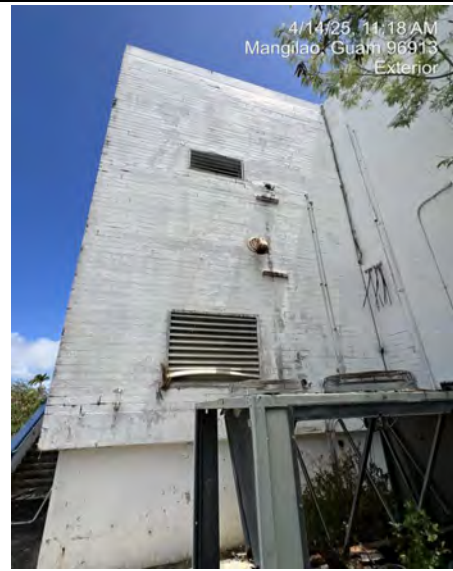
**Photo-30:**

**Location:** Outdoor - Air cooled condensing unit (ACCU)

**Remarks:** Damage and blown-out refrigerant piping. Damage intake air louvers.

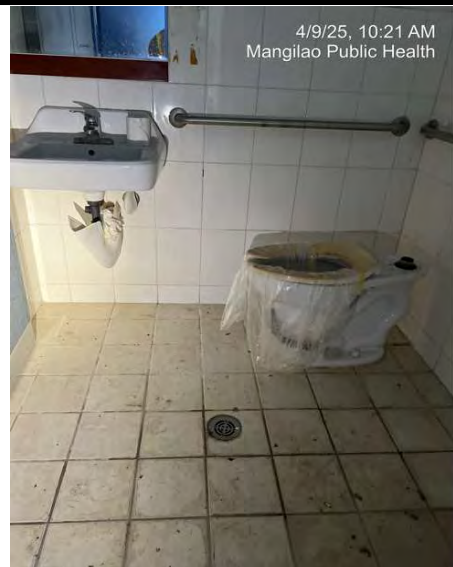
**Photo-1:**

| Location: | Ground Floor - Womens Restroom |
| Remarks: | Typical condition of damage Water Closets with cut piping connections and missing flush Valves and covers. |

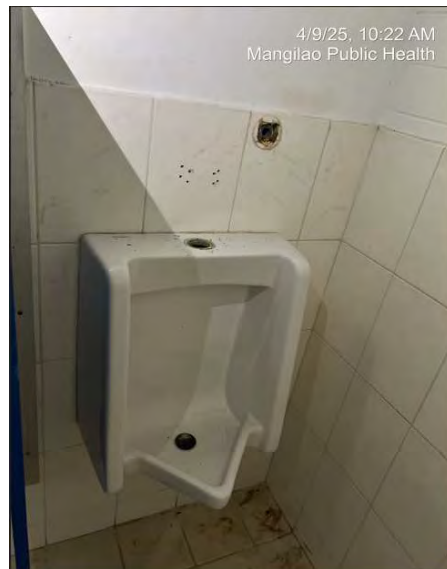
**Photo-2:**

| Location: | Ground Floor - Mens Restroom ADA |
| Remarks: | Typical condition of damage Water Closets with cut piping connections and missing flush Valves and covers. Damage Lavatory piping covers. |

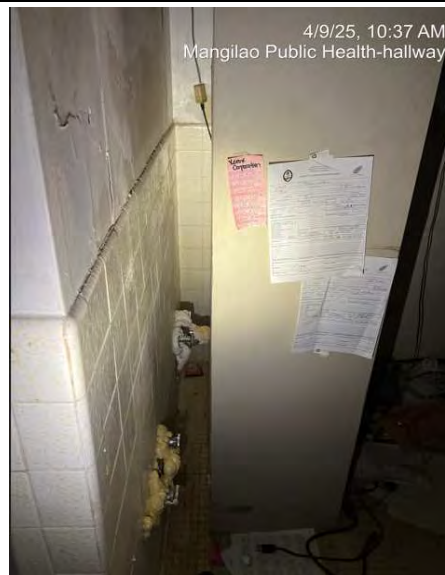
**Photo-5:**

Location: Ground Floor - Mens Restroom 1A  
Remarks: Missing Water closet, piping and faucets.

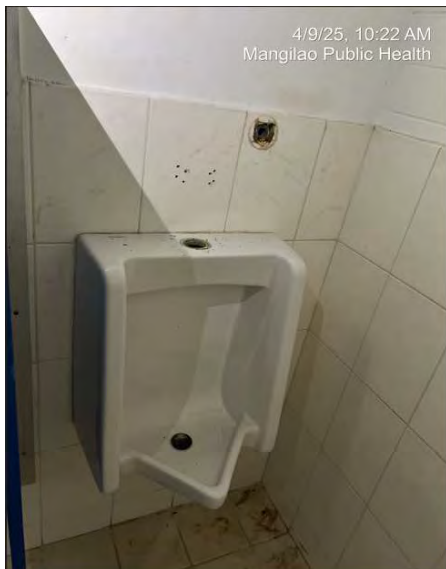
**Photo-6:**

Location: Ground Floor - Mens Restroom 1A  
Remarks: Cut and missing Plumbing fixtures.

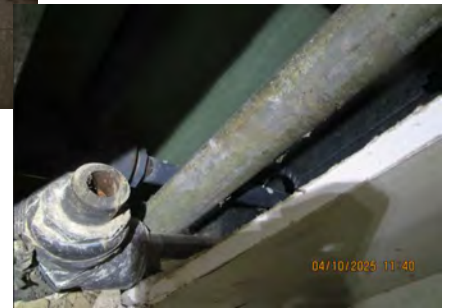
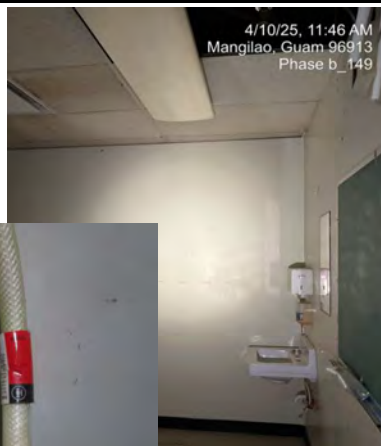
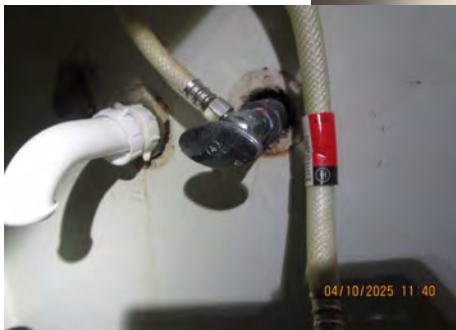
| Location: | Ground Floor - Clinic Area Toilet | Location: | Ground Floor - Typical Clinic Area with Sink |
| Remarks: | Typical condition of damage Water closet and lavatory with cut piping connections, missing flush valveset, piping and faucets. | Remarks: | Cut piping connections (ABS piping). |

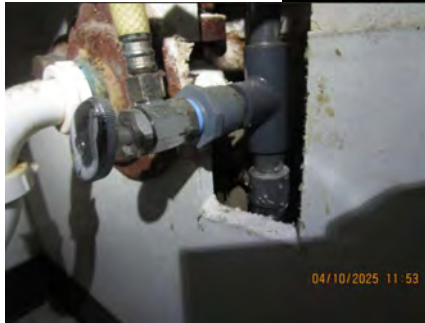
| Location: | Ground Floor - Typical Clinic Area with Sink | Location: | Ground Floor - Typical Clinic Area with Sink |
| Remarks: | Typical condition of damage Clinic room Lavatory sink with cut piping connections and missing flush valve sets. | Remarks: | Typical condition of Sink with signs of aging, visible corrosion. |

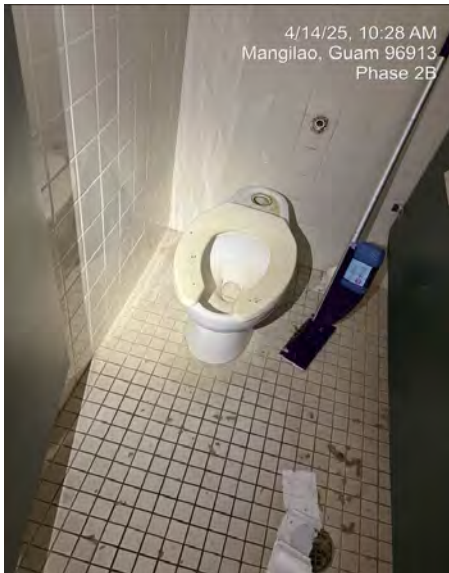
**Photo 27:**

| Location: | Second Floor - Rest Rooms |
| Remarks: | Typical condition of damage Water Closets with cut piping connections and missing flush Valves and covers. |

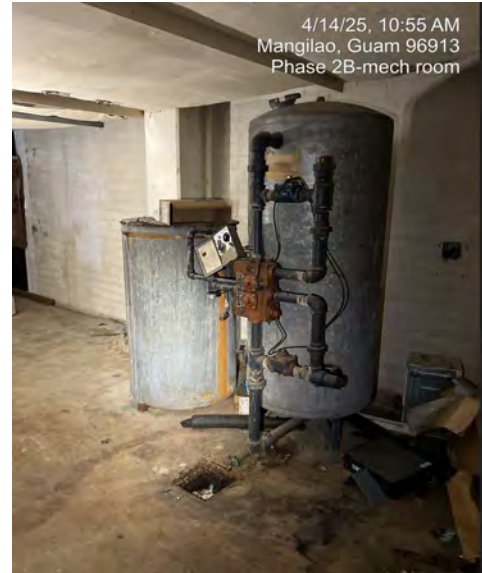
**Photo-32:**

| Location: | Second Floor - Mechanical Room |
| Remarks: | Disconnected and cut piping for Water Softener and Brine Tank. Tank shown visible signs of corrosion. Typical corroded Floor drains in mechanical rooms. |

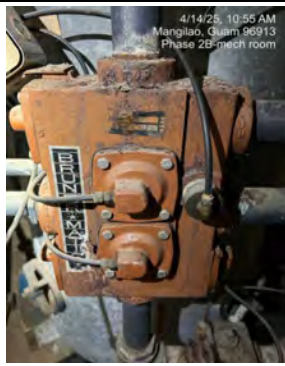
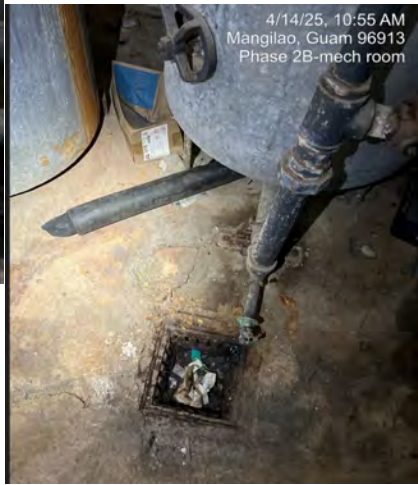
**Photo-33:**

| Location: | Second Floor - Mechanical room | | |
| Remarks: | Disconnected and cut piping for Water Softener and Brine Tank. Tank shown visible signs of corrosion. Typical corroded Floor drains in mechanical rooms. | | |

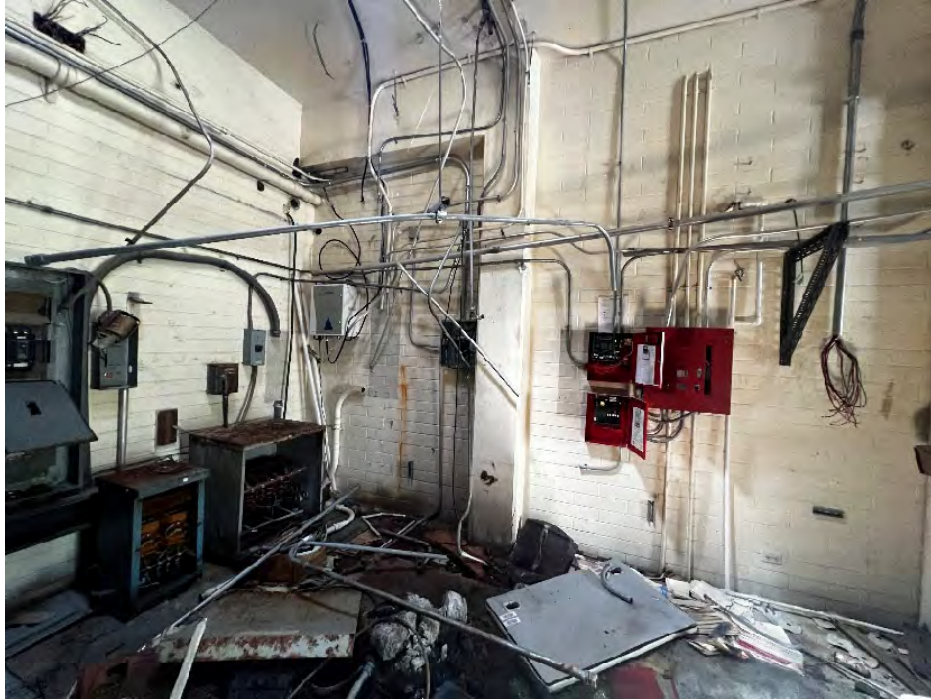
PHOTO #3 – UNUSABLE ELECTRICAL EQUIPMENT, CONDUITS, AND WIRING

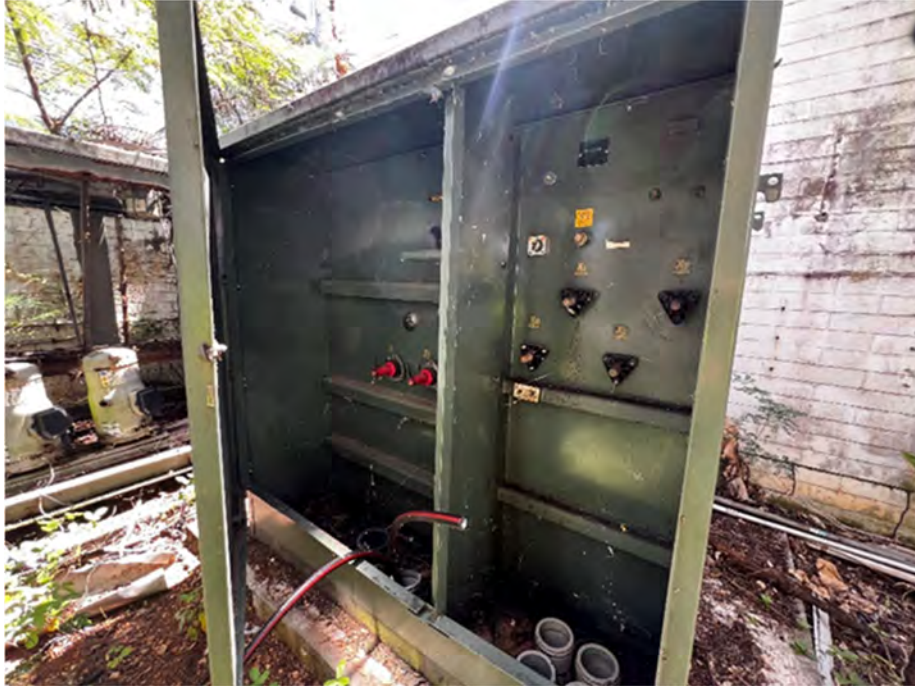
PHOTO #7 – THEFT OF TRANSFORMER PARTS AND WIRING

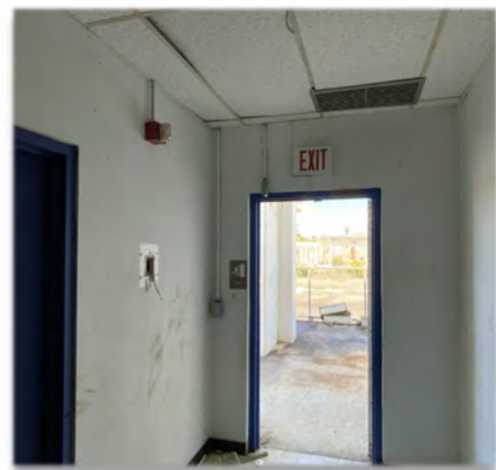
Fig. 5 Missing pull station.

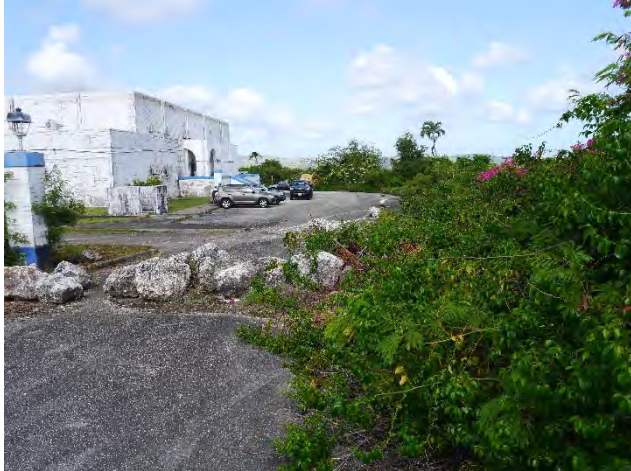
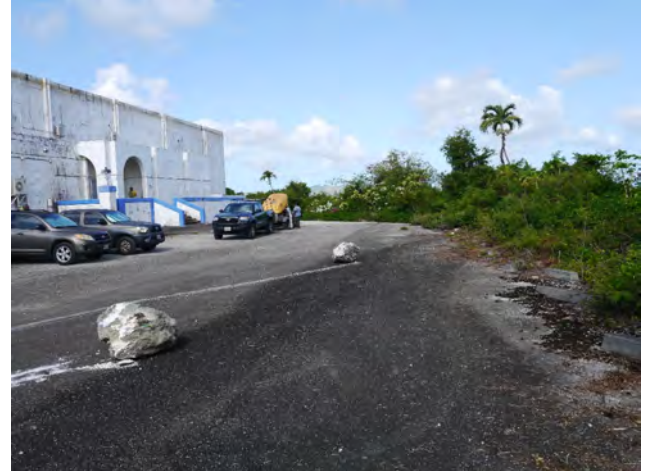
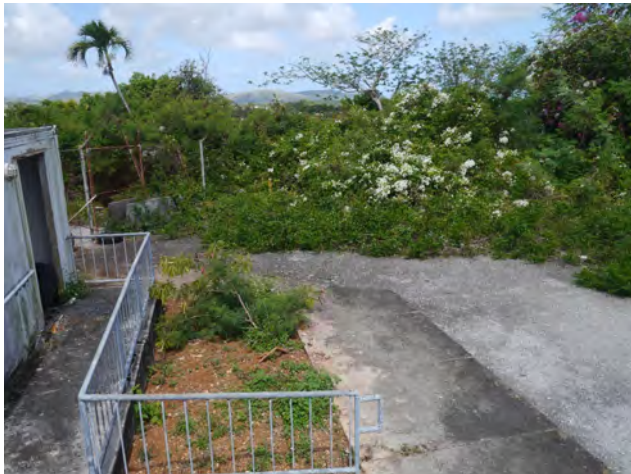
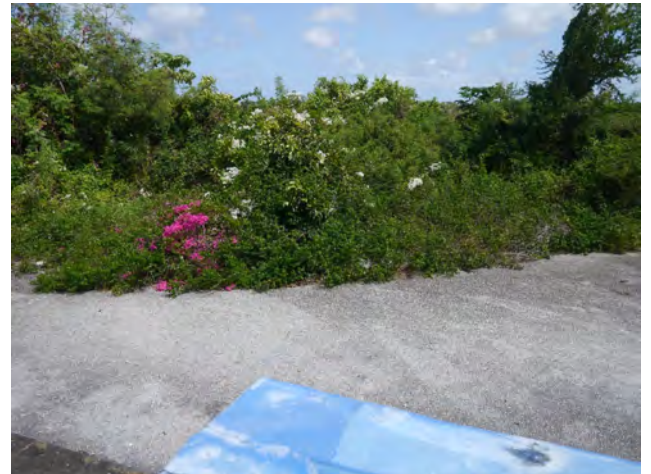
EMPSCO observed significant thick growth of shrubs and bushes around the property boundaries and adjacent to the building around at the north, northwest, and west portions (see pages 1-2; page 3, photo 1).

| 1 | Description: | Overgrown shrubs and bushes – North Side |

| 2 | Description: | Overgrown shrubs and bushes – North Side |

| 3 | Description: | Overgrown shrubs and bushes – North Side |

| 4 | Description: | Overgrown shrubs and bushes – North Side |

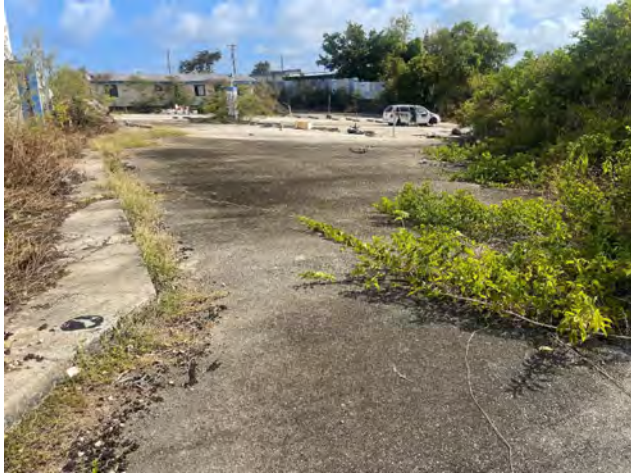
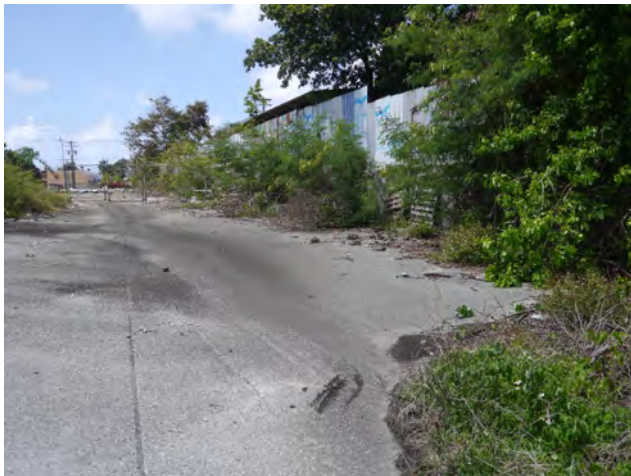
| 1 | Description: | Overgrown shrubs and bushes – Northwest Side |

| 2 | Description: | Overgrown shrubs and bushes – West Side |

| 3 | Description: | Overgrown shrubs and bushes – West Side |

| 4 | Description: | Overgrown shrubs and bushes – West Side |
