| BILL NO. | SPONSOR | TITLE | DATE INTRODUCED | DATE REFERRED | CMTE REFERRED | FISCAL NOTES | PUBLIC HEARING DATE | DATE COMMITTEE REPORT FILED | NOTES |
|---|---|---|---|---|---|---|---|---|---|
| 12-38 (COR) | Therese M. Terlaje | AN ACT TO RESERVE LOT NO. 2417-I-R7, THE FORMER DEPARTMENT OF PUBLIC HEALTH AND SOCIAL SERVICES MAIN BUILDING IN MANGILAO, FOR IMMEDIATE USE BY THE DEPARTMENT OF PUBLIC HEALTH AND SOCIAL SERVICES AND TO AUTHORIZE ITS USE FOR THE GUAM COMMUNITY COLLEGE NURSING PROGRAM. | 1/13/25<br>9:18 a.m. | 1/21/25 | Committee on Land, Environment, Housing, Agriculture, Parks, and Infrastructure. | Request: 1/21/25 | 4/1/25<br>9:00 a.m. | 7/11/25<br>As Amended. | Exhibit A |

RE: **Committee Report on Public Hearing** [Bill No. 12-38 \(COR\)](#) – Therese M. Terlaje – AN ACT TO RESERVE LOT NO. 2417-1-R7, THE FORMER DEPARTMENT OF PUBLIC HEALTH AND SOCIAL SERVICES MAIN BUILDING IN MANGILAO, FOR IMMEDIATE USE BY THE DEPARTMENT OF PUBLIC HEALTH AND SOCIAL SERVICES AND TO AUTHORIZE ITS USE FOR THE GUAM COMMUNITY COLLEGE NURSING PROGRAM.

# CONDITIONAL ASSESSMENT OF MANGILAO PUBLIC HEALTH BUILDING

PROJECT NO.: 460-5-1007-F-MAN  
FINAL REPORT  
July 18, 2025

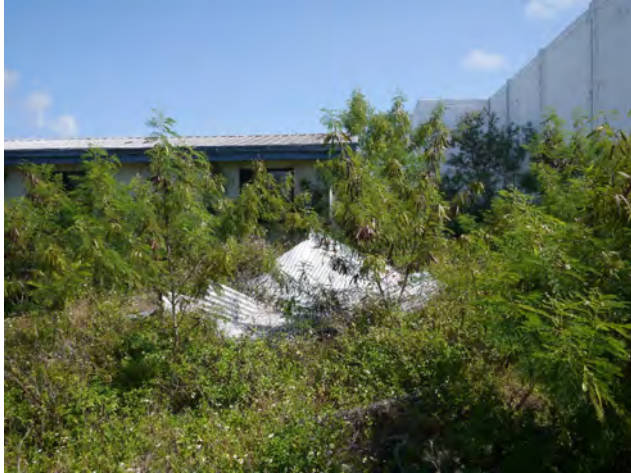
| 1 | Description: | <b>Overgrown shrubs and bushes, and debris around Building 5 – West Side</b> |

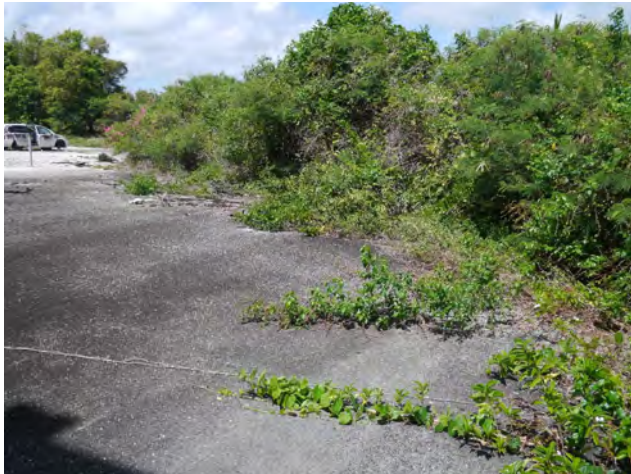
| 3 | Description: | <b>Cyclone fence is barely visible due to overgrown shrubs and bushes – West side</b> |

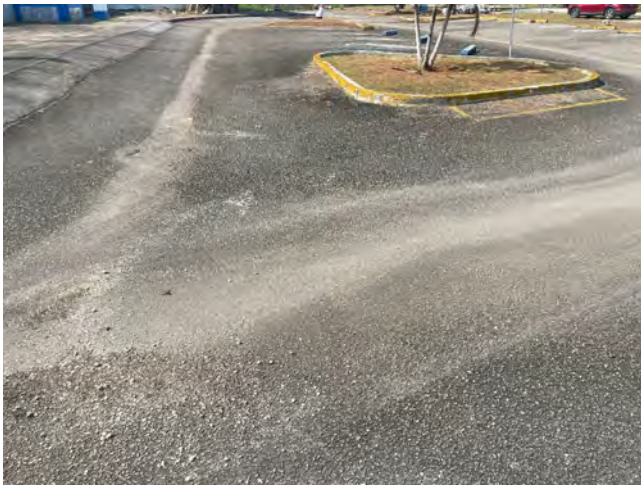
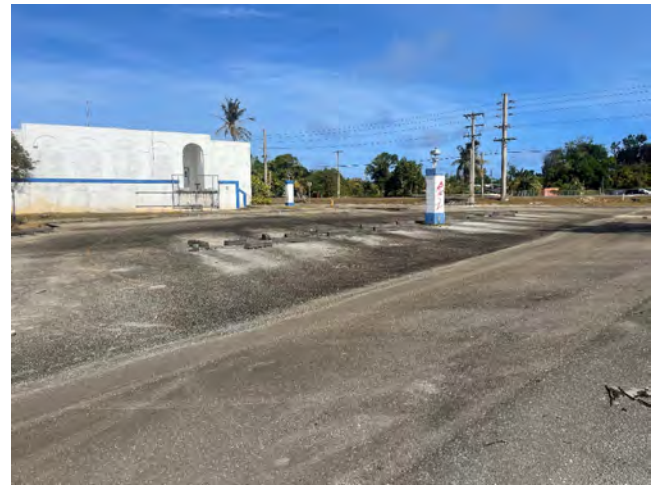
| 3 | Description: | <b>Typical existing condition of pavement.</b> |

| 4 | Description: | <b>Typical existing condition of pavement.</b> |

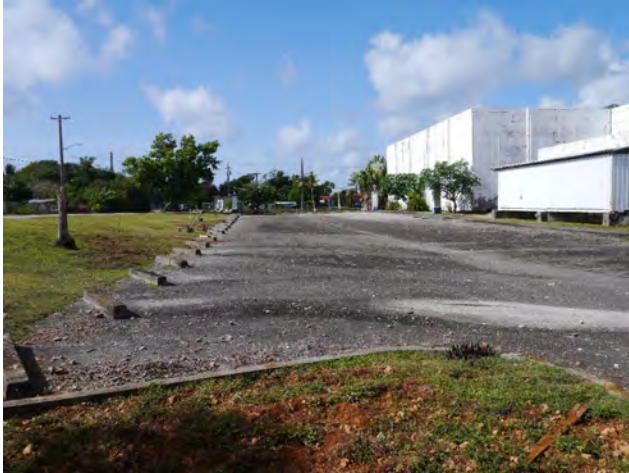
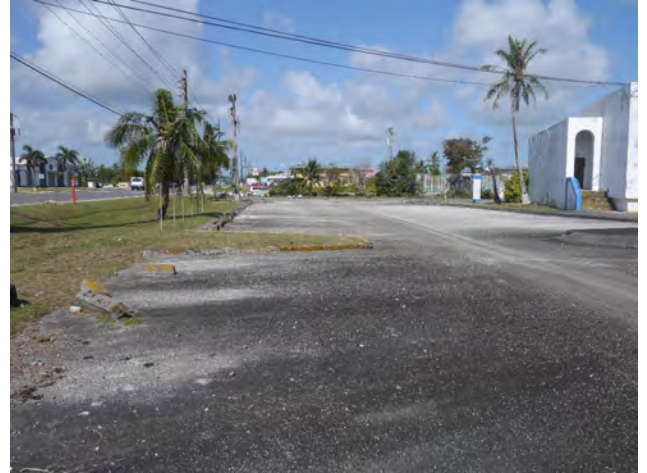
| 1 | Description: | <b>Parking stripes are hardly visible and eroded.</b> |

| 2 | Description: | <b>Parking stripes are hardly visible and eroded.</b> |

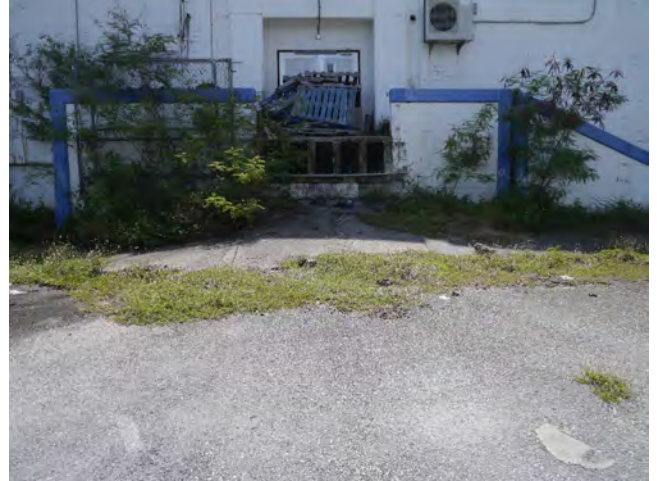
| 2 | Description:: | <b>Loading dock at building 3.</b> |

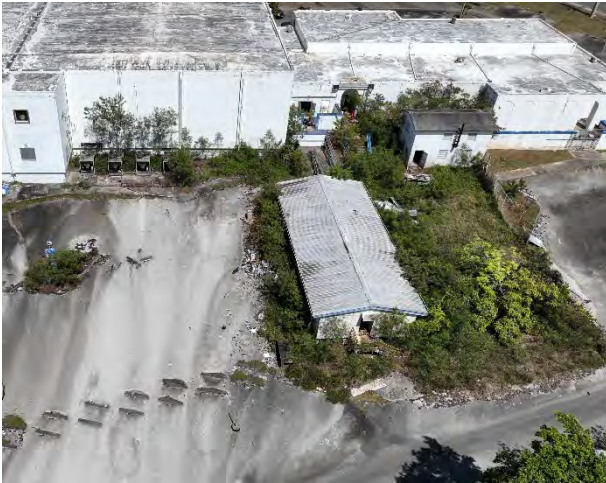
| 3 | Description: | <b>Heavy vegetation growth around building 5.</b> |

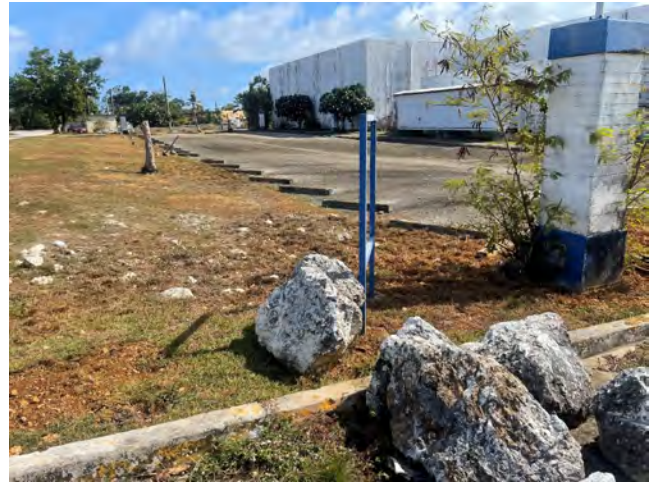
| 4 | Description: | <b>Unnecessary vegetation and tree stumps.</b> |

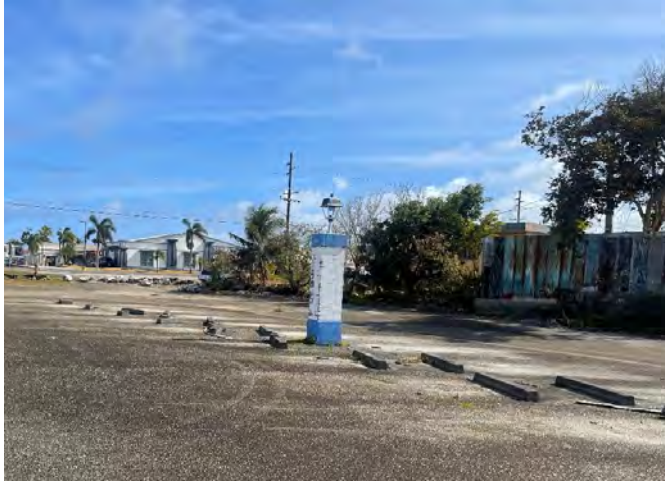
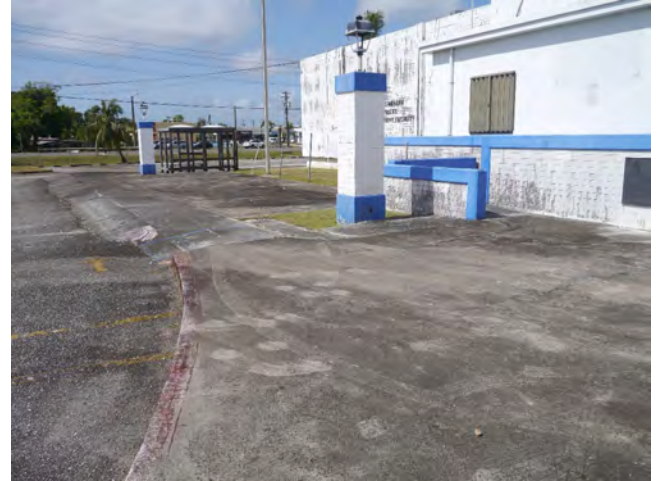
| 1 | Description: | Typical outdoor concrete post-mounted lighting. |

| 2 | Description: | Typical outdoor concrete post-mounted lighting. |

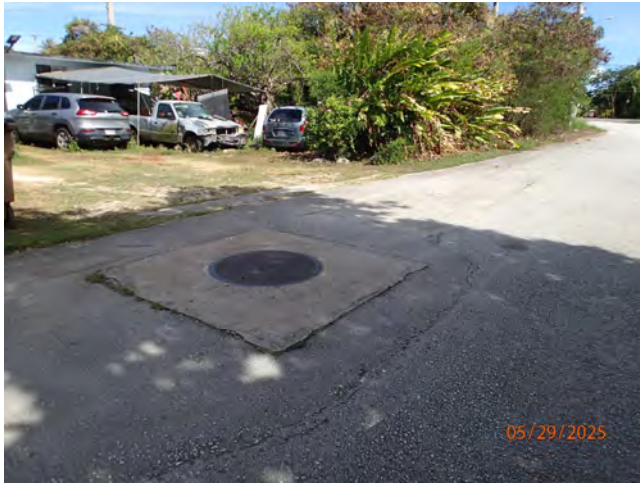
Currently, the facility is serviced through a buried sanitary sewer line that exits from below the building on the East side of the property, and which is assumed to connect to a sewer manhole which is located along Chalan Kareta Road (see page 8, photo 3). From this manhole, the sewer hookup is assumed to connect with another buried sanitary sewer piping that connects via gravity flow to another manhole located on Route 10.

| 3 | Description: | Existing sewer manhole located along Chalan Kareta Road. |

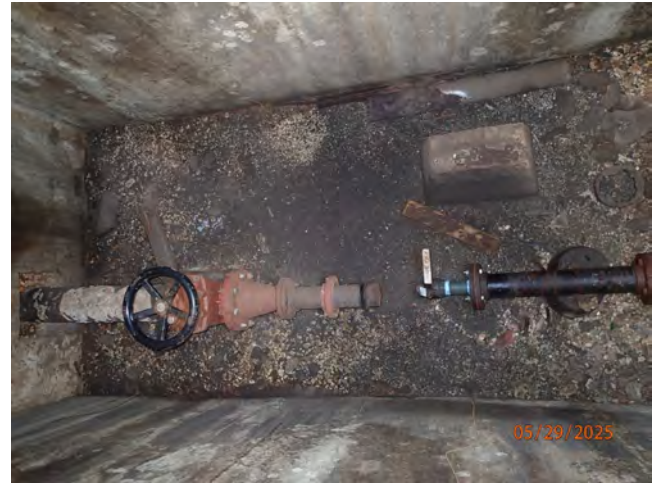
| 4 | Description: | Gate valves and water meter (removed) inside the concrete vault. |

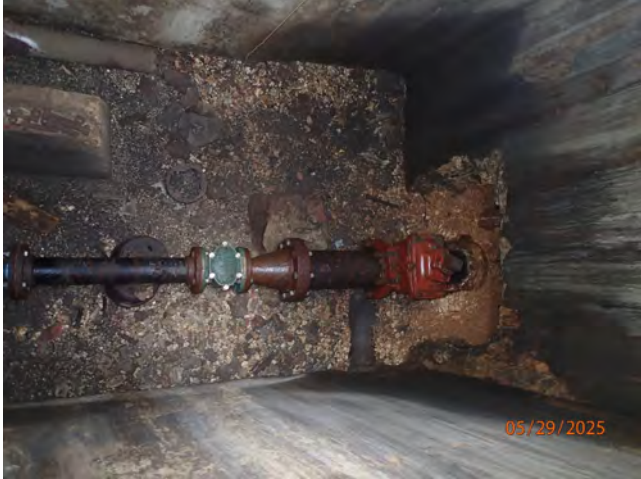
| 1 | Description: | Gate valves and water meter (removed) inside the concrete vault. |

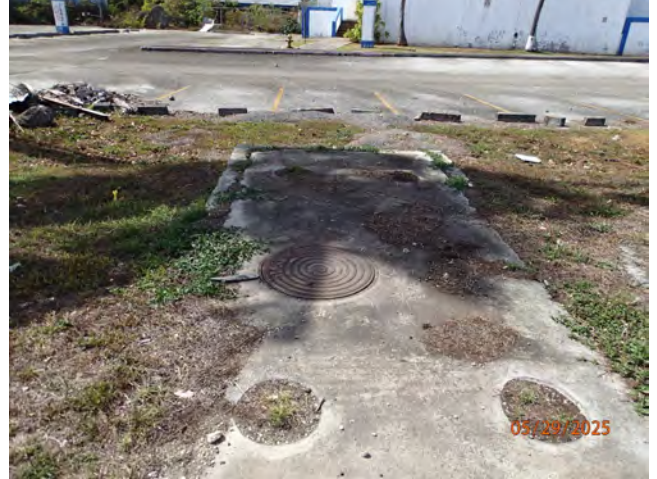
Site inspection of the facility shows that the water supply network is located on the west side of the building. Outside the property line at the south, there is an existing concrete vault that houses the 6-inch waterline, gate valves, and water meter leading to the fire hydrant located inside the property (see page 8, photo 4; page 9, photos 1-2). The water meter was probably removed to terminate water supply to the fire hydrant and to the buildings. Our scope of assessment does not include testing of valves and fire hydrants. Water supply to the facility has been shut off at the time of inspection.

| 2 | Description: | Concrete vault housing the gate valves and water meter (removed). |
