RE: **Amended Committee Report on Public Hearing [Bill No. 21-38 \(COR\)](#)** – Tina Rose Muna Barnes – AN ACT TO TRANSFER LOT NO. 2417-1-R7, MUNICIPALITY OF MANGILAO FORMERLY KNOWN AS THE DEPARTMENT OF PUBLIC HEALTH AND SOCIAL SERVICES CENTRAL HEADQUARTERS, FROM THE DEPARTMENT OF PUBLIC HEALTH AND SOCIAL SERVICES TO THE GUAM COMMUNITY COLLEGE FOR THE CONSTRUCTION OF A NURSING ANNEX.

# CONDITIONAL ASSESSMENT OF MANGILAO PUBLIC HEALTH BUILDING

PROJECT NO.:460-5-1007-F-MAN  
FINAL REPORT  
July 18, 2025

**PROJECT: Professional Consulting Services for a Conditional Assessment of the Mangilao Public Health Building, Project No. 460-5-1007-F-MAN**

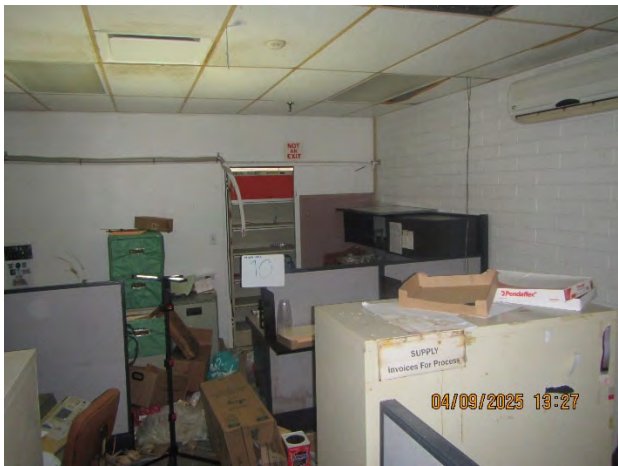
3	<i>Building Component:</i>	<b>1<sup>ST</sup> FLOOR TYPICAL OFFICE ROOMS</b>

Several office spaces are observed have loose furniture and equipment. The condition of these furnishings varies from satisfactory, fair to damaged. As observed, there are remaining pieces of furniture that are observed in good condition and may be still useable.

Recommend that an inventory of stored FFE (fixture, furnishings and equipment) be made by DPHSS prior to beginning any renovation work.

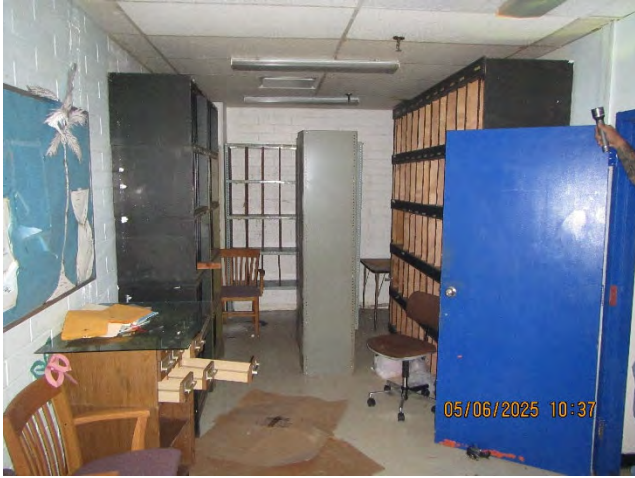
1	Building Component:	<b>1ST FLOOR – CABINETS AND SHELVES</b>

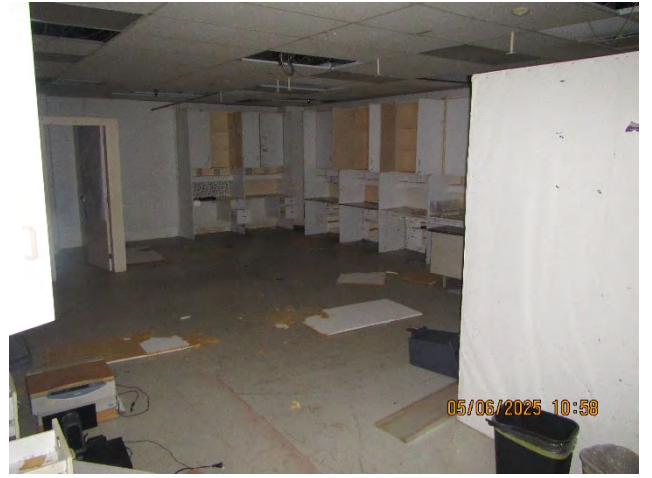
2	Building Component:	<b>1ST FLOOR – CABINETS AND SHELVES</b>

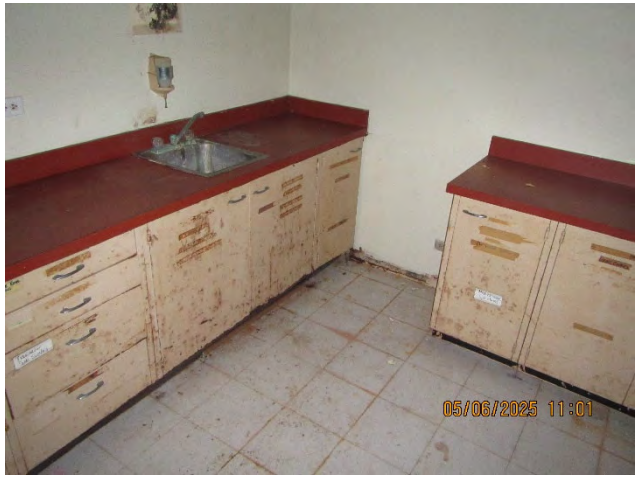
3	Building Component:	<b>1ST FLOOR – CABINETS AND SHELVES</b>

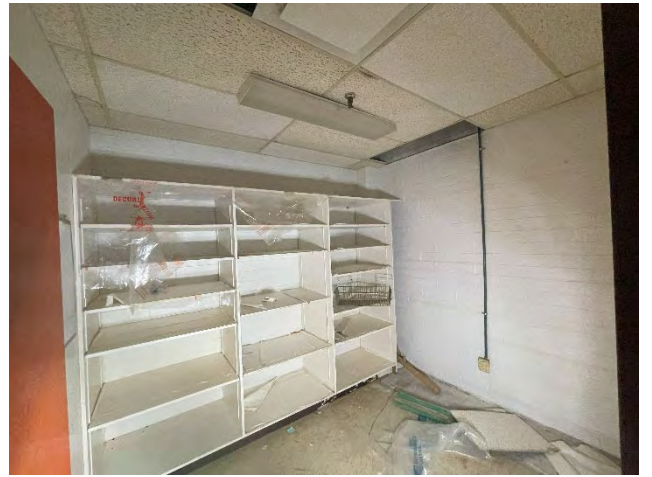
4	Building Component:	<b>1ST FLOOR – CABINETS AND SHELVES</b>

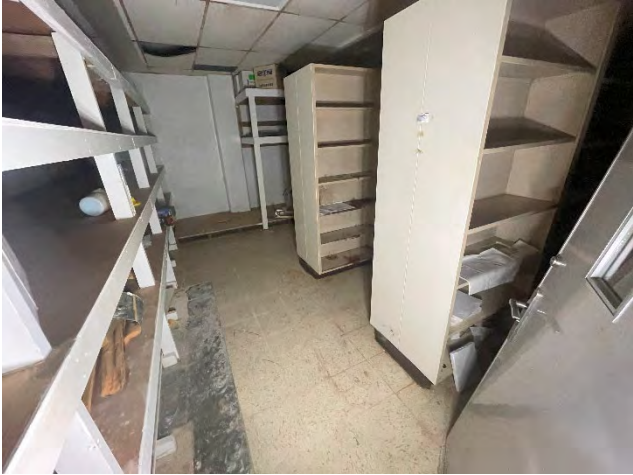
1	Building Component:	<b>1<sup>ST</sup> FLOOR – CABINETS AND SHELVES</b>

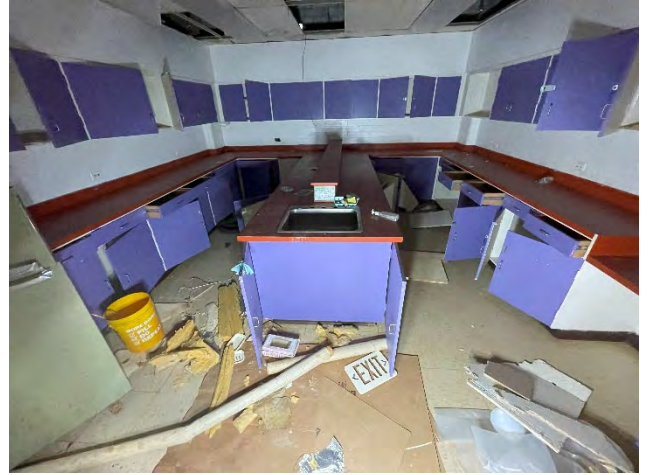
2	Building Component:	<b>1<sup>ST</sup> FLOOR – CABINETS AND SHELVES</b>

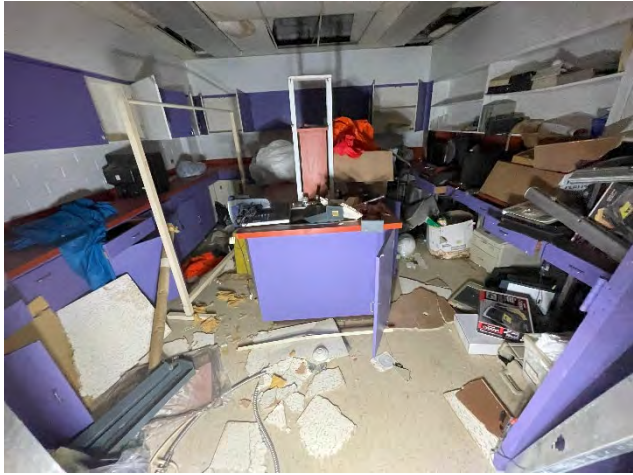
3	Building Component:	<b>1<sup>ST</sup> FLOOR – CABINETS AND SHELVES</b>

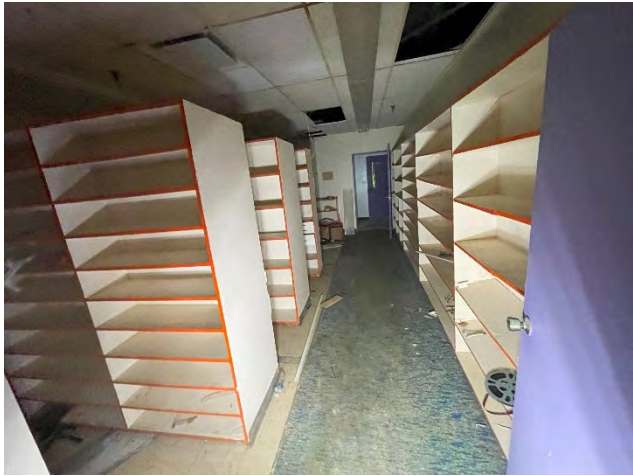
1	Building Component:	<b>1<sup>ST</sup> FLOOR – CABINETS AND SHELVES</b>

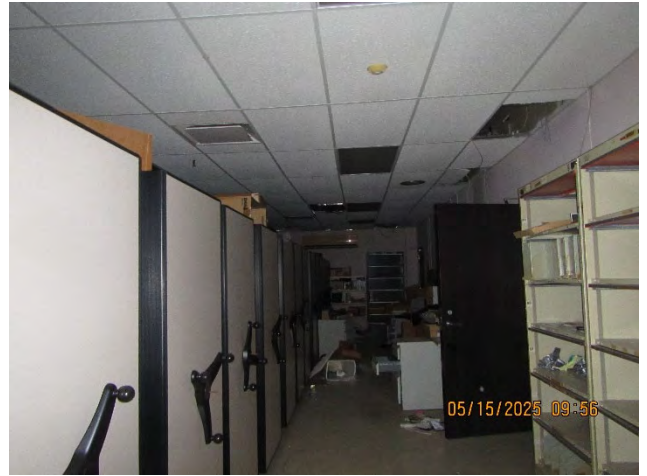
2	Building Component:	<b>2<sup>ND</sup> FLOOR – CABINETS AND SHELVES</b>

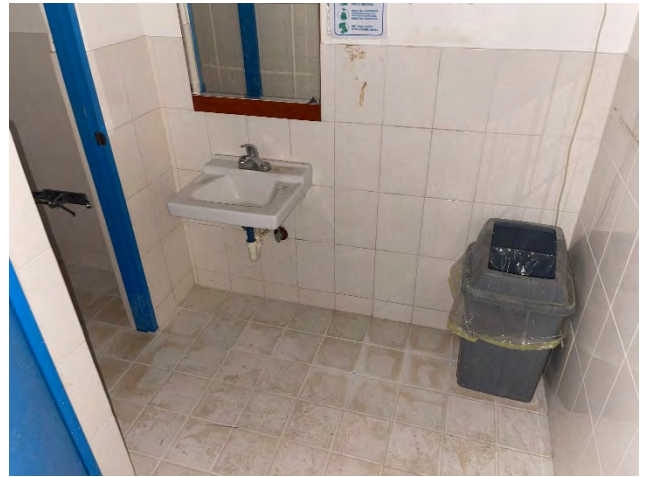
4	Building Component:	<b>1<sup>ST</sup> FLOOR – RESTROOMS</b>

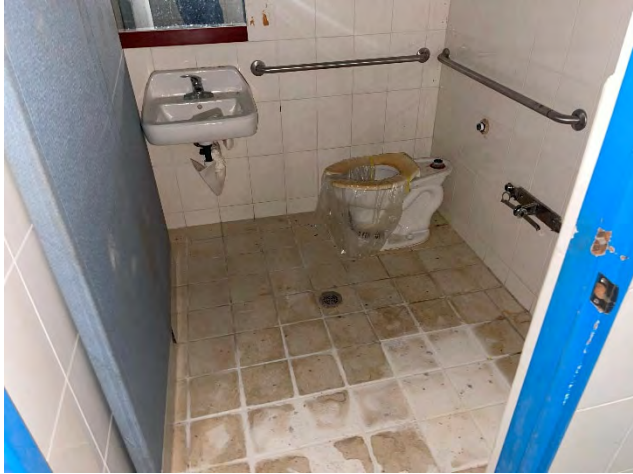
1	<i>Building Component:</i>	<b>1<sup>ST</sup> FLOOR – RESTROOMS</b>

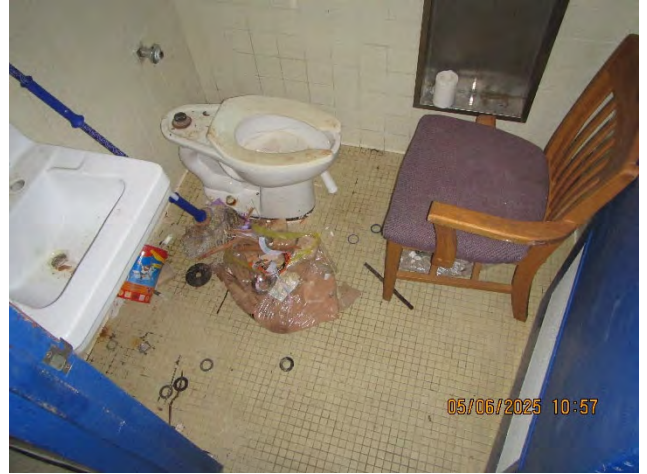
2	<i>Building Component:</i>	<b>1<sup>ST</sup> FLOOR – RESTROOMS</b>

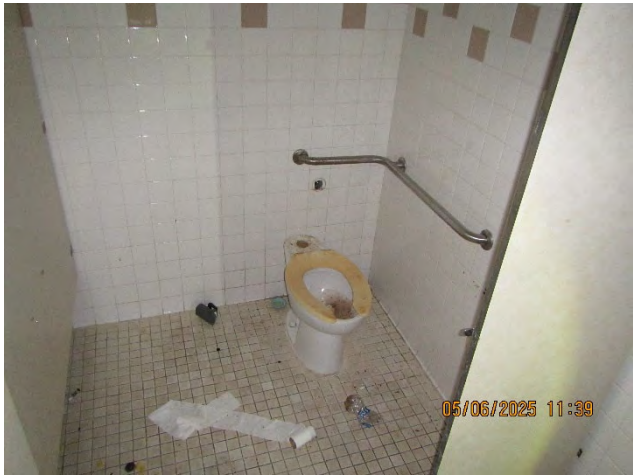
3	<i>Building Component:</i>	<b>1<sup>ST</sup> FLOOR – RESTROOMS</b>

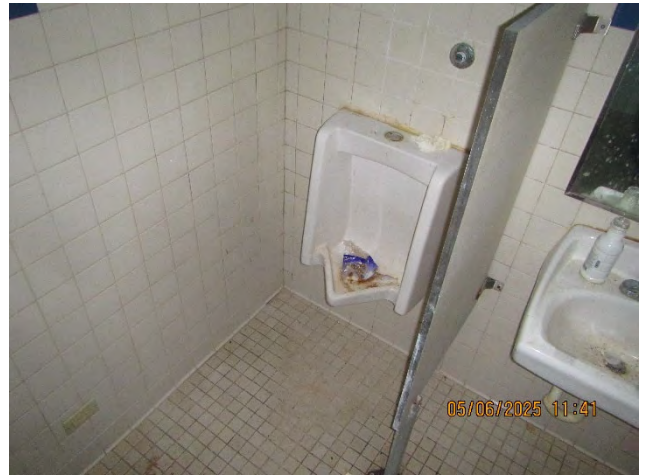
4	<i>Building Component:</i>	<b>1<sup>ST</sup> FLOOR – RESTROOMS</b>

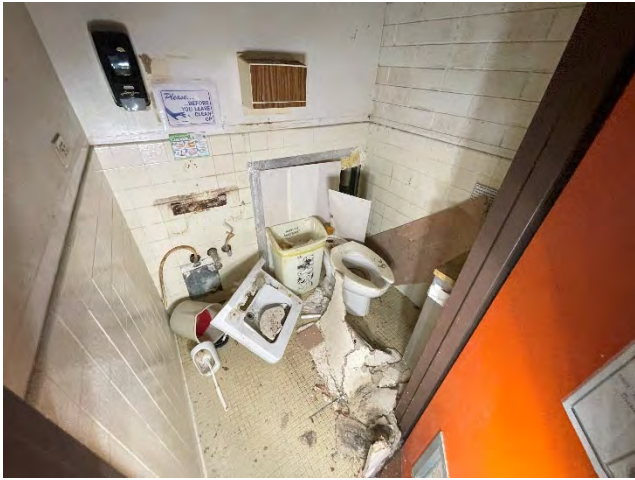
1	Building Component:	<b>1<sup>ST</sup> FLOOR – RESTROOMS</b>

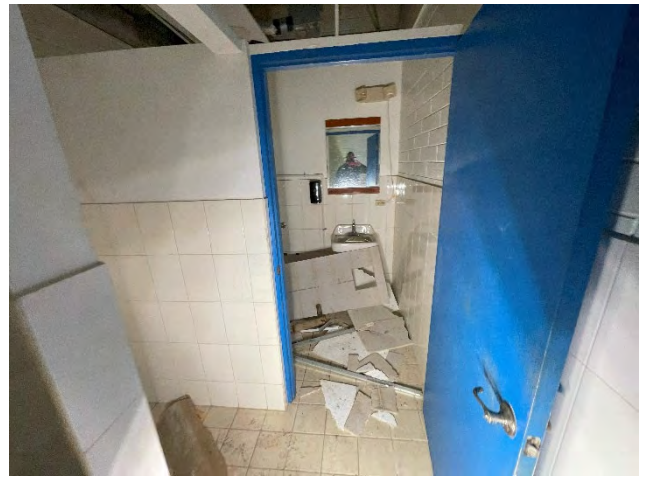
2	Building Component:	<b>1<sup>ST</sup> FLOOR – RESTROOMS</b>

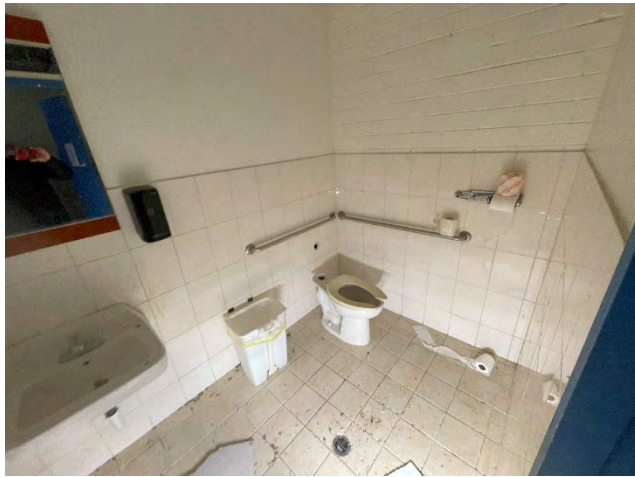
3	Building Component:	<b>1<sup>ST</sup> FLOOR – RESTROOMS</b>

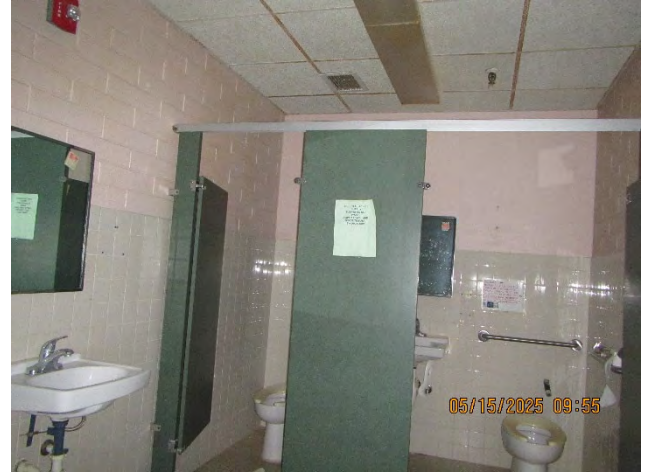
2	Building Component:	<b>2<sup>ND</sup> FLOOR – RESTROOMS</b>

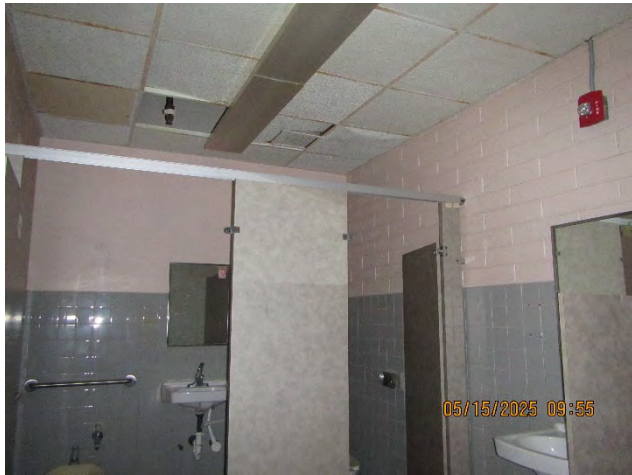
3	Building Component:	<b>2<sup>ND</sup> FLOOR – RESTROOMS</b>

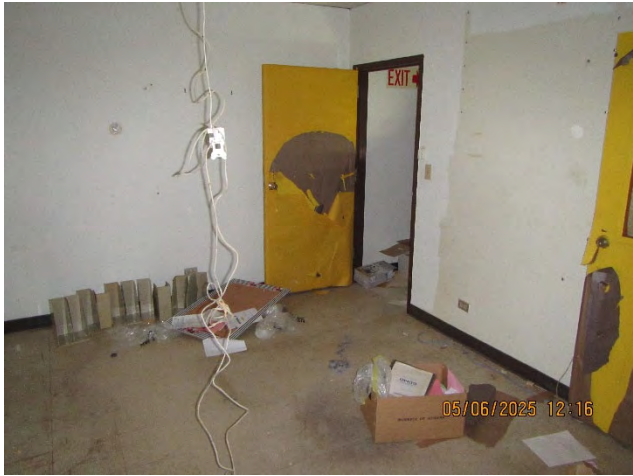
1	<i>Building Component:</i>	<b>1<sup>ST</sup> FLOOR TYPICAL FLOOR CONDITIONS</b>

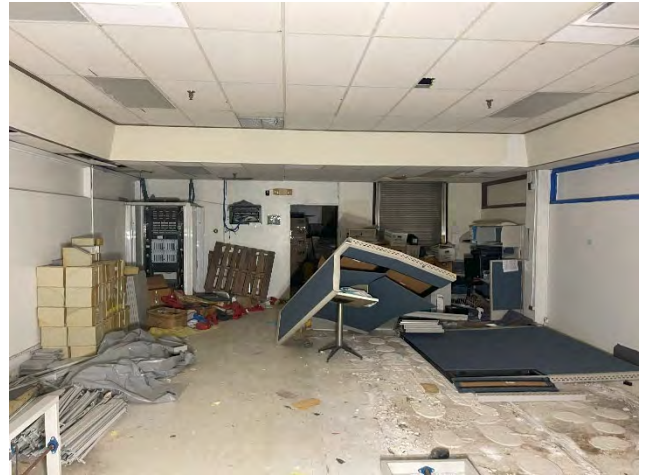
2	<i>Building Component:</i>	<b>1<sup>ST</sup> FLOOR TYPICAL FLOOR CONDITIONS</b>

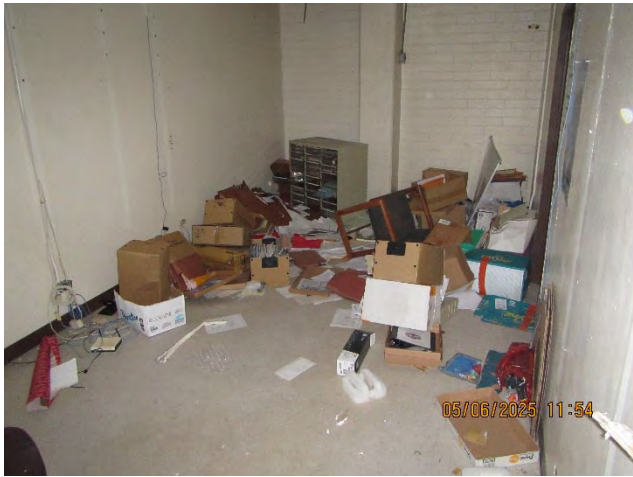
3	<i>Building Component:</i>	<b>1<sup>ST</sup> FLOOR TYPICAL FLOOR CONDITIONS</b>

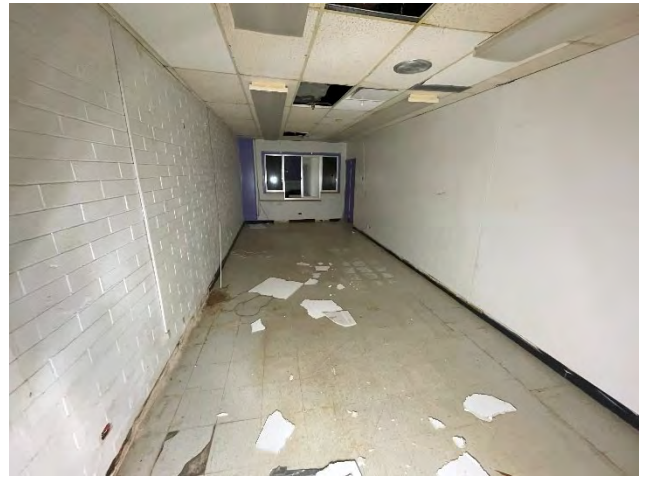
4	<i>Building Component:</i>	<b>1<sup>ST</sup> FLOOR TYPICAL FLOOR CONDITIONS</b>

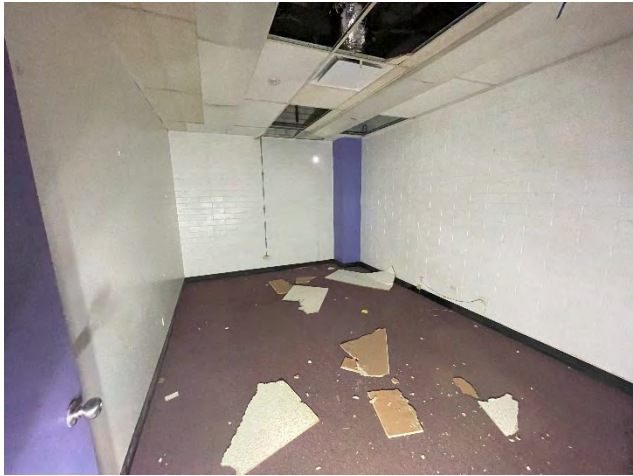
1	Building Component:	<b>1<sup>ST</sup> FLOOR TYPICAL FLOOR CONDITIONS</b>

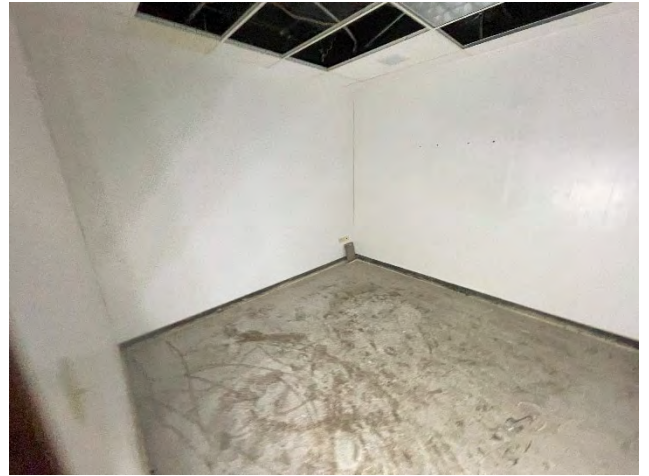
2	Building Component:	<b>1<sup>ST</sup> FLOOR TYPICAL FLOOR CONDITIONS WITH MOLD</b>

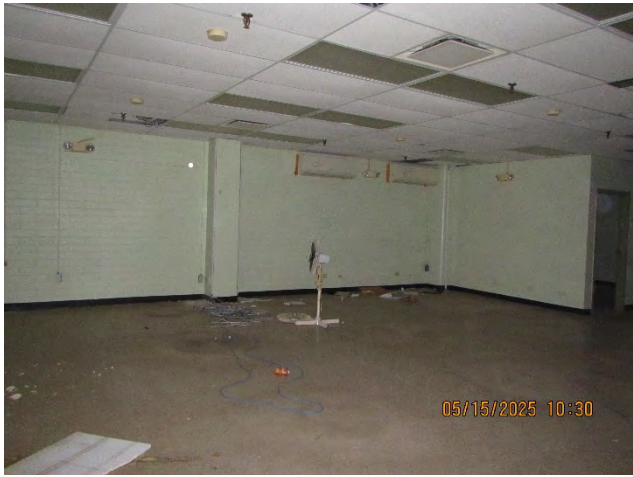
3	Building Component:	<b>2<sup>ND</sup> FLOOR TYPICAL FLOOR CONDITIONS</b>

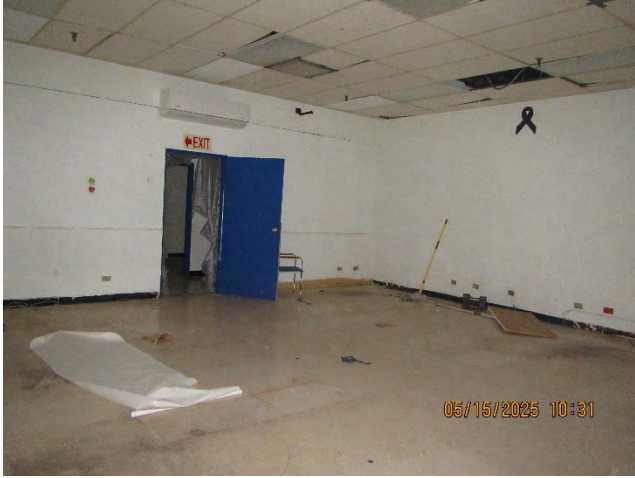
1	<i>Building Component:</i>	<b>2<sup>ND</sup> FLOOR TYPICAL FLOOR CONDITIONS</b>

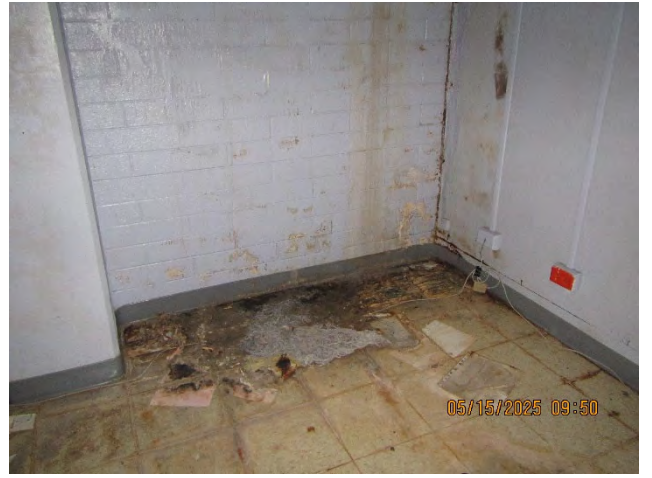
2	<i>Building Component:</i>	<b>2<sup>ND</sup> FLOOR TYPICAL FLOOR CONDITIONS WITH MOLD</b>

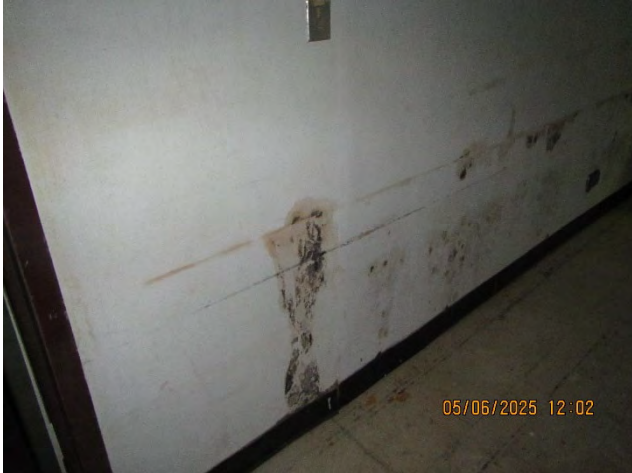
1	Building Component:	<b>1<sup>ST</sup> FLOOR TYPICAL WALL CONDITION WITH MOLD</b>

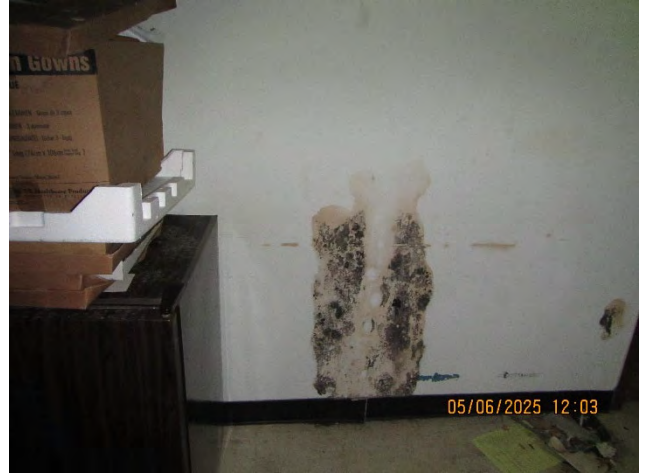
2	Building Component:	<b>1<sup>ST</sup> FLOOR TYPICAL WALL CONDITION WITH MOLD</b>

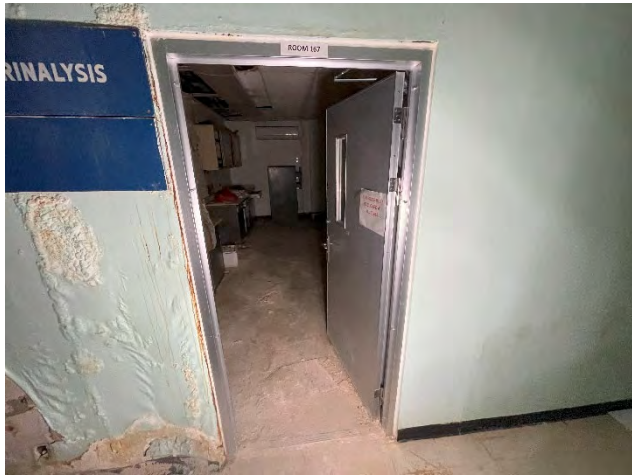
3	Building Component:	<b>1<sup>ST</sup> FLOOR TYPICAL WALL CONDITION WITH MOLD</b>

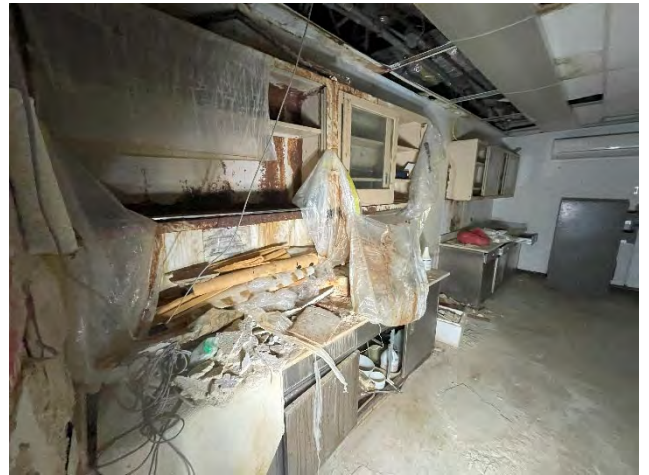
4	Building Component:	<b>1<sup>ST</sup> FLOOR TYPICAL WALL CONDITION WITH MOLD</b>

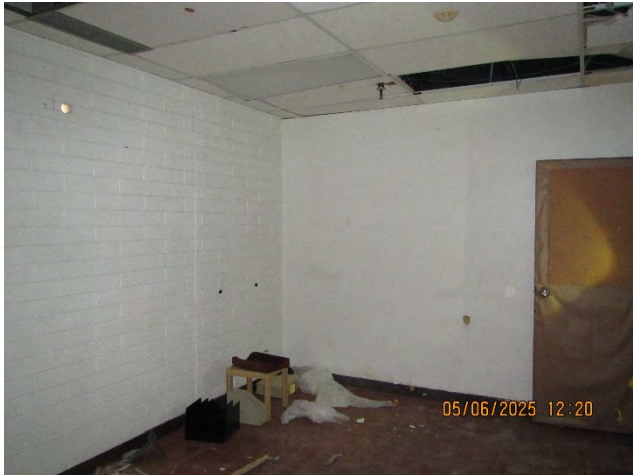
1	<i>Building Component:</i>	<b>1ST FLOOR TYPICAL WALL CONDITION</b>

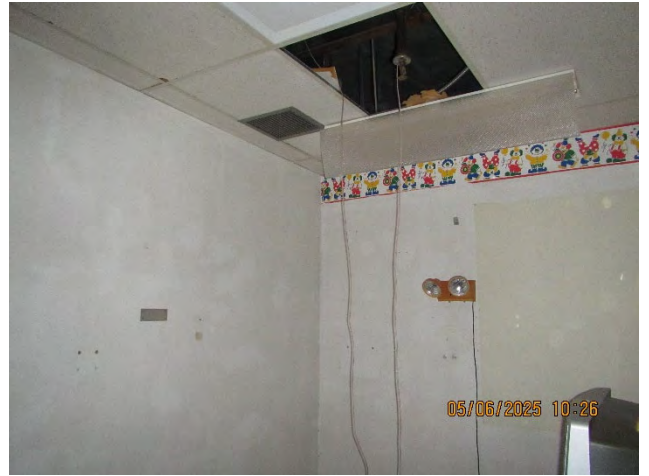
2	<i>Building Component:</i>	<b>1ST FLOOR TYPICAL WALL CONDITION</b>

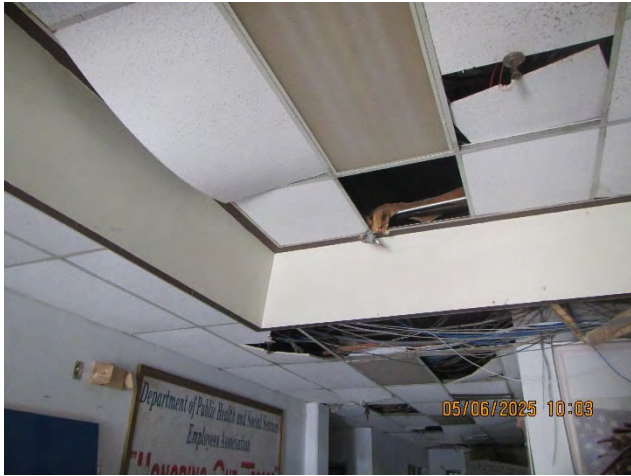
3	<i>Building Component:</i>	<b>1ST FLOOR TYPICAL WALL CONDITION</b>

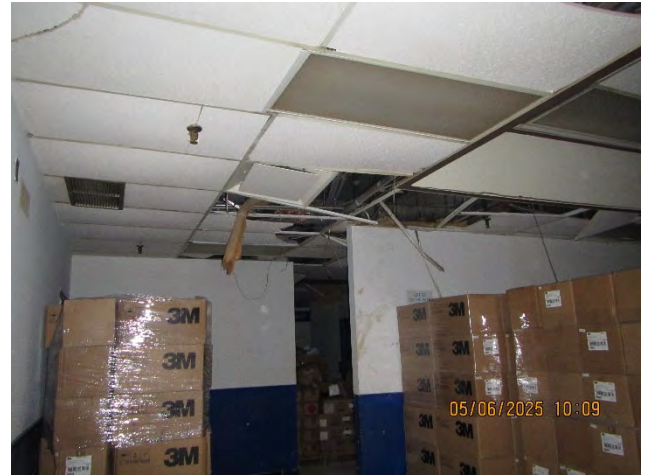
4	<i>Building Component:</i>	<b>1ST FLOOR TYPICAL WALL CONDITION</b>

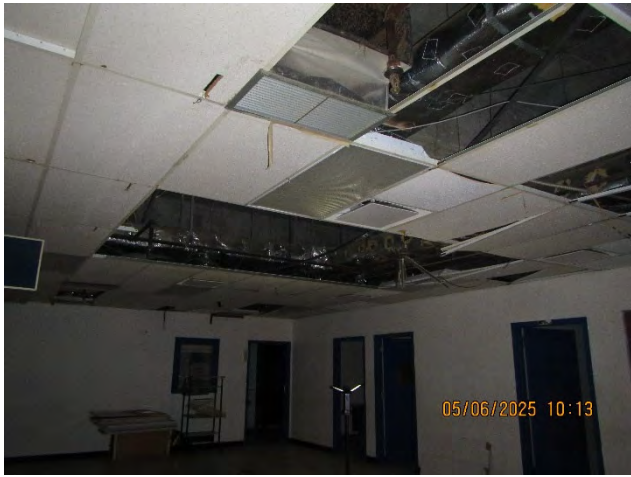
1	Building Component:	1 <sup>ST</sup> FLOOR TYPICAL CEILING CONDITIONS

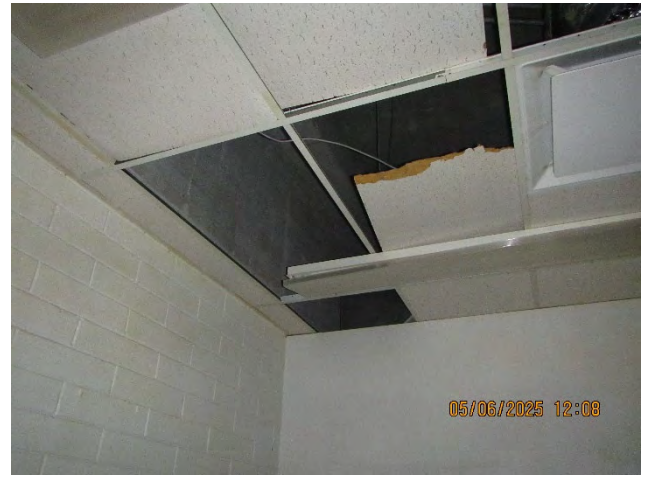
2	Building Component:	1 <sup>ST</sup> FLOOR TYPICAL CEILING CONDITIONS

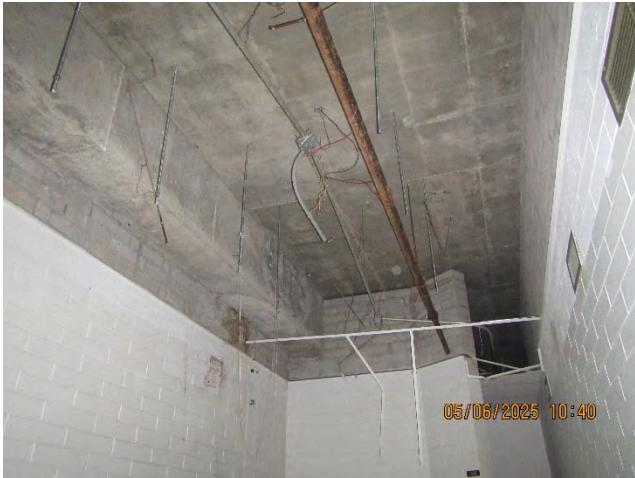
3	Building Component:	1 <sup>ST</sup> FLOOR TYPICAL CEILING CONDITIONS

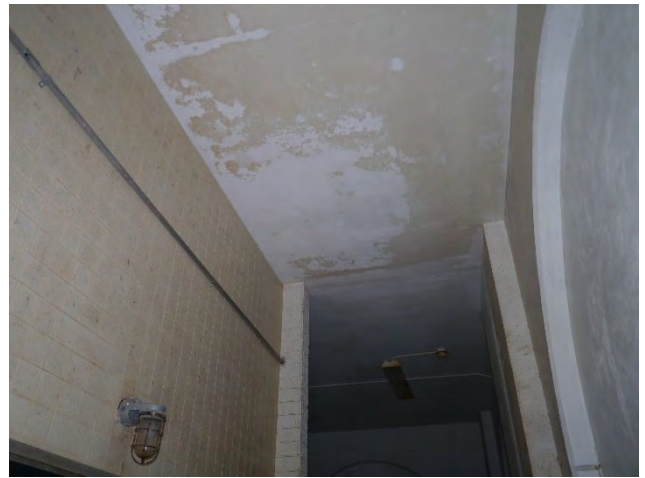
4	Building Component:	1 <sup>ST</sup> FLOOR TYPICAL CEILING CONDITIONS

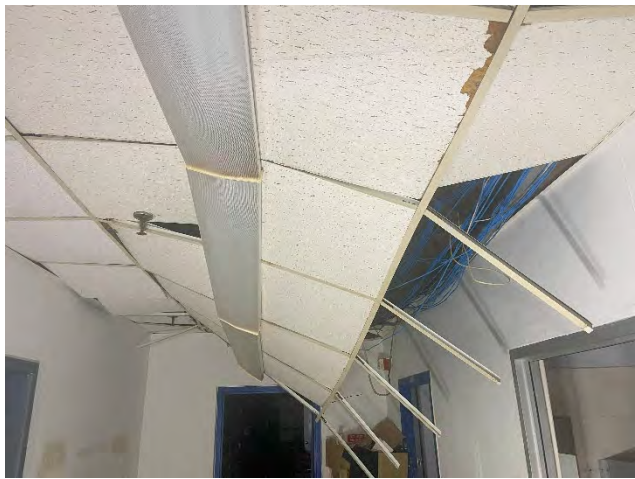
1	<i>Building Component:</i>	<b>1<sup>ST</sup> FLOOR TYPICAL CEILING CONDITIONS</b>

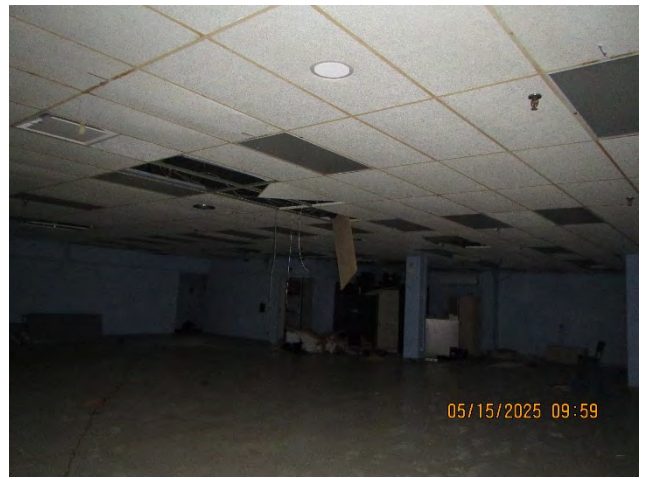
2	<i>Building Component:</i>	<b>1<sup>ST</sup> FLOOR TYPICAL CEILING CONDITIONS</b>

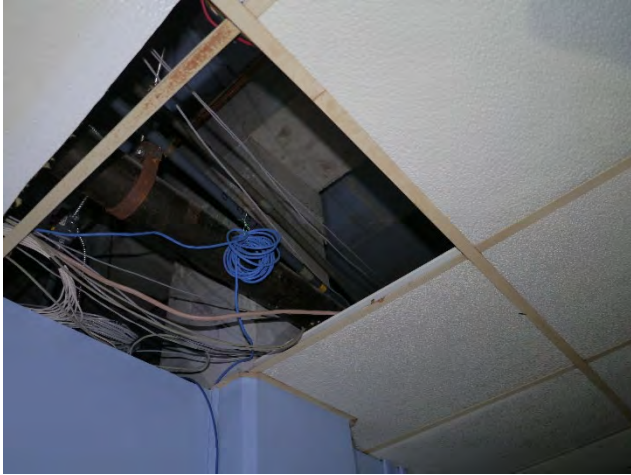
3	<i>Building Component:</i>	<b>2<sup>ND</sup> FLOOR TYPICAL CEILING CONDITIONS</b>

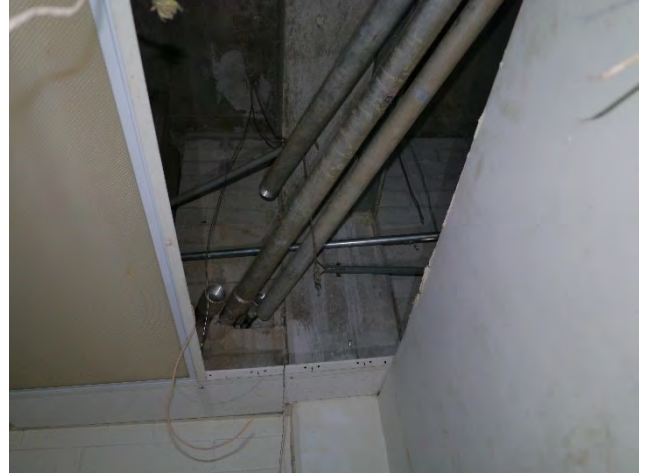
4	<i>Building Component:</i>	<b>2<sup>ND</sup> FLOOR TYPICAL CEILING CONDITIONS</b>

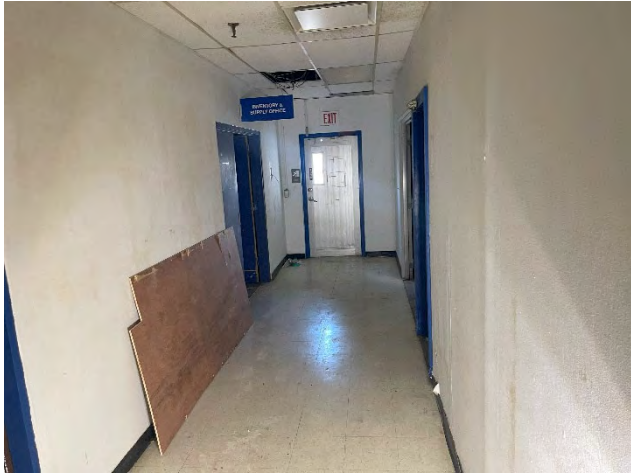
1	Building Component:	<b>2<sup>ND</sup> FLOOR TYPICAL CEILING CONDITIONS</b>

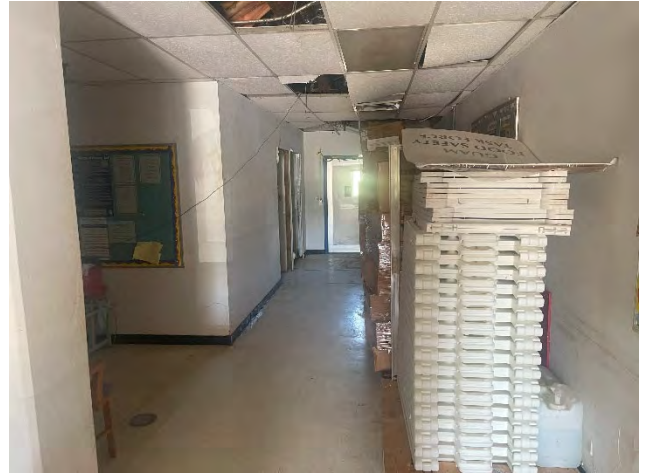
2	Building Component:	<b>2<sup>ND</sup> FLOOR TYPICAL CEILING CONDITIONS</b>

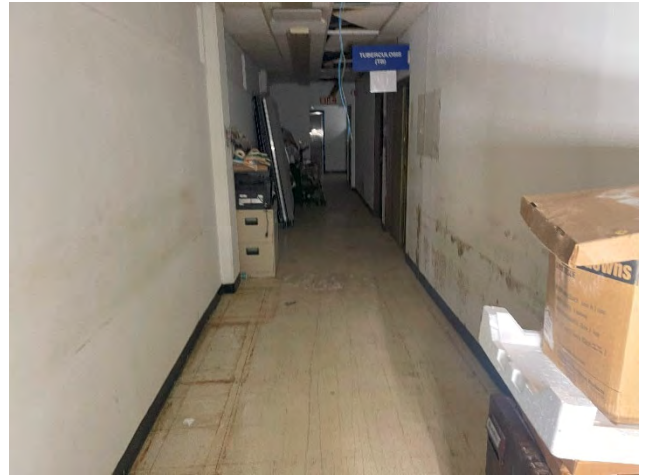
4	Building Component:	<b>TYPICAL HALLWAY CONDITION</b>

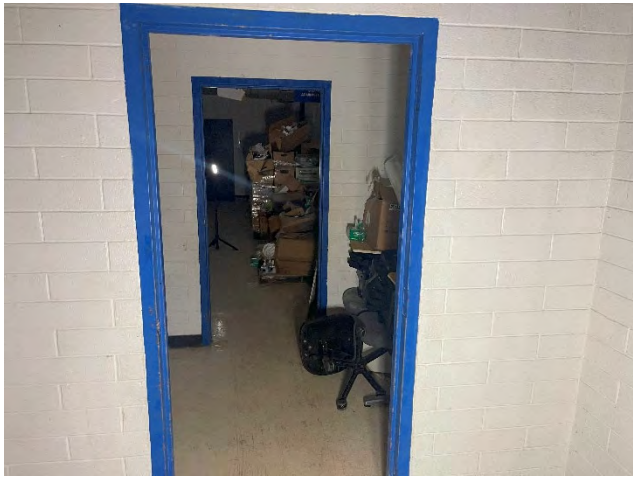
1	Building Component:	TYPICAL HALLWAY CONDITION

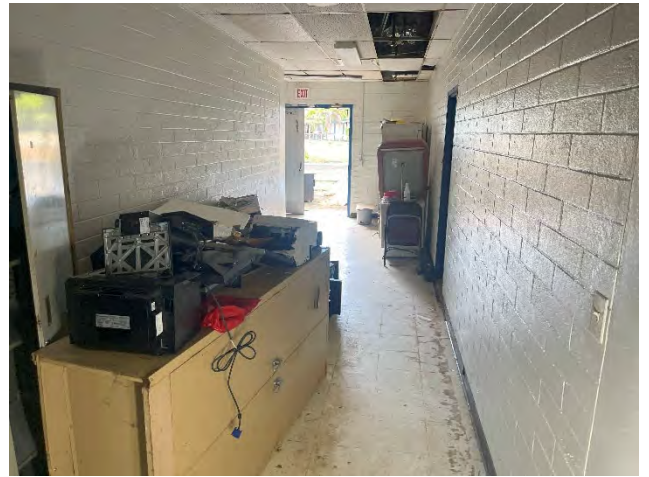
2	Building Component:	TYPICAL HALLWAY CONDITION

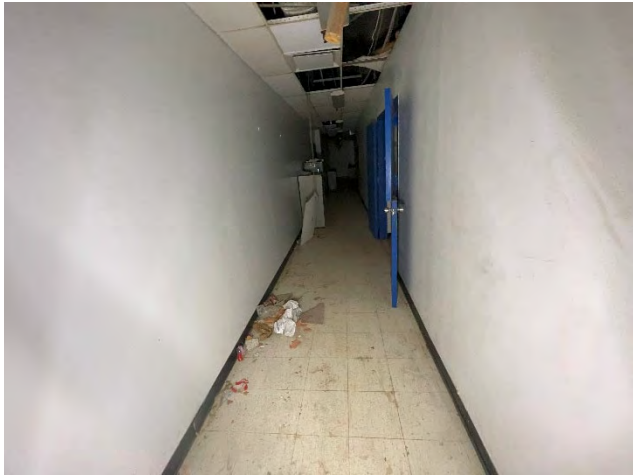
3	Building Component:	TYPICAL HALLWAY CONDITION

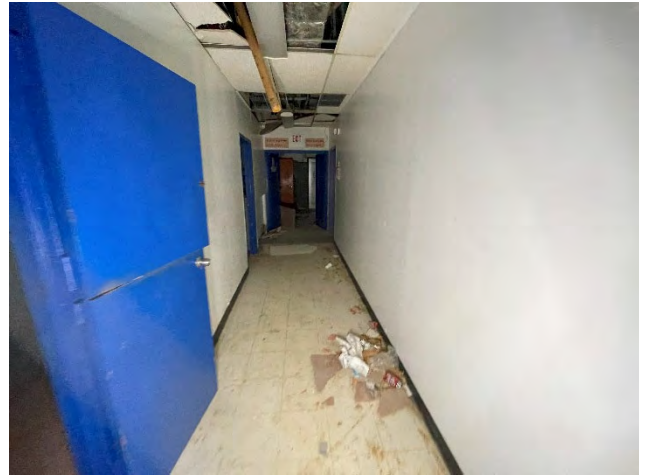
4	Building Component:	TYPICAL HALLWAY CONDITION

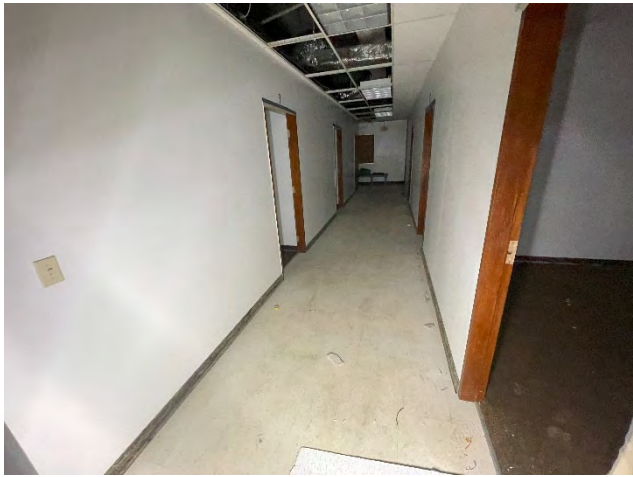
1	<i>Building Component:</i>	<b>TYPICAL HALLWAY CONDITION</b>

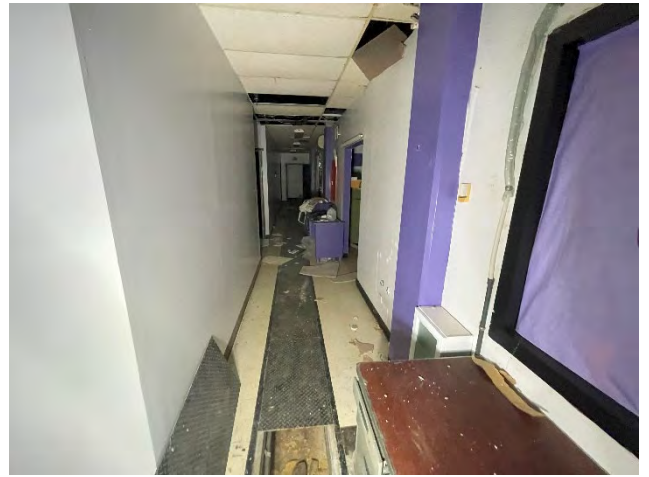
2	<i>Building Component:</i>	<b>TYPICAL HALLWAY CONDITION</b>

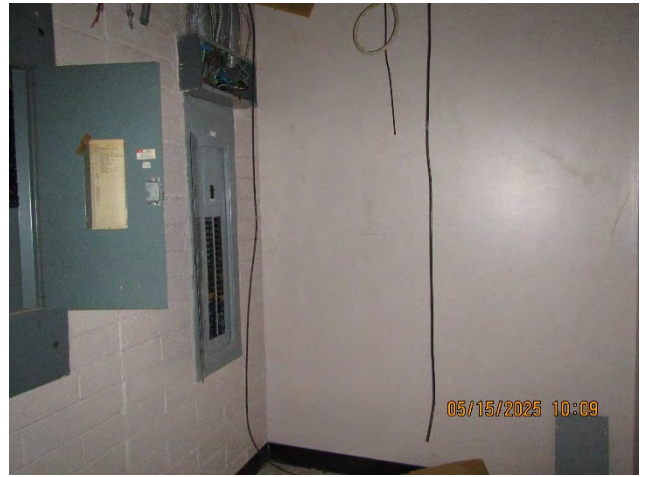
2	Building Component:	<b>2<sup>ND</sup> FLOOR COMMUNICATION ROOM/ SERVER ROOM</b>

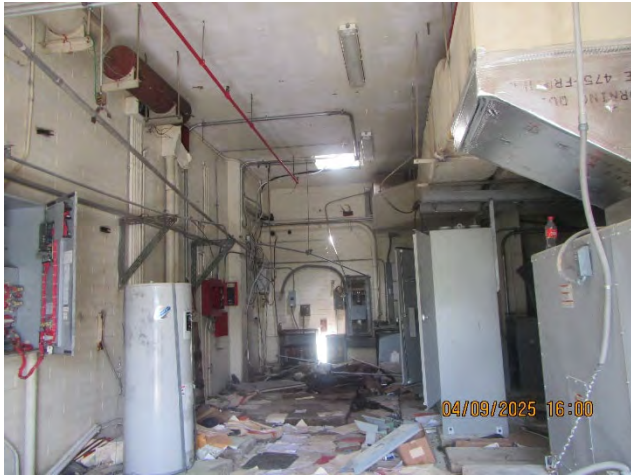
3	Building Component:	<b>2<sup>ND</sup> FLOOR ELECTRICAL ROOM</b>

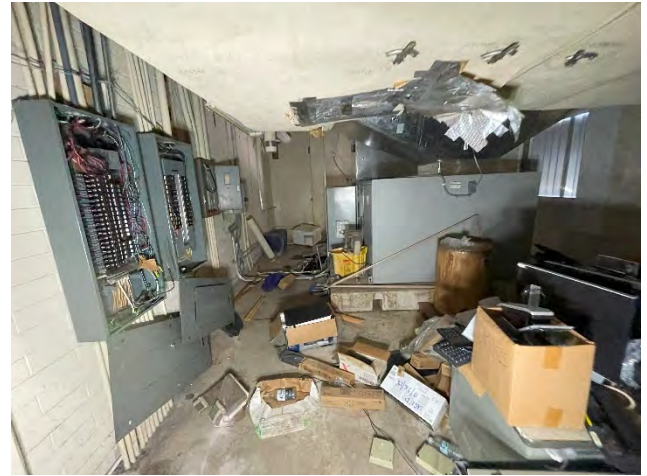
4	Building Component:	<b>2<sup>ND</sup> FLOOR ELECTRICAL ROOM</b>

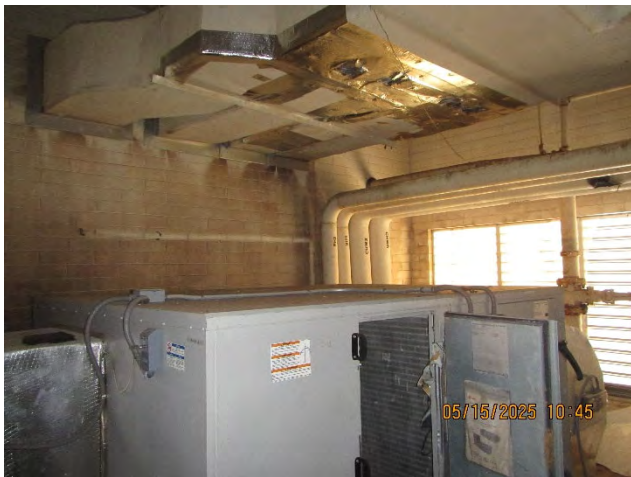
1	<i>Building Component:</i>	<b>1<sup>ST</sup> FLOOR MECHANICAL ROOM</b>

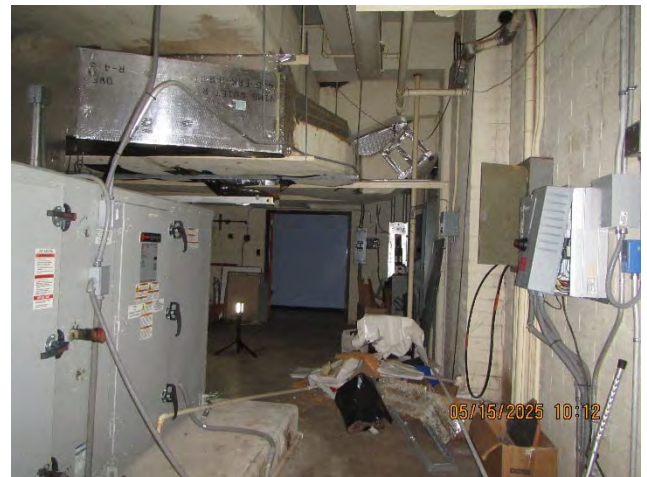
2	<i>Building Component:</i>	<b>1<sup>ST</sup> FLOOR MECHANICAL ROOM</b>

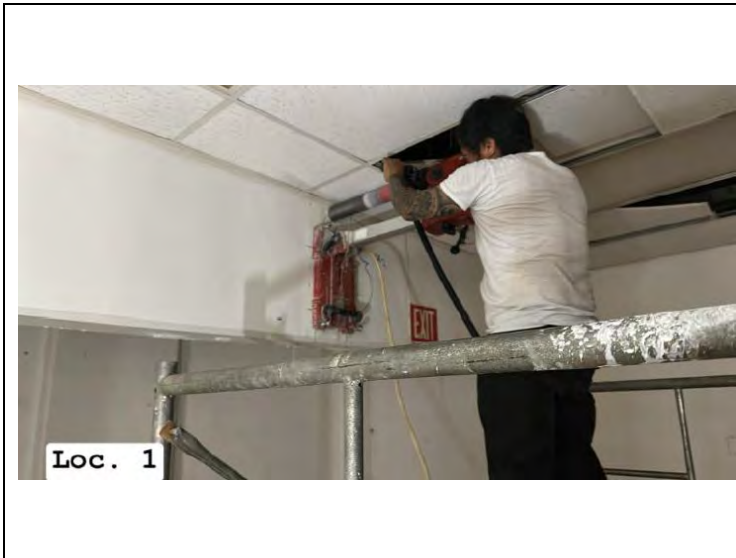
1	Building Component:	Concrete Beam
	Location:	Segment #1, Ground floor
	Activity:	Concrete Core Drilling

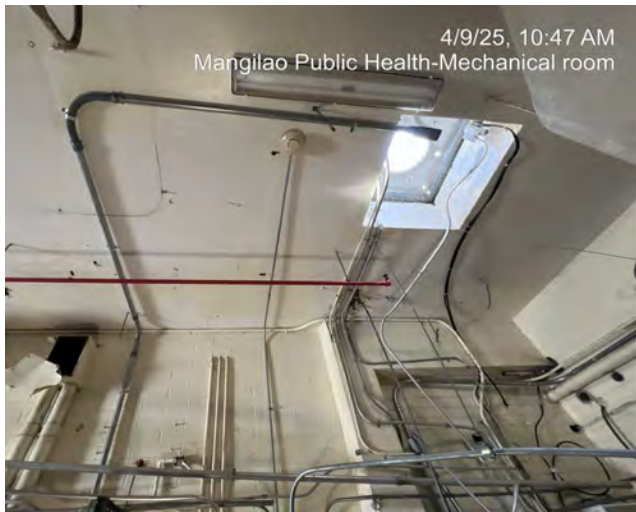
**Photo-1:**

Location:	Ground Floor - Mechanical Room
Remarks:	Blown-out Exhaust Ventilator

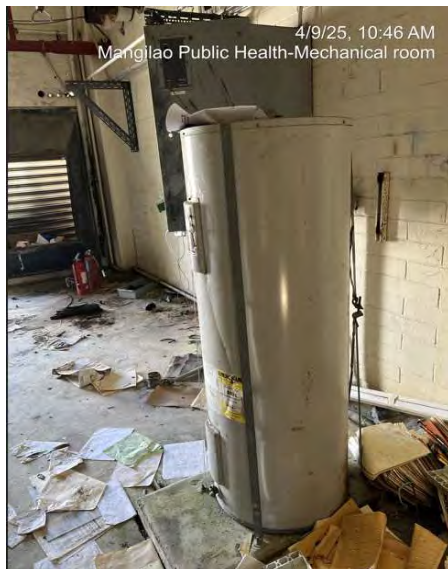
**Photo 3:**

Location:	Ground Floor - Mechanical Room
Remarks:	Abandoned Electric water heater. No piping

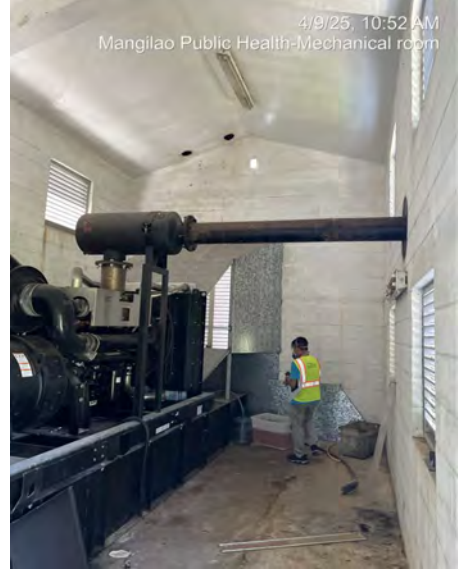
**Photo-12:**

The building has an existing generator located in an adjacent building near ground floor mechanical room with an internal sub-base fuel tank. The generator's exhaust pipe & muffler exhibited corrosion build up. The generator's radiator's exhaust duct had been damaged and torn out. The generator room didn't have room exhaust ventilation equipment. The room was naturally ventilated by the existing aluminum wall and door louver. The generator exhaust flue gas was vented through an opening penetration on the wall.

Location:	Generator Room
Remarks:	Exhaust Muffer with visible signs of corrosion. Damage generator radiator exhaust duct transition. No room exhaust ventilation fan.

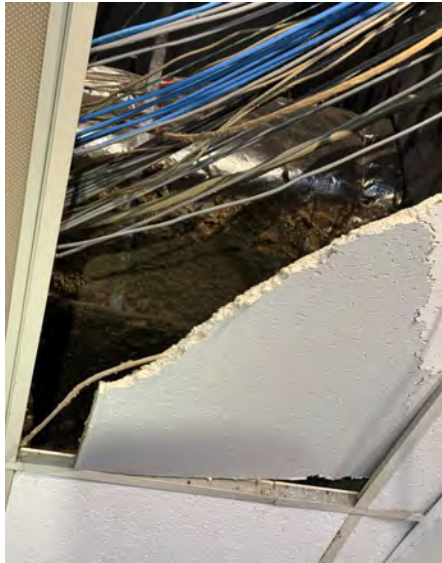
**Photo 19:**

Location:	Ground Floor - Dental Clinic Areas
Remarks:	Typical Supply Air Ductworks with visible sign of mold build-up.

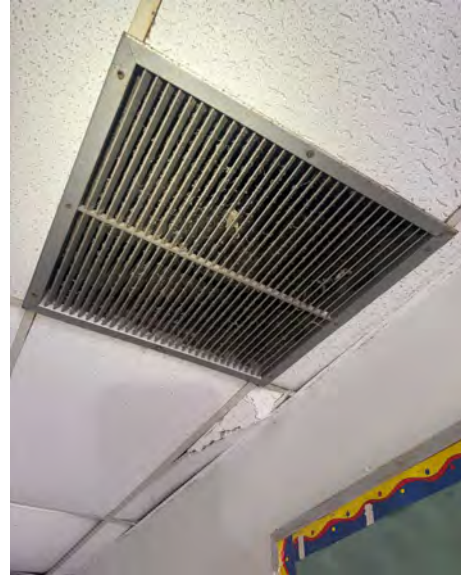
**Photo-20:**

Location:	Ground Floor - Dental Clinic Areas
Remarks:	Typical condition of return air registers with visible mold build-ups.

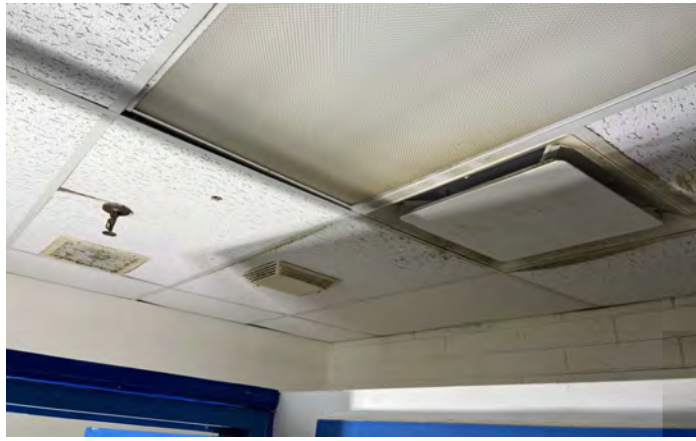
**Photo-21:**

Location:	Ground Floor - Restroom
Remarks:	Typical restroom supply and exhaust air registers condition. Shows visible sign of molds, deterioration & corrosion.

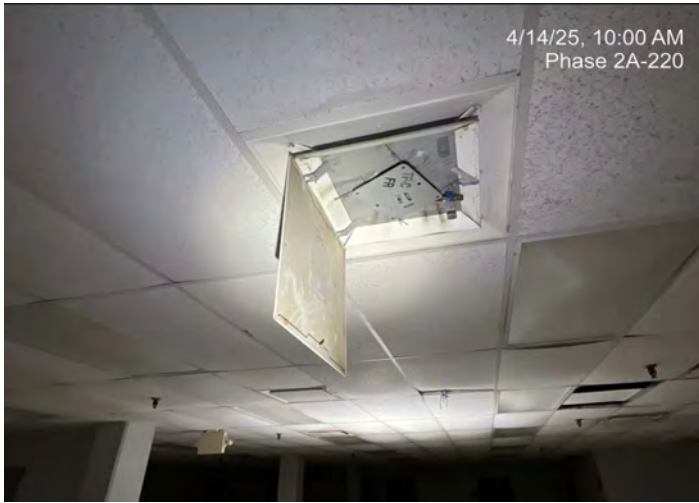
**Photo-25:**

Location:	Second Floor - Typical Office Area
Remarks:	Damage Supply register. Shows visible sign of molds and aging.

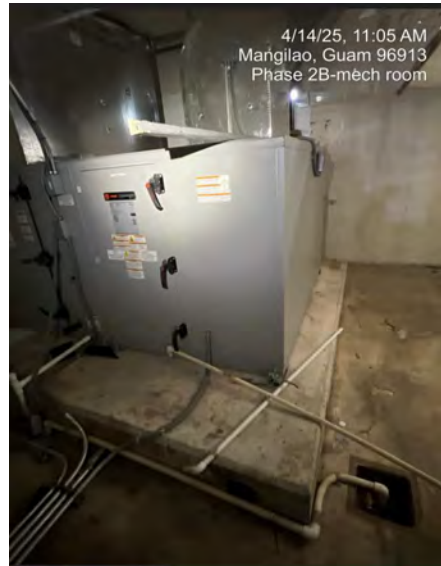
**Photo-26:**

Location:	Second Floor - Mechanical Room
Remarks:	Damage and abandoned Air-Handling unit. Cut refrigerant piping connections and electrical wirings

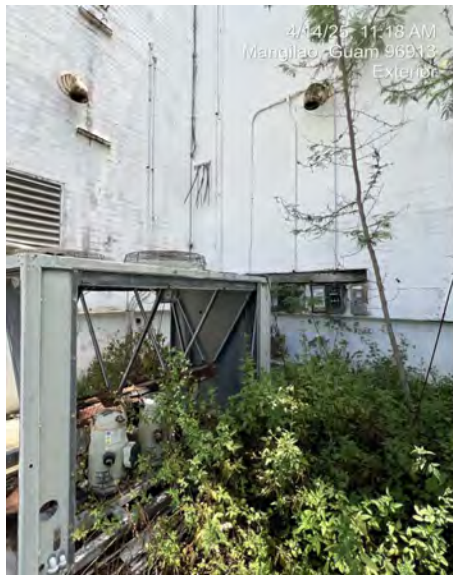
**Photo-29:**

**Location:** Outdoor - Air cooled condensing unit (ACCU)  
**Remarks:** Damage, corroded and blown-away casing of condensing unit of the split Air Conditioning system serving the facility. Damage control wirings and disconnect switch of ACCU units.
