RE: **Amended Committee Report on Public Hearing [Bill No. 21-38 \(COR\)](#)** – Tina Rose Muna Barnes – AN ACT TO TRANSFER LOT NO. 2417-1-R7, MUNICIPALITY OF MANGILAO FORMERLY KNOWN AS THE DEPARTMENT OF PUBLIC HEALTH AND SOCIAL SERVICES CENTRAL HEADQUARTERS, FROM THE DEPARTMENT OF PUBLIC HEALTH AND SOCIAL SERVICES TO THE GUAM COMMUNITY COLLEGE FOR THE CONSTRUCTION OF A NURSING ANNEX.

# CONDITIONAL ASSESSMENT OF MANGILAO PUBLIC HEALTH BUILDING

PROJECT NO.:460-5-1007-F-MAN  
FINAL REPORT  
July 18, 2025

**PROJECT: Professional Consulting Services for a Conditional Assessment of the Mangilao Public Health Building, Project No. 460-5-1007-F-MAN**

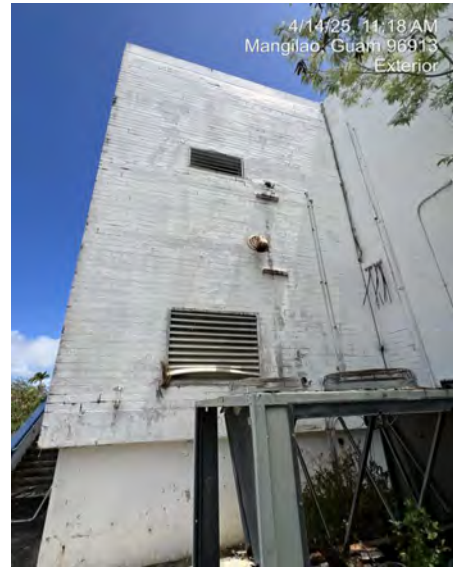
**Photo-30:**

**Location:** Outdoor - Air cooled condensing unit (ACCU)  
**Remarks:** Damage and blown-out refrigerant piping. Damage intake air louvers.

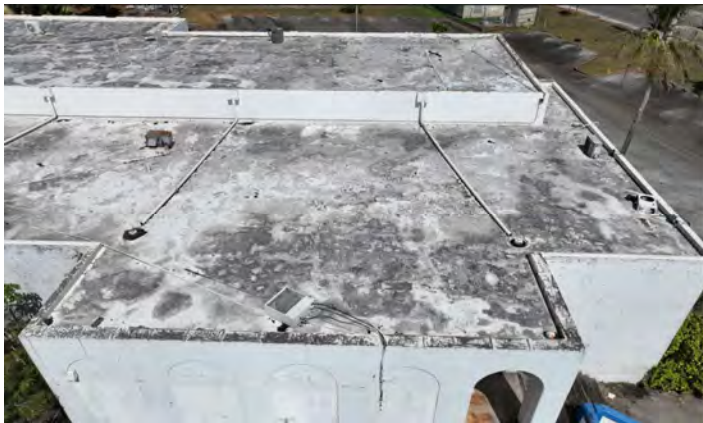
**Photo 31:**

**Location:** Roof Area 1A  
**Remarks:** Damage and blown-out roof mounted ACCU units and Ventilation Equipment including refrigerant piping, supports, wirings and accessories.

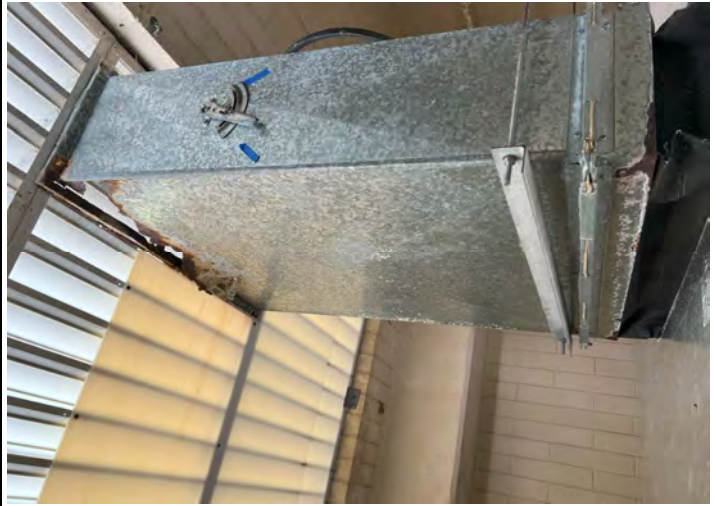
**Location:** Second Floor - Mechanical Room

**Remarks:** No insulation of outside air intake ductwork (Not compliance). Corroded duct.

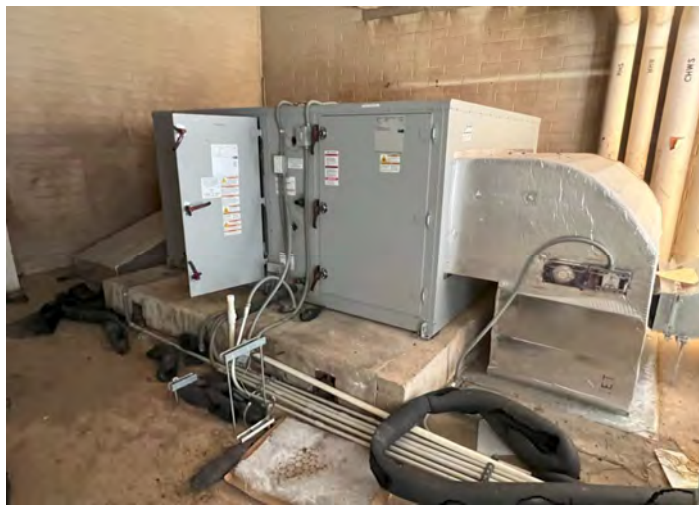
**Photo 35:**

**Location:** Ground Floor - General Return Registers

**Remarks:** Not working Air Handling unit (AHU. Shows cut refrigerant piping connections to AHU unit. No insulation of outside air intake ductwork (Not compliance)

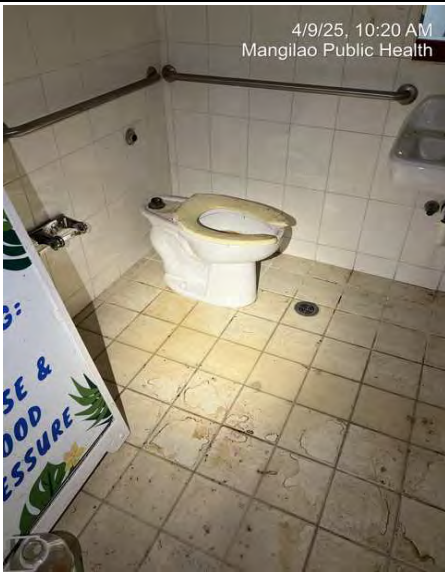
**Photo-1:**

Location:	Ground Floor - Womens Restroom
Remarks:	Typical condition of damage Water Closets with cut piping connections and missing flush Valves and covers.

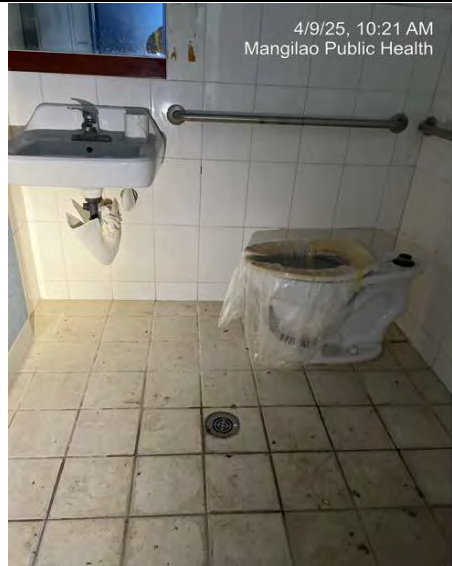
**Photo-2:**

Location:	Ground Floor - Mens Restroom ADA
Remarks:	Typical condition of damage Water Closets with cut piping connections and missing flush Valves and covers. Damage Lavatory piping covers.

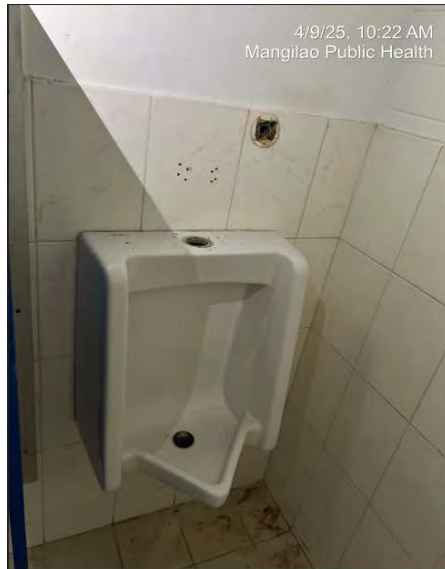
**Photo 3:**

Location:	Ground Floor - Mens Restroom
Remarks:	Typical condition of damage Urinals with cut piping connections and missing flush valves.

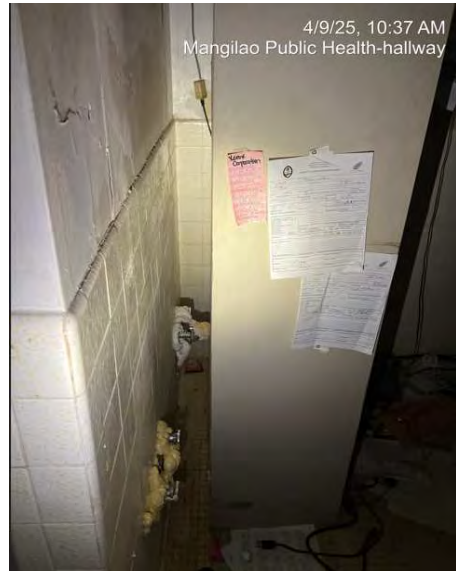
**Photo-6:**

Location: Ground Floor - Mens Restroom 1A  
Remarks: Cut and missing Plumbing fixtures.

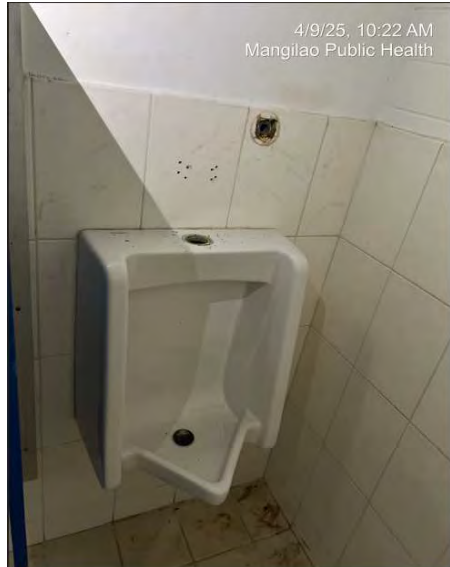
**Photo 7:**

Location: Ground Floor - Mens Restroom 1A  
Remarks: Typical condition of damage Urinals with cut piping connections and missing flush valves.

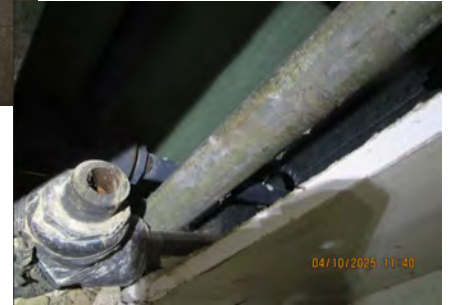
**Photo-10:**

Location:	Ground Floor - Typical Clinic Area with Sink
Remarks:	Cut piping connections (ABS piping).

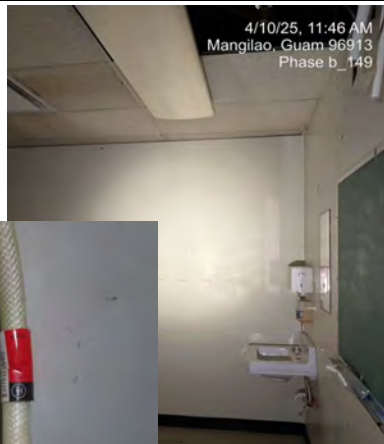
**Photo 11:**

Location:	Ground Floor - Typical Clinic Area with Sink
Remarks:	Typical condition of damage Clinic room Lavatory sink with cut piping connections and missing flush valve sets.

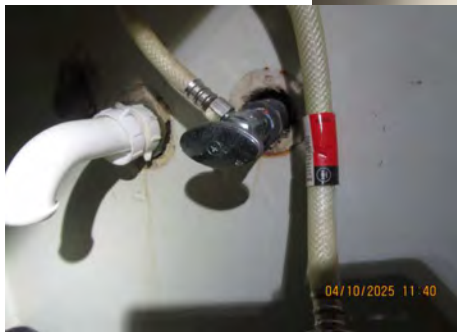
**Photo-12:**

Location:	Ground Floor - Typical Clinic Area with Sink
Remarks:	Typical condition of Sink with signs of aging, visible corrosion.

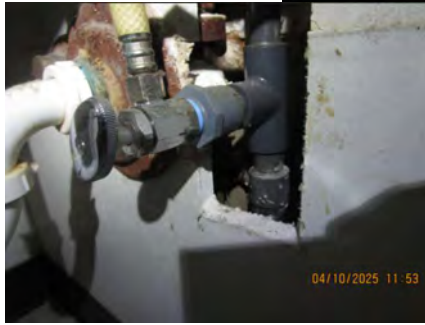
**Photo-13:**

Location:	Ground Floor - Clinic Area Rooms
Remarks:	Typical condition of damage Sink visible sign of aging and corrosion.

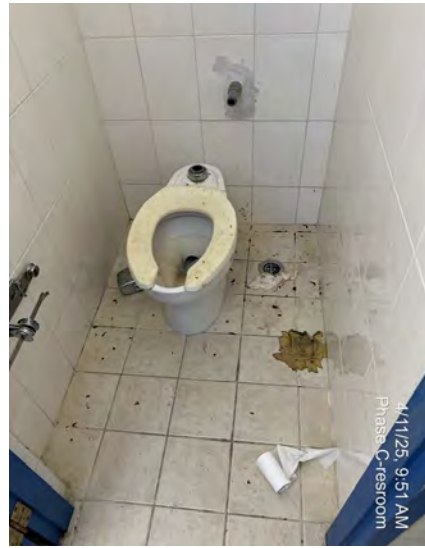
**Photo-14:**

Location:	Ground Floor - Dental Area Restroom
Remarks:	Typical condition of damage Water Closets with cut piping connections and missing flush Valves and covers. Damage Lavatory piping covers.

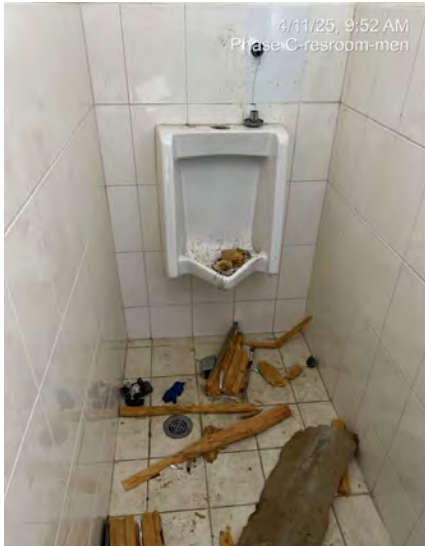
**Photo 15:**

Location:	Ground Floor - Dental Area Restroom
Remarks:	Typical condition of damage Urinals with cut piping connections and missing flush valves.

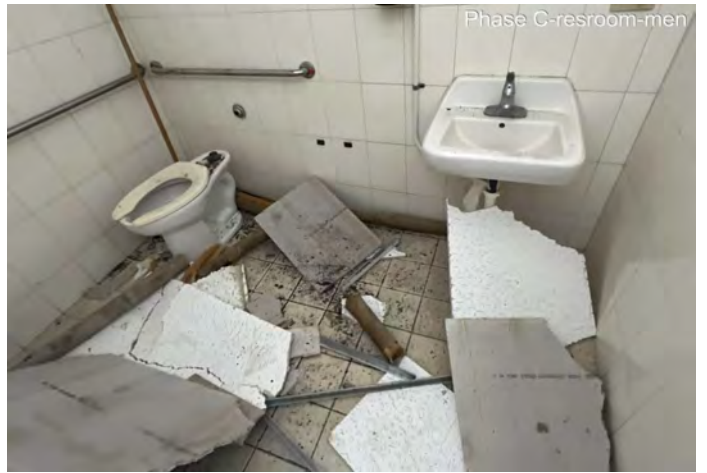
**Photo-16:**

Location:	Ground Floor - Typical Clinic Area with Sink
Remarks:	Typical condition of damage Water Closets with cut piping connections and missing flush Valves and covers. Damage Lavatory piping covers.

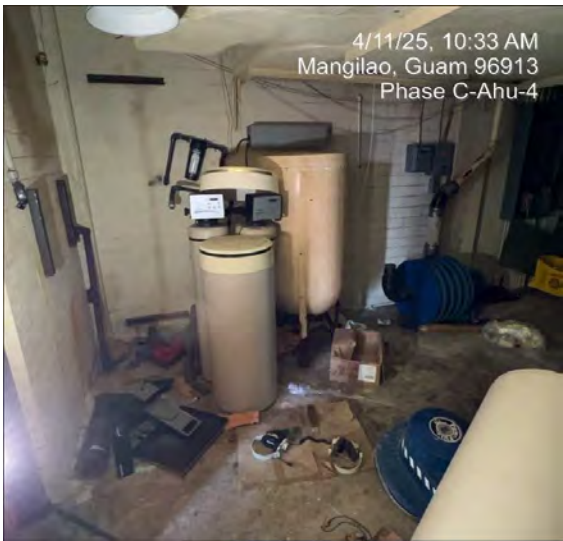
**Photo-17:**

Location:	Ground Floor - Mechanical Room 1C
Remarks:	Abandoned Water softener including brine tanks. Cut piping connections

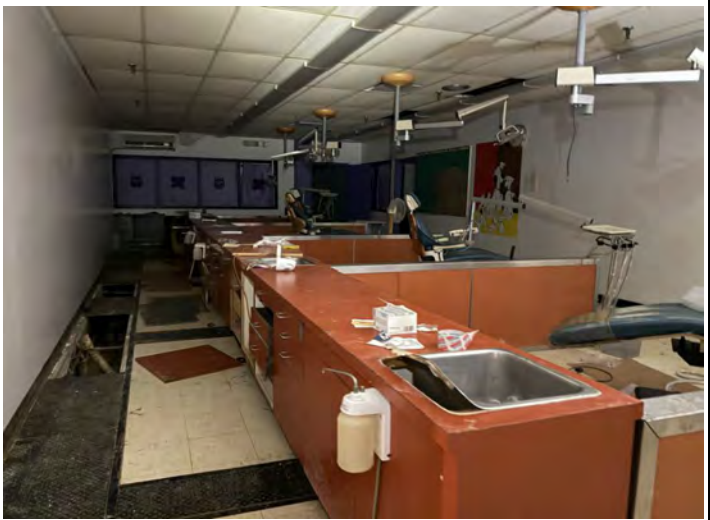
**Photo-18:**

Location:	Ground Floor - Dental Clinic Area
Remarks:	Cut and damage coldwater piping in trench for dental equipments and sinks cold water supply. Damage sink

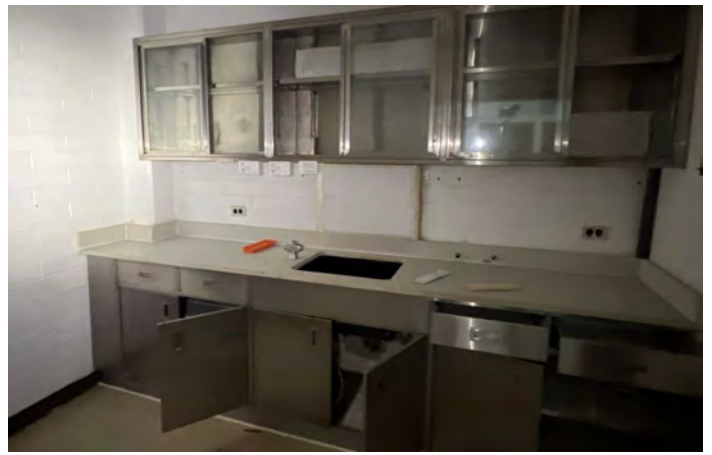
**Photo-22:**

Location:	Ground Floor - Enzymes Room
Remarks:	Cut and damage cold & hot water piping supply and waste piping in sink. Missing faucets.

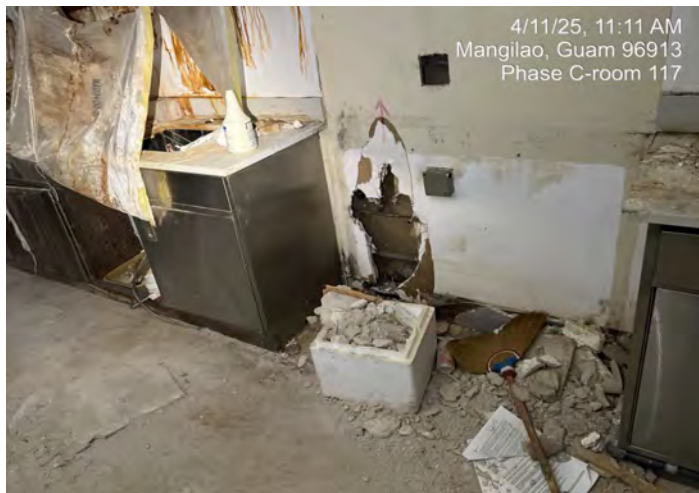
**Photo 23:**

Location:	Ground Floor - Urinalysis
Remarks:	Cut and damage pipings, sink, missing plumbing fixtures.

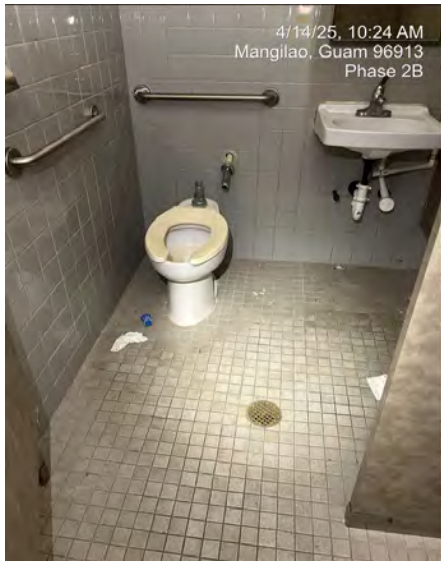
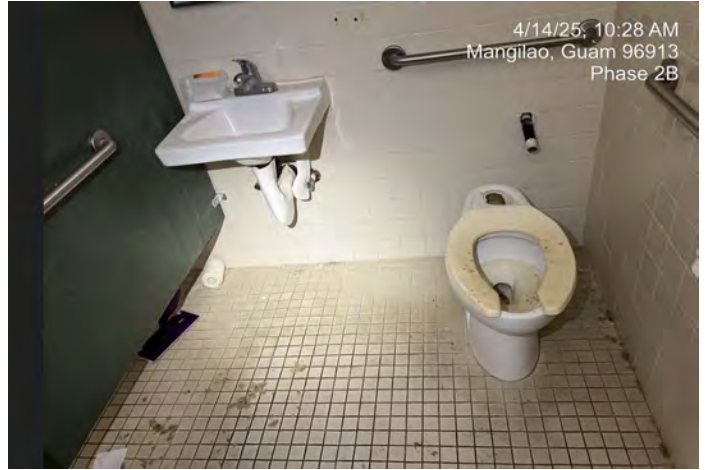
Location:	Second Floor - Rest Rooms ADA	Location:	Second Floor - Rest Rooms ADA
Remarks:	Typical condition of damage Water Closets with cut piping connections and missing flush Valves and covers.	Remarks:	Typical condition of damage Water Closets with cut piping connections and missing flush Valves and covers.

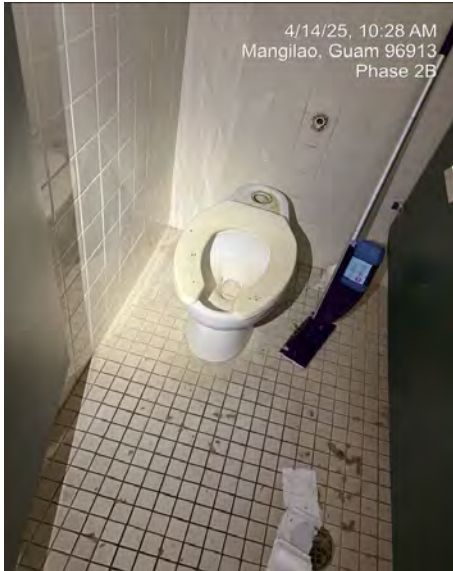
Location:	Second Floor - Rest Rooms	Location:	Second Floor - Rest Rooms
Remarks:	Typical condition of damage Water Closets with cut piping connections and missing flush Valves and covers.	Remarks:	Typical condition of damage Water Closets with cut piping connections and missing flush Valves and covers.

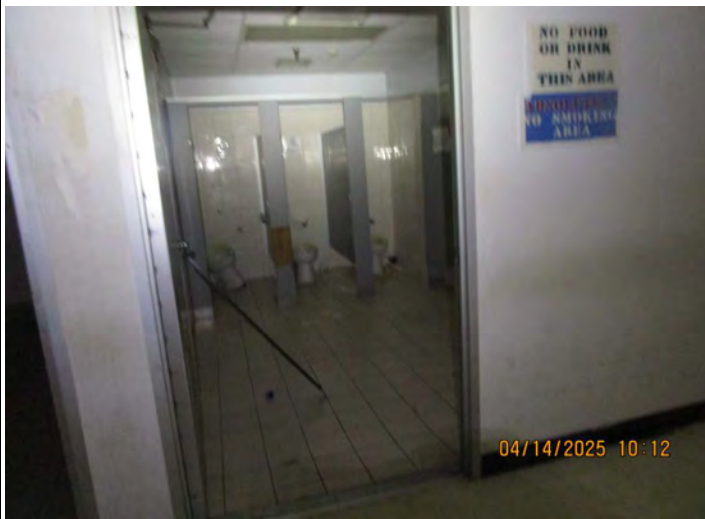
**Photo-29:**

**Location:** Second Floor - Rest Rooms  
**Remarks:** Typical condition of damage Water Closets with cut piping connections and missing flush Valves and covers.

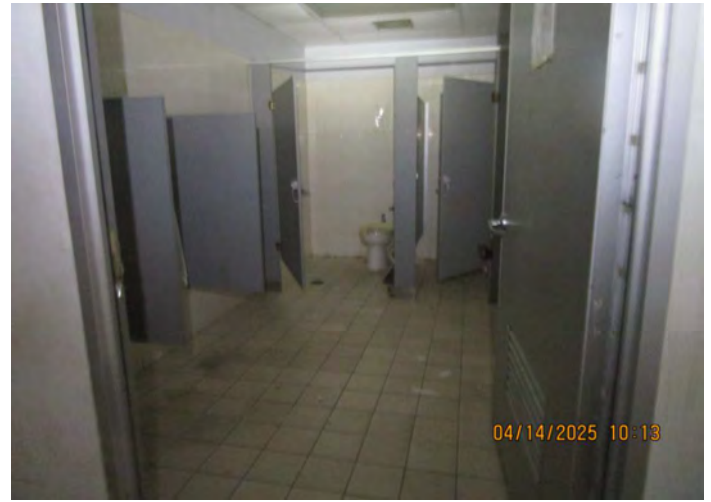
**Photo-30:**

**Location:** Second Floor - Rest Rooms ADA  
**Remarks:** Typical condition of damage Water Closets with cut piping connections and missing flush Valves and covers.

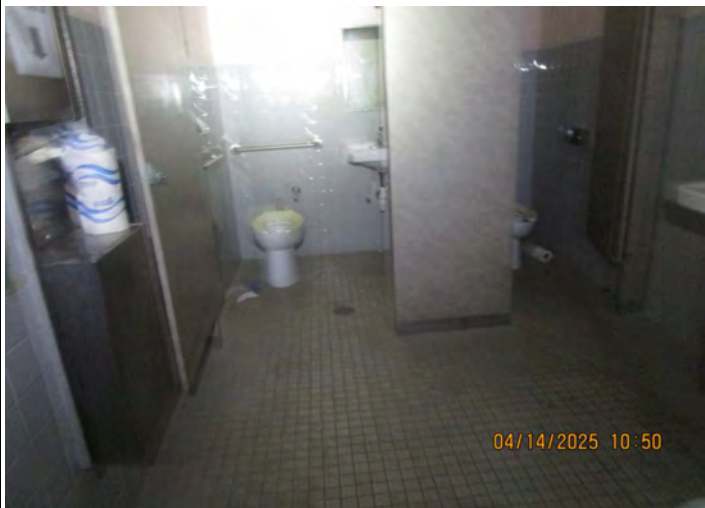
**Photo 31:**

**Location:** Second Floor - Rest Rooms  
**Remarks:** Typical condition of damage Water Closets with cut piping connections and missing flush Valves and covers.

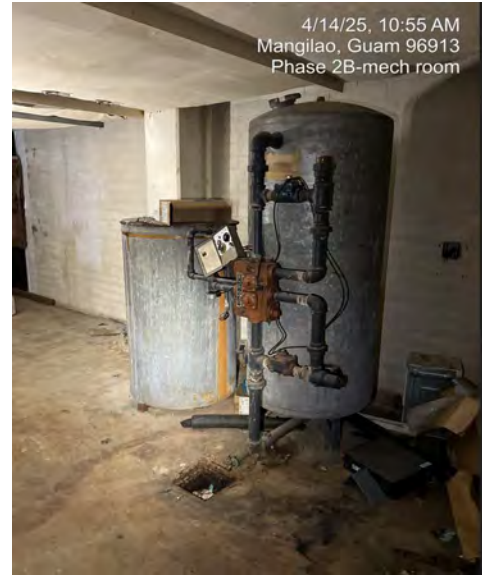
**Photo-32:**

**Location:** Second Floor - Mechanical Room  
**Remarks:** Disconnected and cut piping for Water Softener and Brine Tank. Tank shown visible signs of corrosion. Typical corroded Floor drains in mechanical rooms.

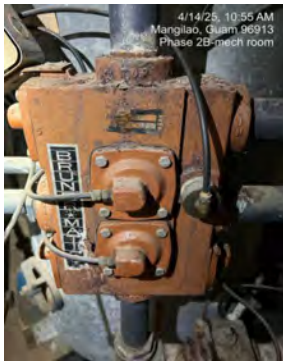
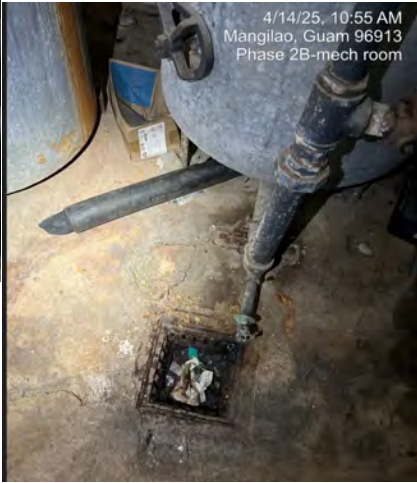
**Photo-33:**

Location:	Second Floor - Mechanical room		
Remarks:	Disconnected and cut piping for Water Softener and Brine Tank. Tank shown visible signs of corrosion. Typical corroded Floor drains in mechanical rooms.

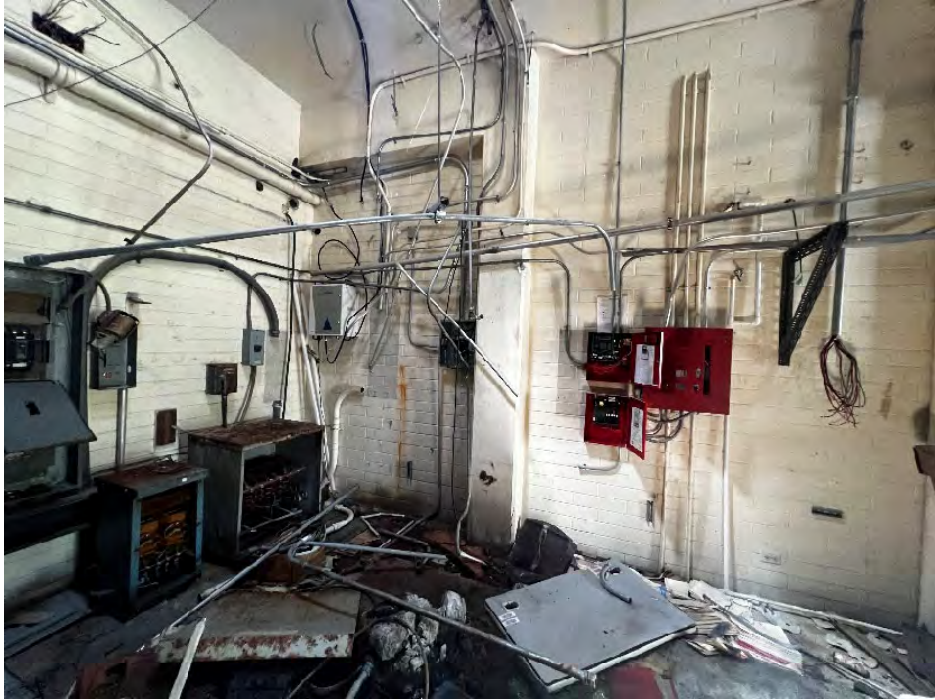
All electrical components in this area, including conduits and wiring, are visibly corroded, outdated, and non-functional. Additionally, the facility's electrical infrastructure includes sub-electrical rooms (one on the 1st floor, two on the 2nd floor), with some panelboards placed in public areas—a clear code and safety concern. The panelboard involved in the 2019 electrical fire incident is located along an office entryway wall.

PHOTO #3 – UNUSABLE ELECTRICAL EQUIPMENT, CONDUITS, AND WIRING

A full and uncompromising replacement of the electrical service and distribution systems is imperative. The existing infrastructure presents serious life safety hazards, is in violation of multiple NEC requirements, and cannot be trusted to support operations—particularly in a facility that delivers essential public health services.

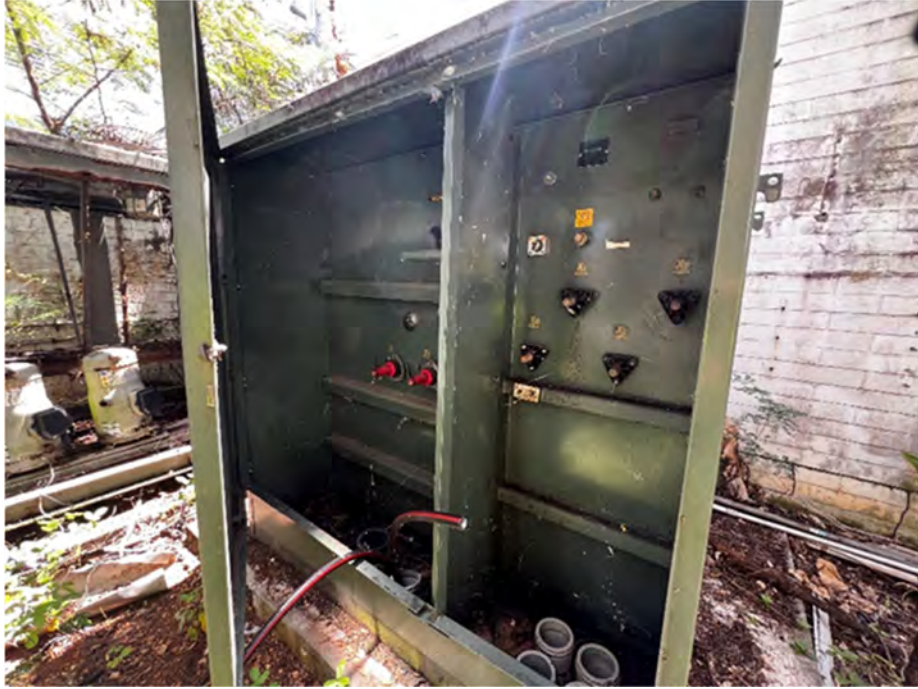
PHOTO #6 – THEFT OF GENERATOR FEEDER WIRING

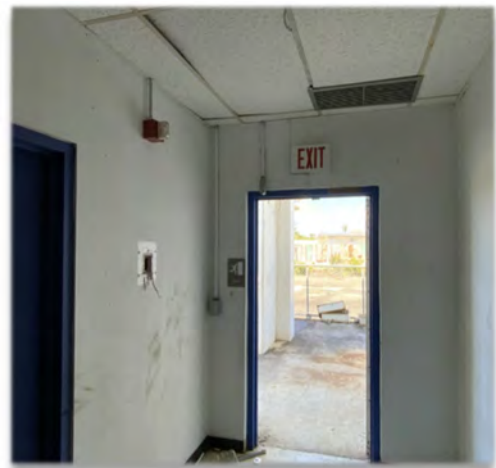
Fig. 5 Missing pull station.

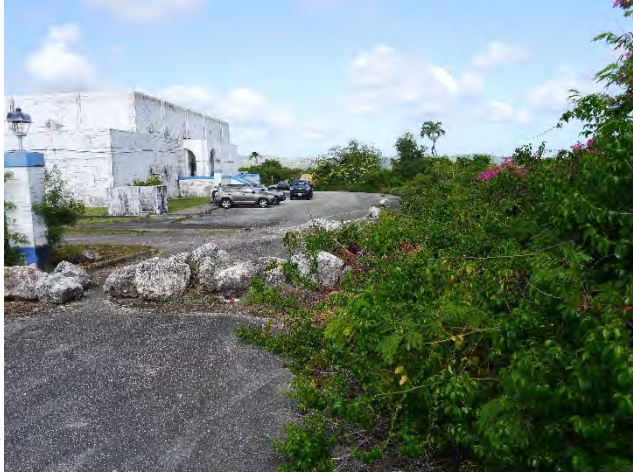
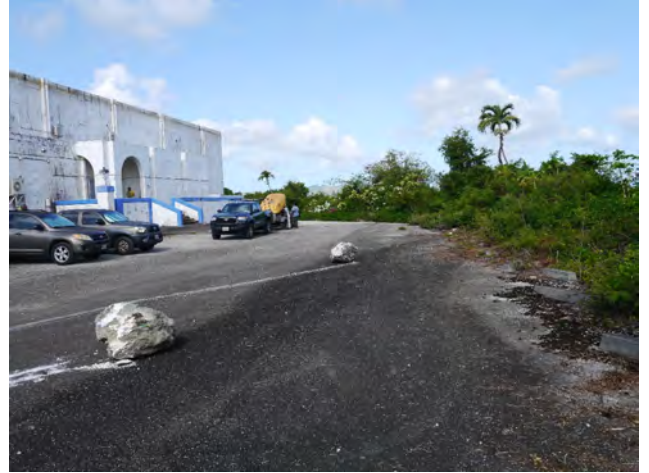
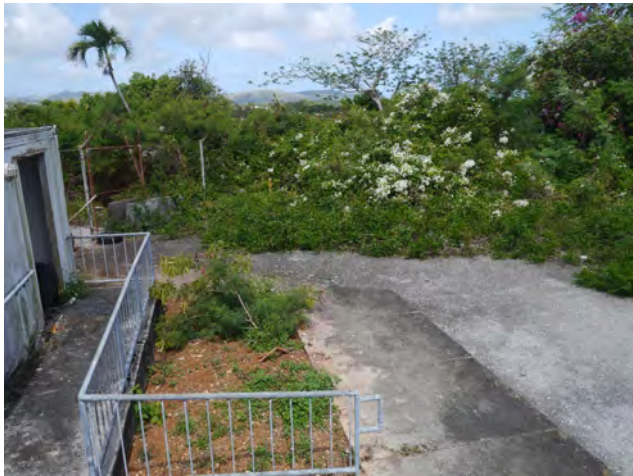
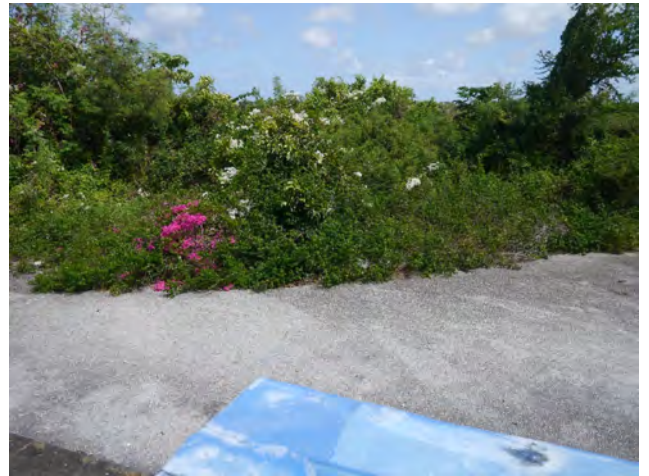
EMPSCO observed significant thick growth of shrubs and bushes around the property boundaries and adjacent to the building around at the north, northwest, and west portions (see pages 1-2; page 3, photo 1).

1	<i>Description:</i>	<b>Overgrown shrubs and bushes – North Side</b>

2	<i>Description:</i>	<b>Overgrown shrubs and bushes – North Side</b>

3	<i>Description:</i>	<b>Overgrown shrubs and bushes – North Side</b>

4	<i>Description:</i>	<b>Overgrown shrubs and bushes – North Side</b>

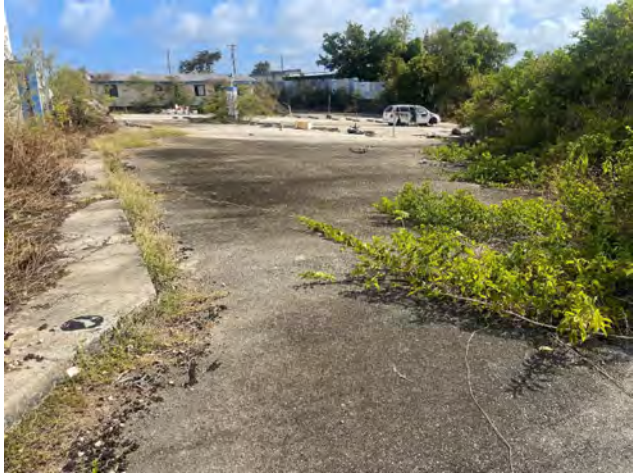
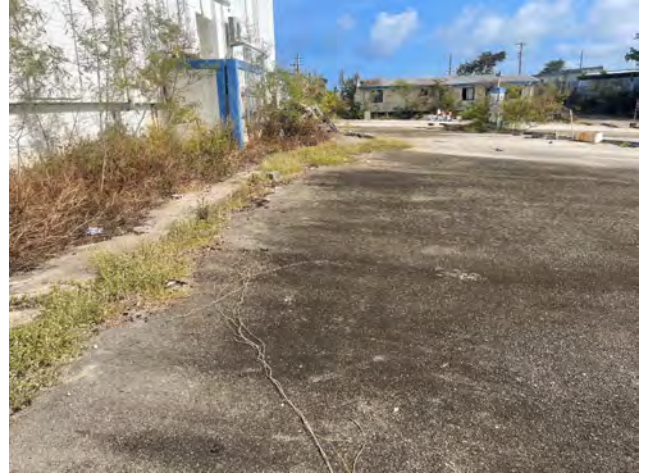
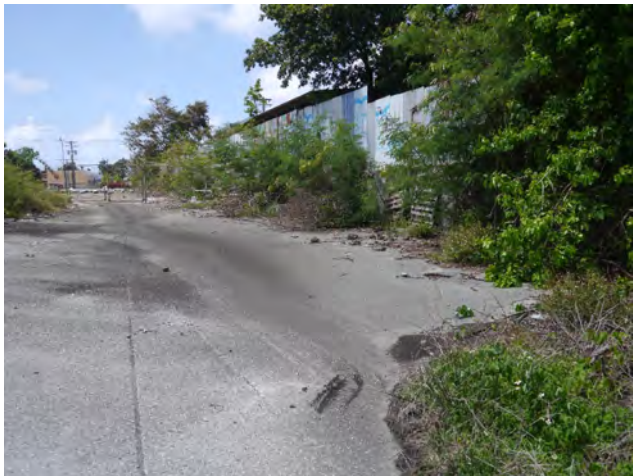
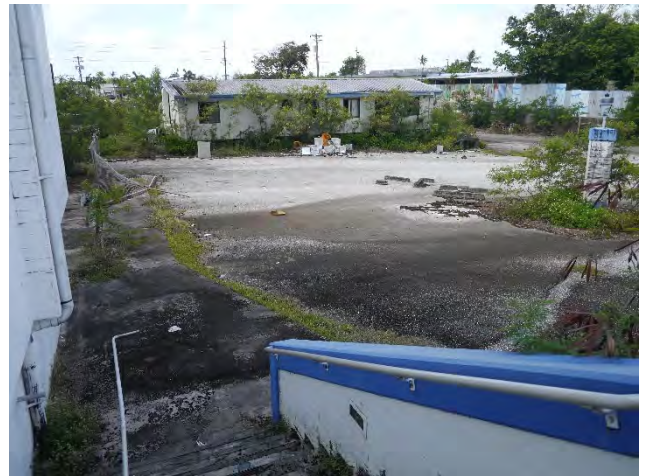
1	<i>Description:</i>	<b>Overgrown shrubs and bushes – Northwest Side</b>

2	<i>Description:</i>	<b>Overgrown shrubs and bushes – West Side</b>

3	<i>Description:</i>	<b>Overgrown shrubs and bushes – West Side</b>

4	<i>Description:</i>	<b>Overgrown shrubs and bushes – West Side</b>

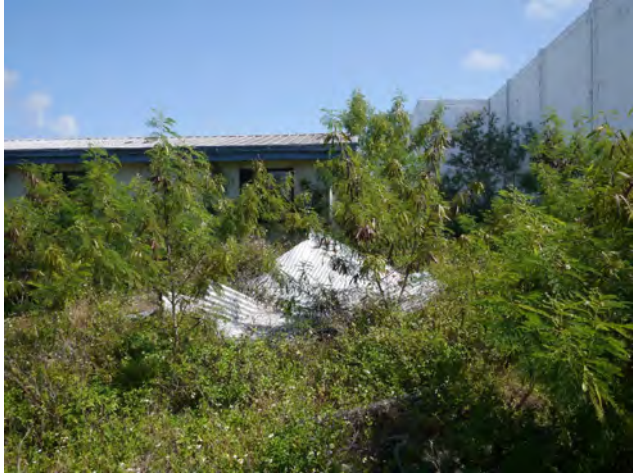
1	<i>Description:</i>	<b>Overgrown shrubs and bushes, and debris around Building 5 – West Side</b>

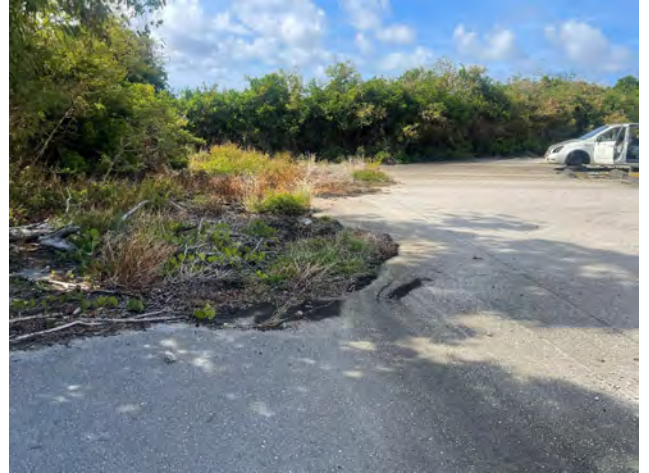
Visual evidence of run-off water and trace of sediments from runoff is observed at the north side area of the property (see page 3, photo 2). Currently storm water flows into a low-lying area which appears to be outside the property boundary. The existing storm water system appears to serve the intended function for the facility. However, such system would no longer be considered as compliant with EPA guidelines for BMP for storm runoff. Property drainage generally appeared to be in fair condition and the site drainage appeared to be satisfactory as observed. There could be possibility that portion of storm water runoff from adjacent properties and the surrounding roadways does occur.

2	<i>Description:</i>	<b>Sediments collected overtime at low area from stormwater runoff – West side</b>

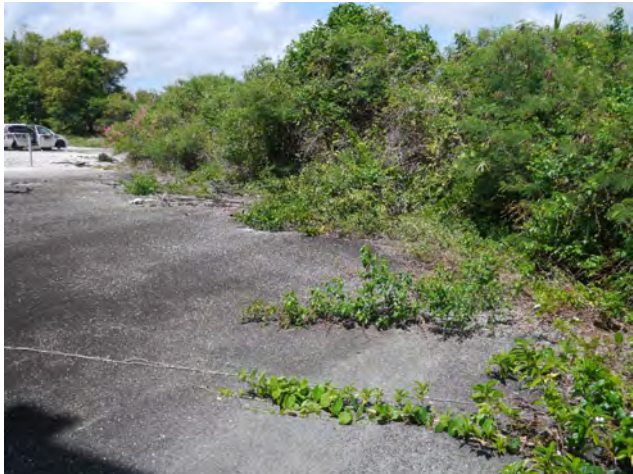
3	<i>Description:</i>	<b>Cyclone fence is barely visible due to overgrown shrubs and bushes – West side</b>

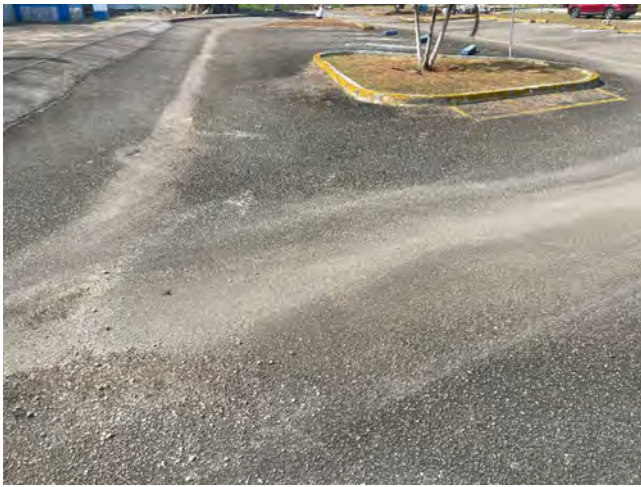
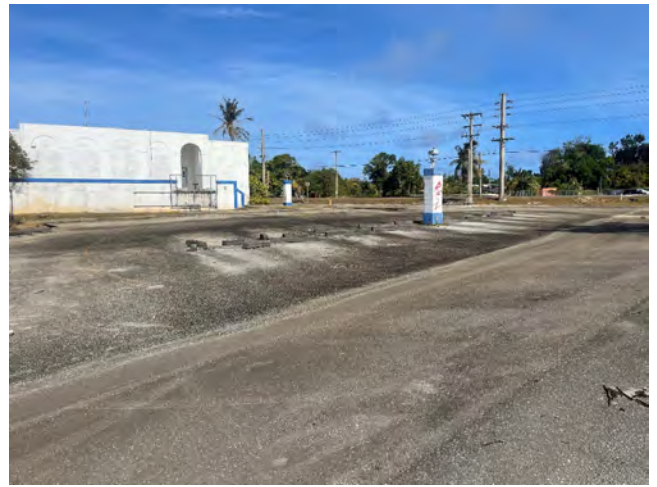
3	<i>Description:</i>	<b>Typical existing condition of pavement.</b>

4	<i>Description:</i>	<b>Typical existing condition of pavement.</b>

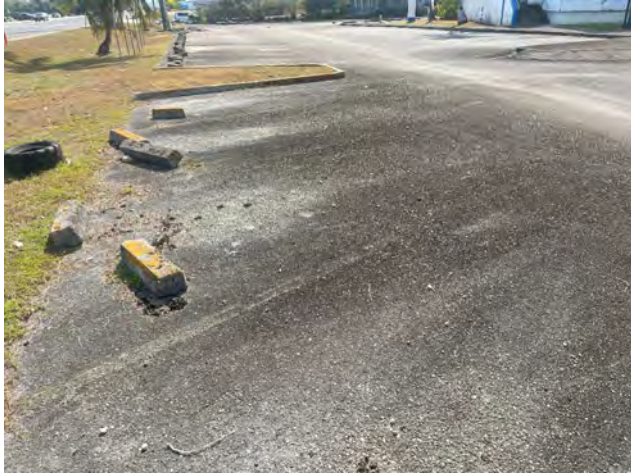
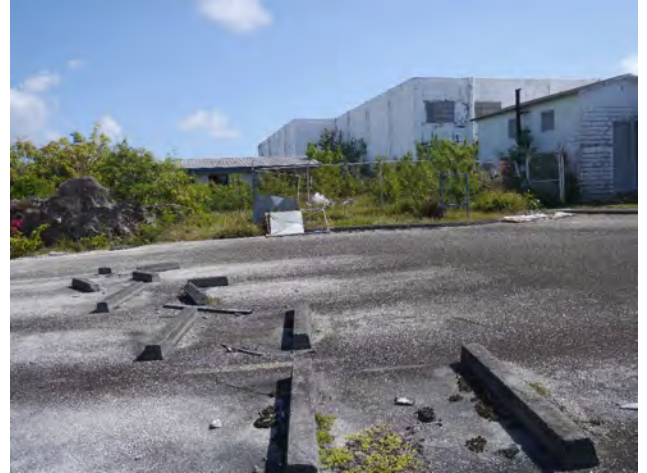
1	<i>Description:</i>	<b>Damaged concrete wheel stops.</b>

2	<i>Description:</i>	<b>Damaged concrete wheel stops.</b>

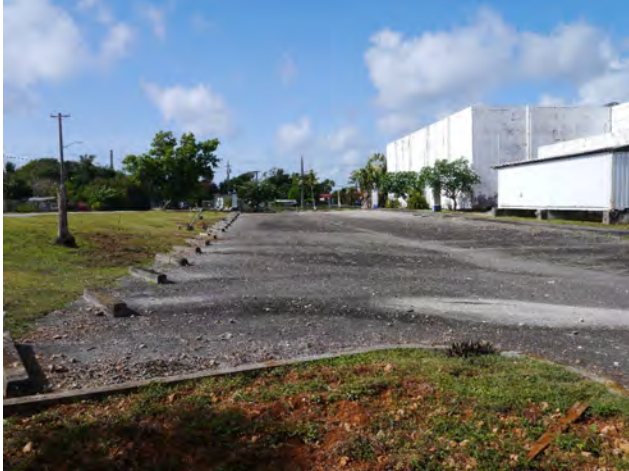
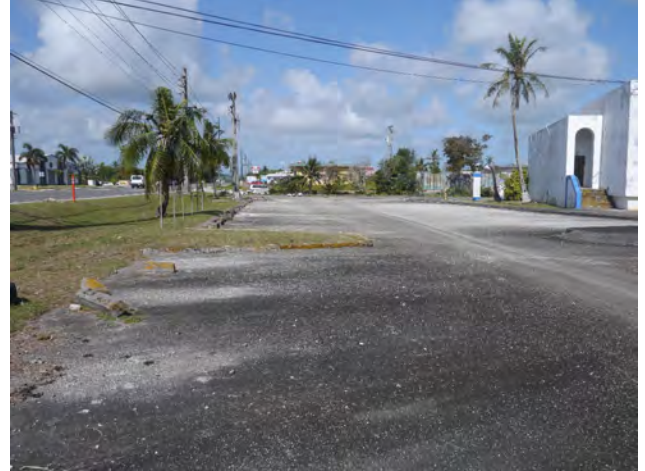
1	<i>Description:</i>	<b>Parking stripes are hardly visible and eroded.</b>

2	<i>Description:</i>	<b>Parking stripes are hardly visible and eroded.</b>

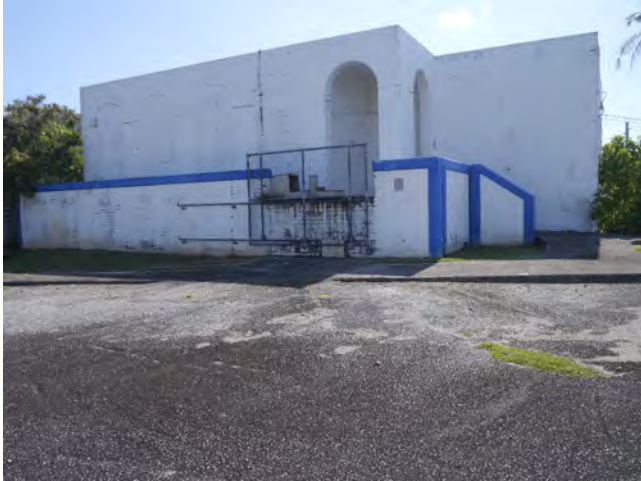
1	<i>Description:</i>	<b>Loading dock at building 1.</b>

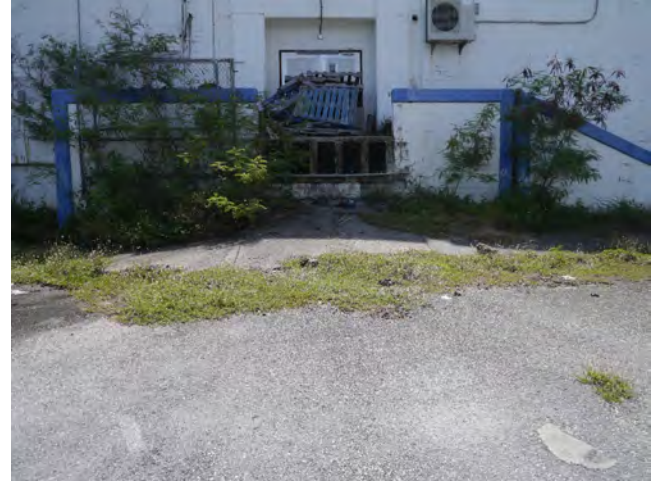
2	<i>Description:</i>	<b>Loading dock at building 3.</b>

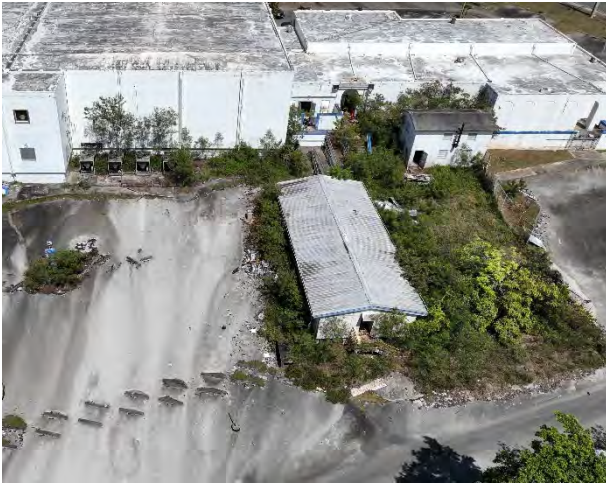
3	<i>Description:</i>	<b>Heavy vegetation growth around building 5.</b>

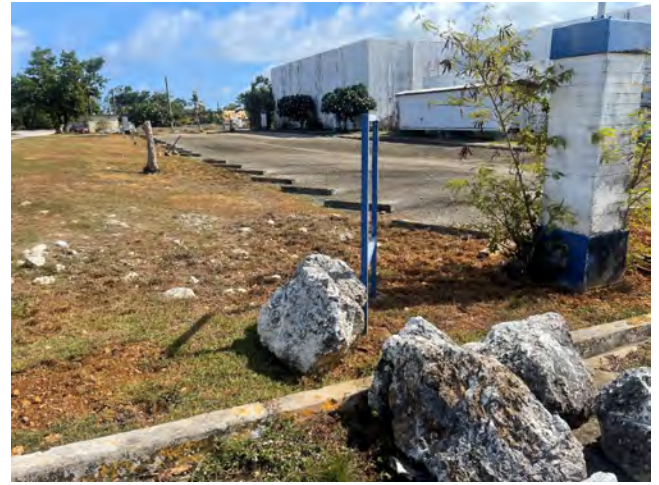
4	<i>Description:</i>	<b>Unnecessary vegetation and tree stumps.</b>

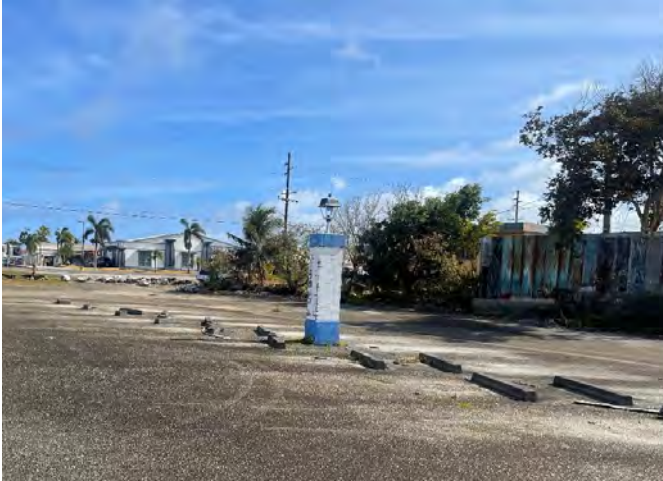
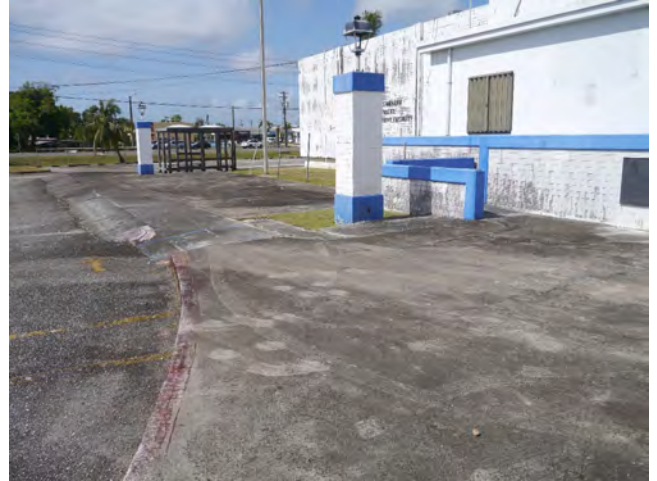
1	<i>Description:</i>	<b>Typical outdoor concrete post-mounted lighting.</b>

2	<i>Description:</i>	<b>Typical outdoor concrete post-mounted lighting.</b>

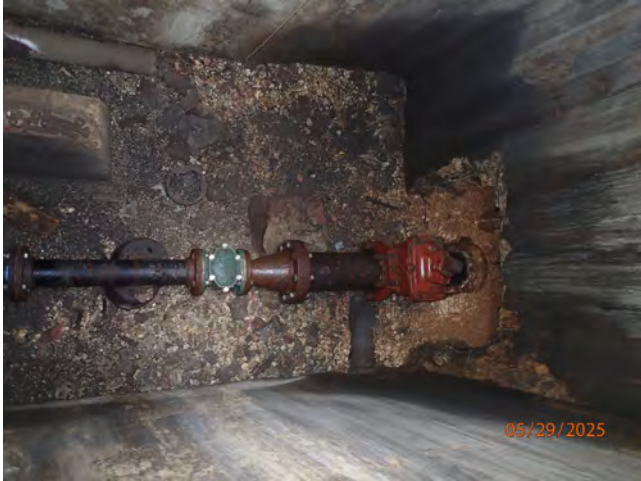
3	<i>Description:</i>	<b>Existing sewer manhole located along Chalan Kareta Road.</b>
